Version: 2.0

6th October 2020

Proposed Removal of Asbestos - Dr Williams's Library: Heritage Statement

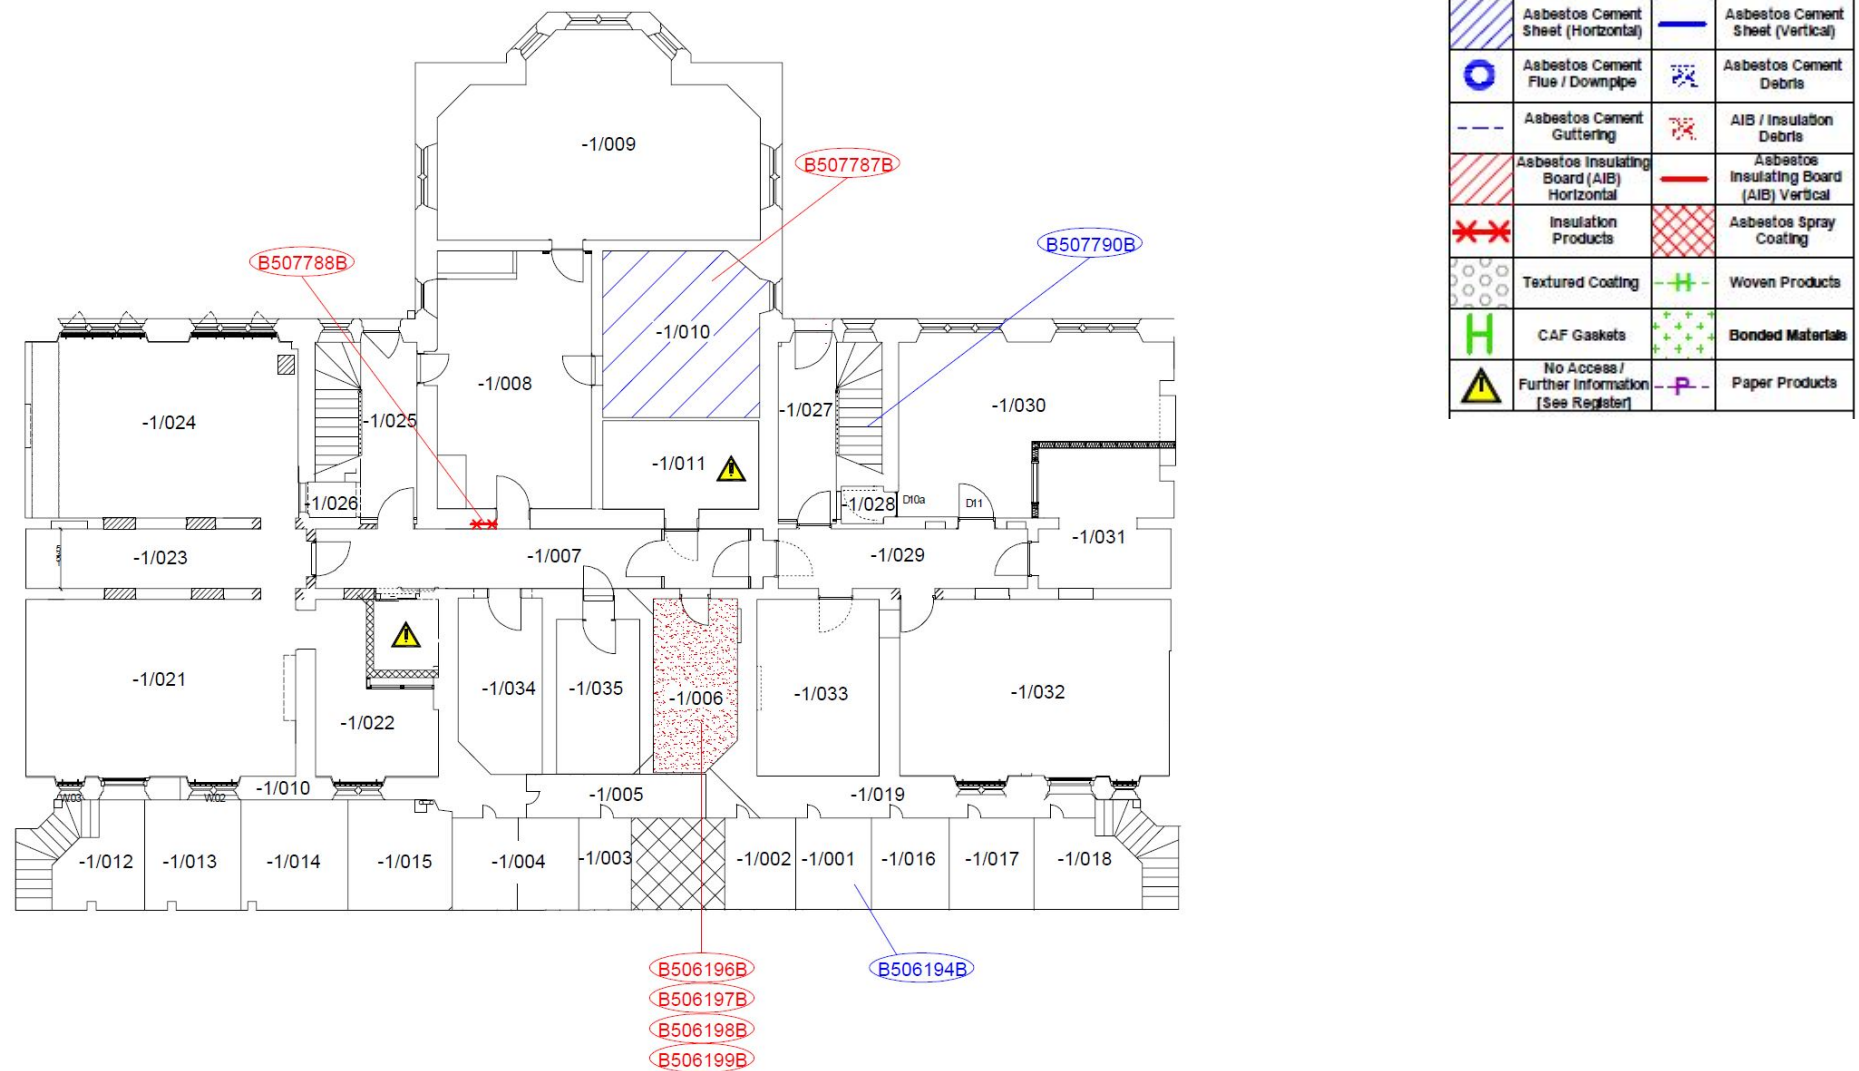
Figure 9: Extract from RPS Asbestos Survey Report 2017 – Plan Level 1

Room Ref	Asbestos	Sample Ref	Form	Location	Extent	Risk Assessment	Action By
1/005 Stair lobby	Present	As B507796B	Insulating Board Products	Door surround panels and panel above door	4 sqm	6/C	17/05/2018
		Recommendations: Re-inspect at recommended intervals.					
1/006 Corridor	Present	As B507796B	Insulating Board Products	Door surround panels and panel above door	4 sqm	6/C	17/05/2018
		Recommendations: Re-inspect at recommended intervals.
