Re: Trees at 12 Park Village West, London NW1 4AE

Tree Condition Letter: 12 Park Village West, London NW1 4AE
 Instructing party: Tony Cox on behalf of Sir Cameron Mackintosh, 1 Bedford Square, London WC1 3RB
 Prepared by: Adam Hollis of Landmark Trees, Holden House, 4th Floor, 57 Rathbone Place, London W1T 4JU

12 Park Village West, London
C737-P-31012019 Proposed arboricultural works

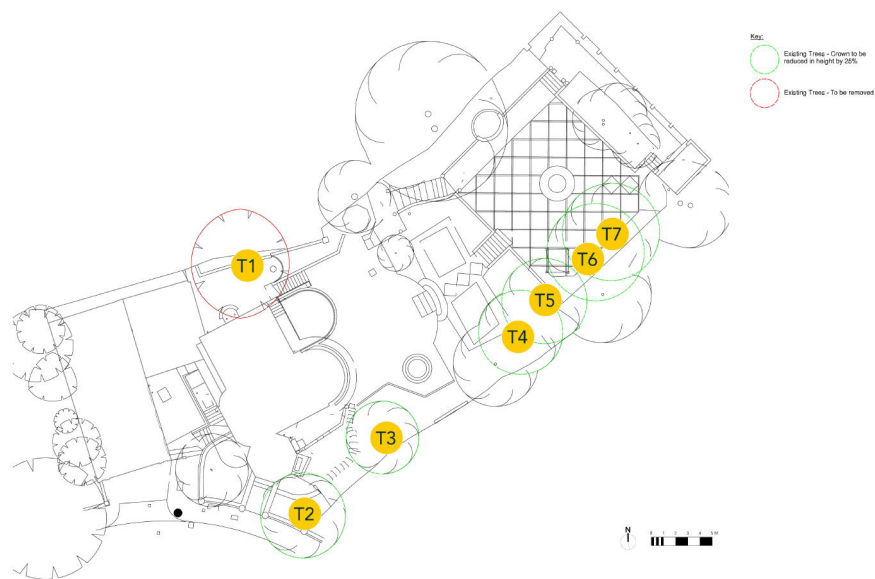
Reference	Botanical name	Common name	Height (metres) (approx.)*	Canopy diameter (metres) (approx.)*
T1	Tilia x europaea	Lime	12	6
T2	Laurus nobilis	Bay	6	4
T3	Laurus nobilis	Bay	6	5
T4	Laurus nobilis	Bay	7	4
T5	Tilia x europaea	Lime	12	5
T6	Acer pseudoplatanus	Sycamore	12	5
T7	Acer pseudoplatanus	Sycamore	12	5

Following exploration of the above potential approaches, a practical and long-term solution would be the removal of T1 and its replacement elsewhere in the garden with a tree more appropriate to the scale of the locality and site conditions. Please see the following page for further information on suggested alternatives.
