TECHNICAL REPORT ON A SUBSIDENCE CLAIM

[REDACTED]
**Fairhazel Co-Operative Limited
Flat 1
26 Canfield Gardens
London
NW6 3LA**

[REDACTED]
DATE 15 December 2018

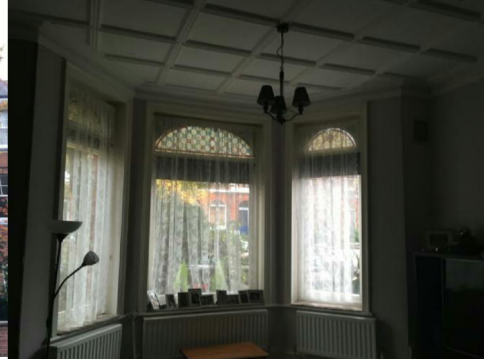
Front lounge – cornice crack

Horizontal crack along front cornices to bay 1 to 6mm

In structural terms the damage falls into Category 3 of Table 1, Building Research Establishment⁷ Digest 251, which describes it as "moderate".

The pattern and nature of the cracks is indicative of an episode of subsidence. The cause of movement appears to be clay shrinkage.
