## Arboricultural Consultancy for Esure

| Insured | | Address | 34 Laurier Road, London, NW5 1SJ | | |
| Report Date | 03/12/2020 | | | | |

Damage relates to the front entrance steps of the insured dwelling. Please refer to the engineers report for a full description of the claim history and damage.

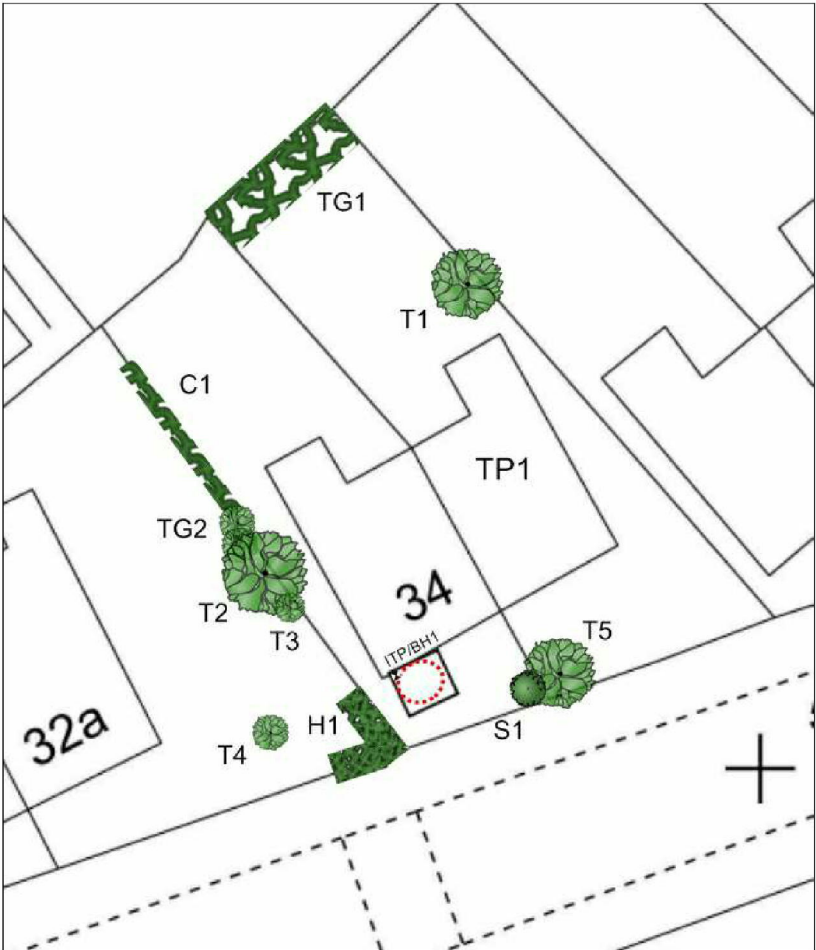
7. Site Plan

Our survey of the site identified H1 (Cypress) and T5 (Plum), given their position relative to the damage it is in our opinion that the roots identified within TP/BH1 will emanate from this vegetation.

Based on our site investigations, and taking account of vegetation location, relative to the focal area of movement/damage, it is our opinion that H1 and T5 are considered the dominant features, and accordingly we have identified them as the principal cause of the subsidence damage.
