Proposals for the Conservation and Environmental Protection of Window nIII (The Butler Window), Lincoln's Inn Chapel, London

August 2020

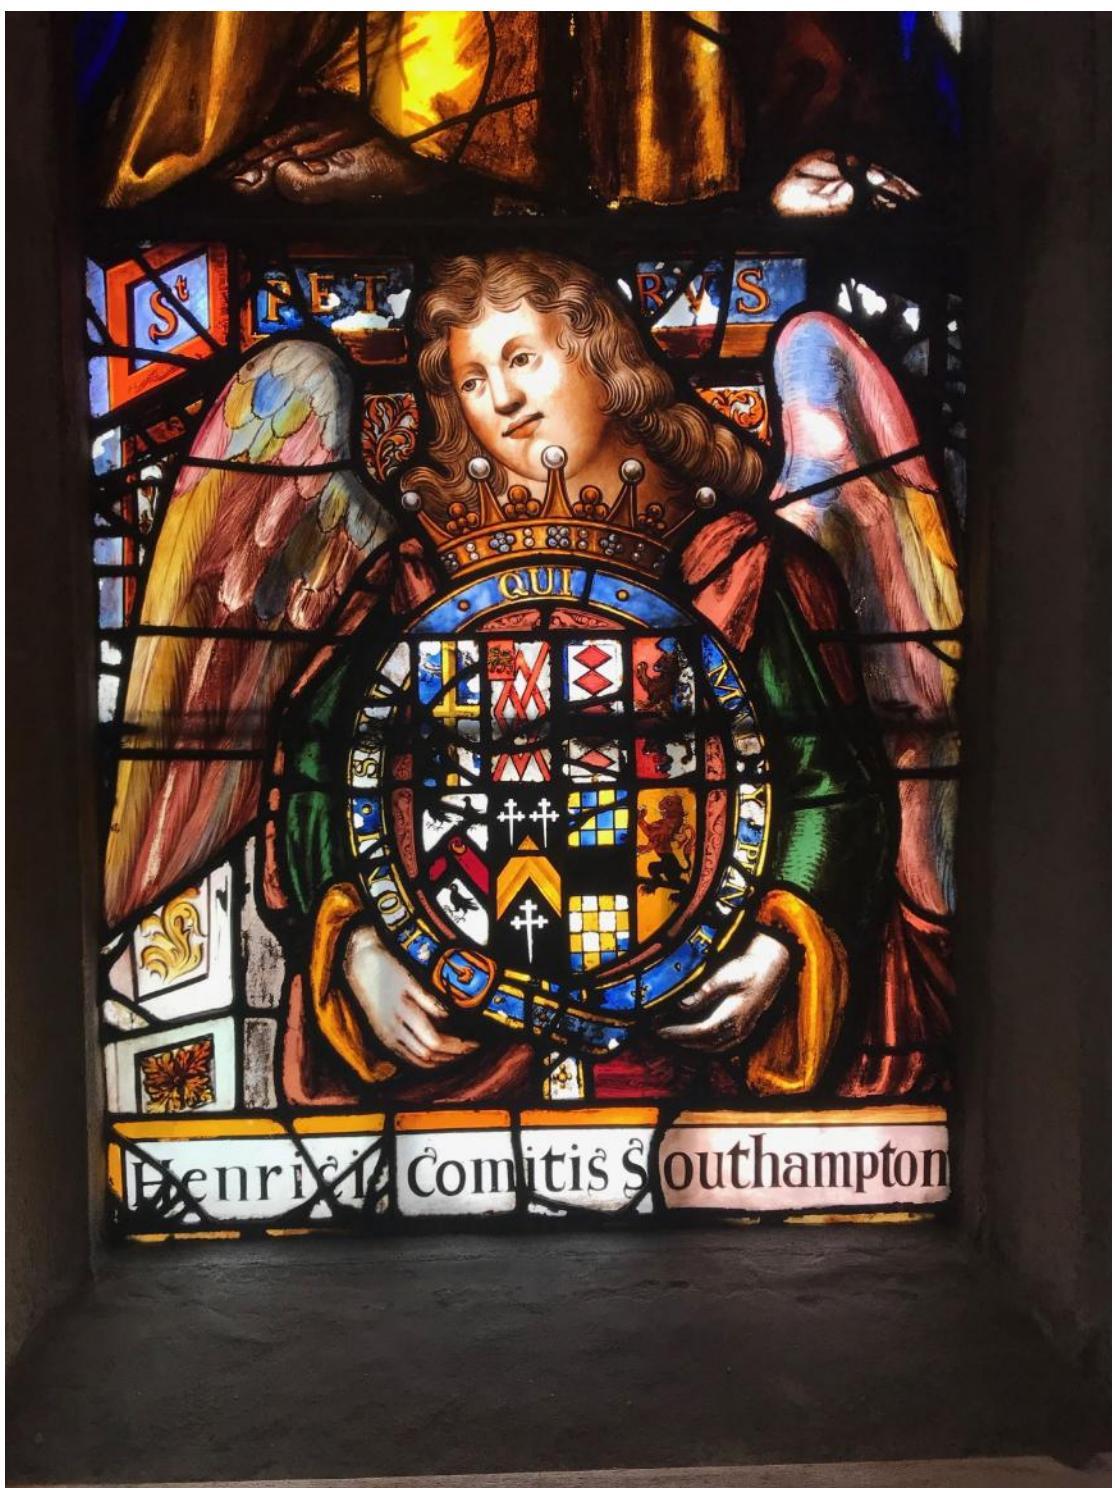
The repertoire of techniques and materials available to the glass painters of the seventeenth century expanded upon those of the medieval period by the inclusion of a new array of glass paints and pigments, and as glass making technology advanced, the ability to make and use thinner glasses. Richard Butler used a wide range of enamel pigments in the production of window nIII for Lincoln's Inn. Panel 1a (Figure 3.) is a prime example of the flamboyant style, which uses and almost rainbow like combination of enamel colours to add vibrancy to the wings of the angel holding the armorial shield. Enamel pigments contain a high proportion of ground glass, which melts at a lower temperature than the base glass to which it is applied and allows the paint to fuse to the surface of the window glass during the firing process. This layer of pigment can be extremely thin and fragile. Whilst the firing process was intended to bring permanency to the painting, in nearly all cases the glass used to make the pigment was different to that used to make the window. The enamel pigments and the base glasses to which they are fused during the firing process have differing coefficients of expansion, meaning that over time, as the glasses heat up and cool down, the very thin enamel layer is prone to dislocate from the base glass. This is exacerbated by the presence of moisture.³

Figure 3. Elaborate use of enamel pigment colours, panel 1a.
