Rennie House
Torriano Mews
LONDON
NW5 2RZ

CONCERNING SUBSIDENCE DAMAGE

ENGINEERING APPRAISAL REPORT

Date: 26/02/2021

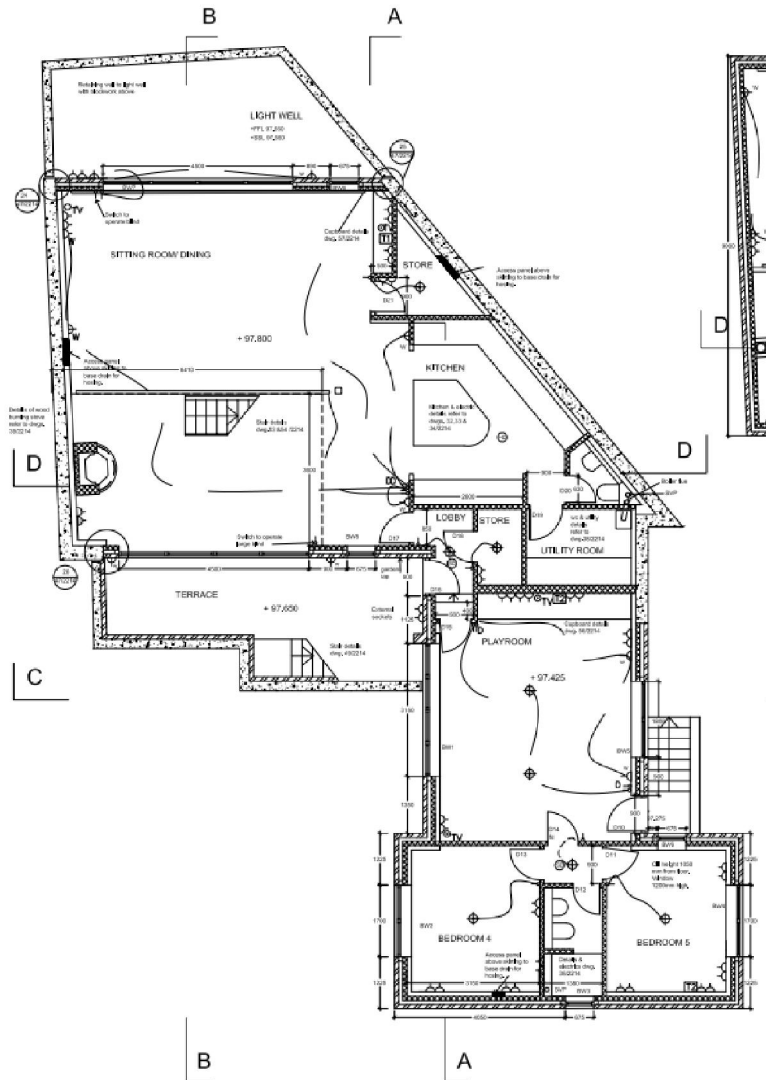
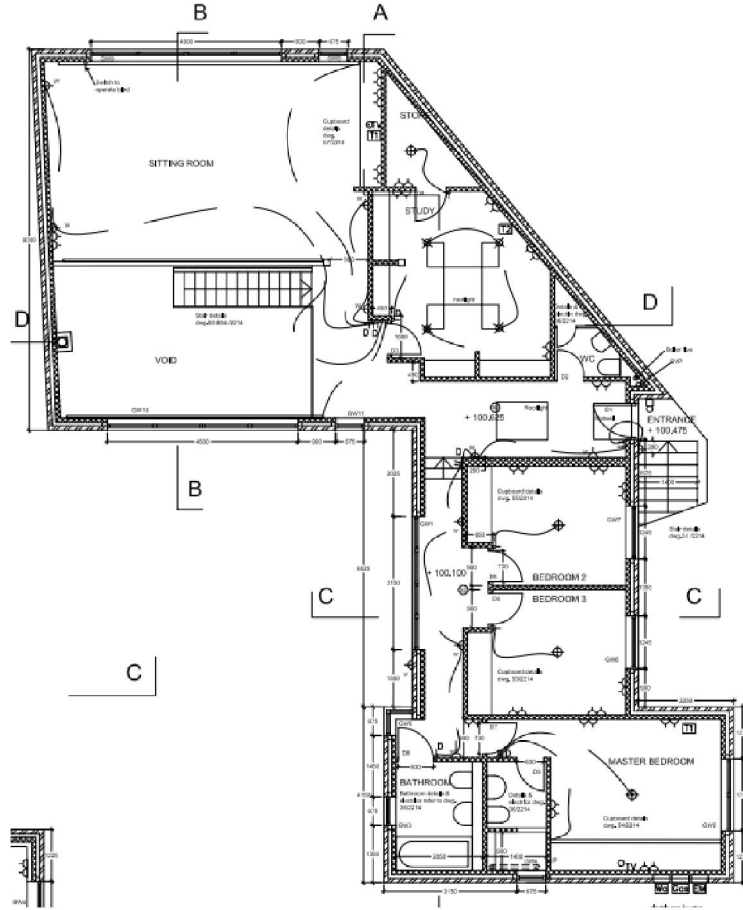
LOWER GROUND FLOOR

On the front elevation there is a 4mm wide stepped crack below the window to the ground floor bedroom. See the plan above to note the location at the front indicating downwards movement to the left.

There is a further damage at the vertical expansion joints between the two parts of the building which has disturbed the seals and shows 10mm movement. See the plan above to note the location indicating downwards movement to the left.

Internal damage takes the form of cracking up to 10mm in width to internal plastered walls in the areas of the ground floor entrance hall and wc, the front right bedroom and the corridor to the bedrooms. The wood floor has also been disturbed causing gaps to appear between the planks. See the plan above to note the location of the hall.
