ADDENDUM TECHNICAL REPORT

151 Gloucester Avenue
London
NW1 8LA

SUBSIDENCE CLAIM

DATE 29 March 2021

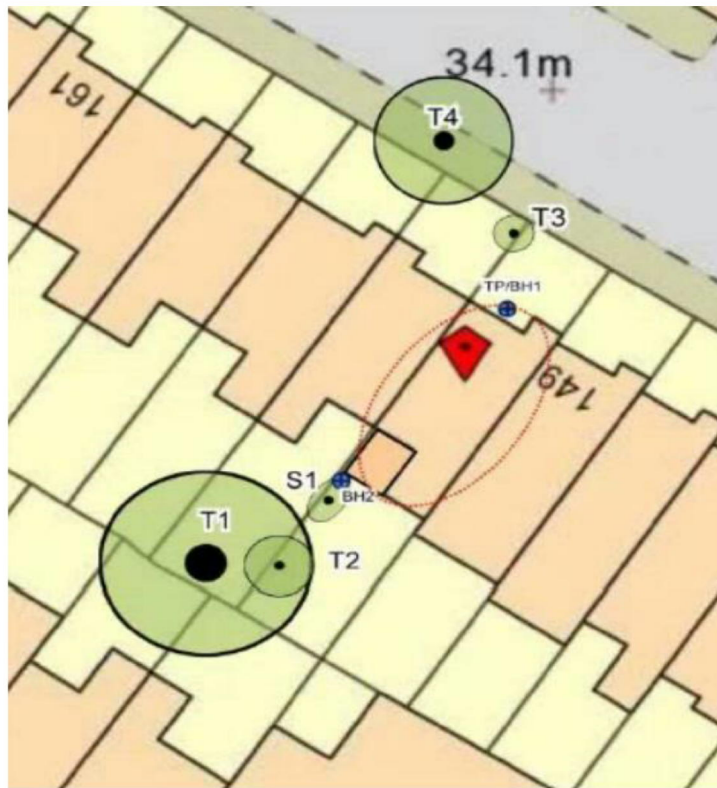
Site Plan

Trial holes were excavated to expose the foundations - see site plan for location and the diagram below for details. Trial Hole 1 revealed a brick corbel on a concrete / crushed brick footing founded at a depth of 0.7m below ground level which bears onto firm, orange / brown, grey veined silty CLAY.

Trial Hole 2 revealed a concrete footing founded at a depth of 0.5m below ground level which bears onto a medium compact made ground. This footing is believed to be a concrete beam spanning between a deeper foundations beneath the rear doors of the extension.

Independent arboricultural experts at MWA Arboriculture provided a report and identified T1 and S1 as the principle cause of movement and damage to the rear of the property. S1 was removed by the insured in August 2020.

The cause of the movement needs to be dealt with first. From the results of the site investigation, the arborist originally recommended removal of T1 London Plane and S1 Bamboo however, the recommendation has now been revised to a reduction of T1 and removal of S1. S1 was removed in August 2020. Based on our analysis, we are satisfied there is no adverse heave risk to the property.
