# PATRICK STILEMAN LTD

### WRITTEN ARBORICULTURAL ADVICE

Site	9 Steele's Road, London, NW3 4SE
Date	26 <sup>th</sup> March 2021
Date of site visit	18 <sup>th</sup> March 2021
Client	James Stephens
Document ref	TI12022101
Subject	Management of trees in rear garden

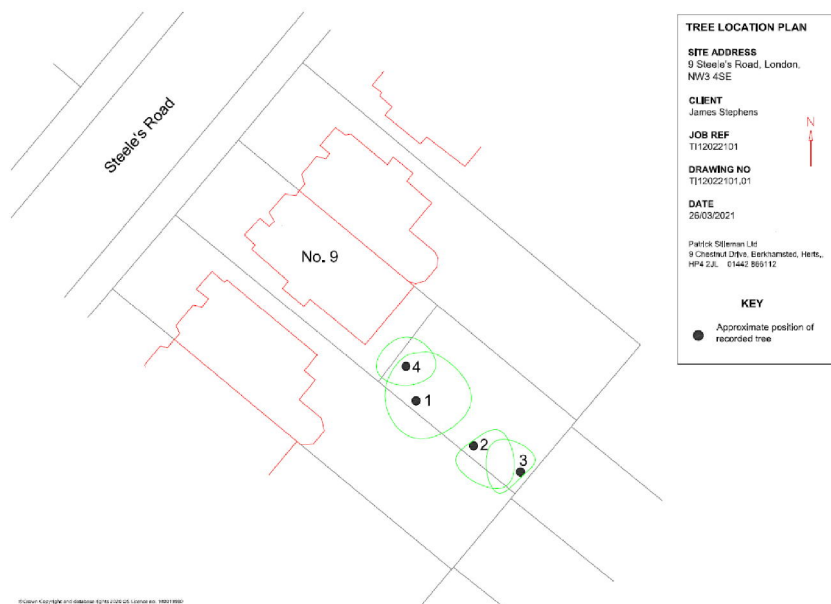
7. 9 Steele's Road is a semi-detached dwelling on the south-east side of the road. It has a single-storey rear extension and small patio. Beyond the patio it has a rectangular-shaped rear garden with a length of 18 metres and width of 10 metres.
8. The largest Eucalyptus (Tree 1) is positioned 0.5 metres from the south-western side boundary wall with the property adjacent, and approximately 8 metres from the rear extension. The two smaller Eucalyptus trees (Trees 2 & 3) are positioned close to the southern corner of the rear garden. The pear tree (Tree 4) is located approximately 1 metre from the patio, which its crown overhangs.
9. The rear garden contains trees and shrubs additional to those which are the subject of this report.
10. The approximate position of trees described in this report is shown in the Tree Location Plan below.
