SITE INVESTIGATION FACTUAL REPORT

20A Merton Rise, London, NW3 3EN

<h1>SITE AND DRAINAGE LAYOUT</h1>	
Site Crew:	Sam McNiff / Harry Kelly	Date:	10th December 2020
Address:	20A Merton Rise, London, NW3 3EN		
Geocore Ref:		Client Ref:

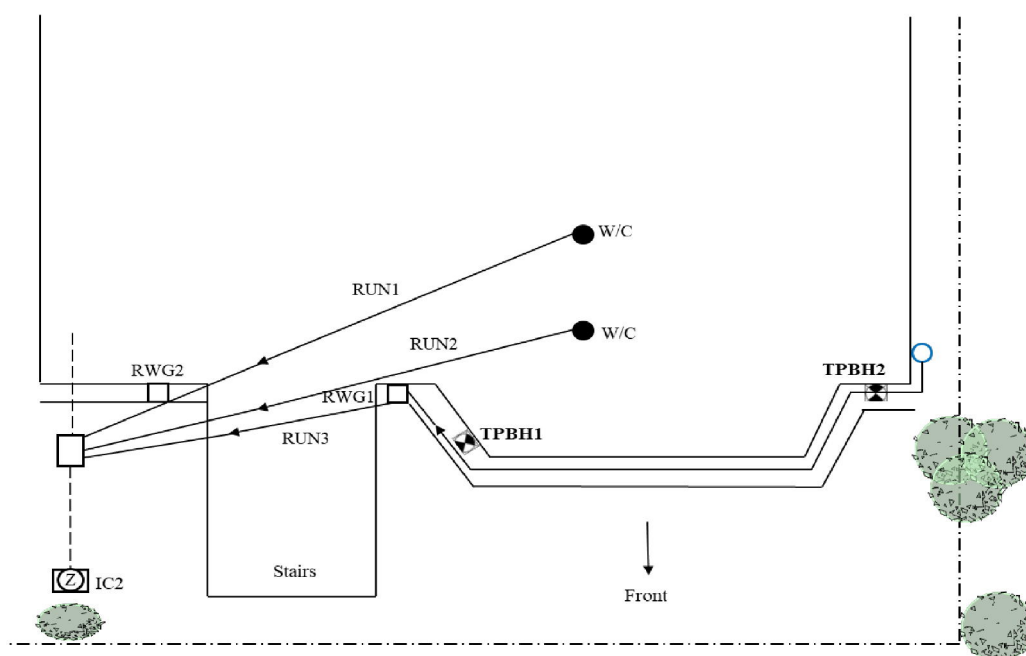
The only drainage within 3 metres of the area of damage is RWG 1. There is also an RWP with a 68 mm plastic pipe which runs across the front of the building above ground and also discharges into RWG 1. The drain run has silt deposits within the pipe but still working. The pipe is 100mm PVC.
