## Site Investigation Report

Client	Crawford & Co - Allianz (Subsidence)
Client ref	
Visit date	20/02/2020
Report date	13/03/2020

### Job Summary

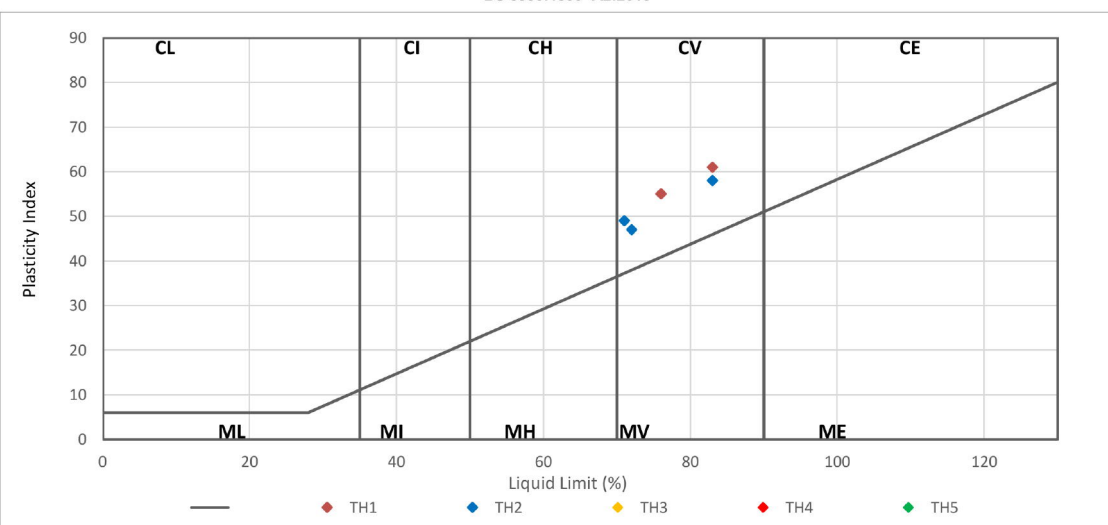
PLASTICITY CHART FOR CASAGRANDE CLASSIFICATION  
BS 5930:1999+A2:2010

Modified Plasticity Index (PI) <10 : Non Classified  
 Modified PI = 10 to <20 : Low volume change potential (LOW VCP)  
 Modified PI = 20 to <40 : Medium volume change potential (Med VCP)  
 Modified PI = 40 or greater : High volume change potential (HIGH VCP)
