## Tree Condition Survey

A Tree Condition Assessment Report utilising Impulse tomography and Resistograph drilling

Christ Church  
Christchurch Hill  
Hampstead  
London NW3 1AB

Date completed:	02.04.18

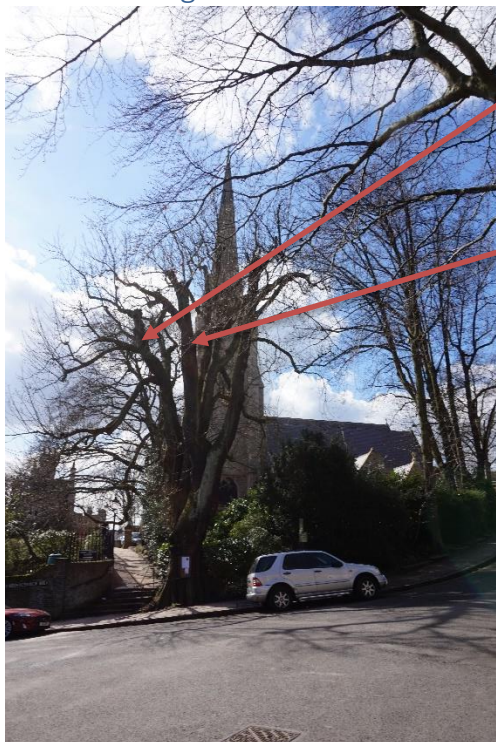
#### 3.1 Positioning of drill tests

Approximate area of investigation of limb to the east

Approximate area of investigation of limb to the north

The limb to the north exhibited structural defects and decay due to historic storm damage. The drill reading at 7.5m showed 200mm of intact wood below the decay, which recovered significantly 1m further down the stem. The limb to the east revealed in significant pockets of decay, although the whole limb exhibited a high degree of unusual movement with the climber in position. There were no visible signs of decay or structural condition at the base of the union of this stem at approx. 4m.

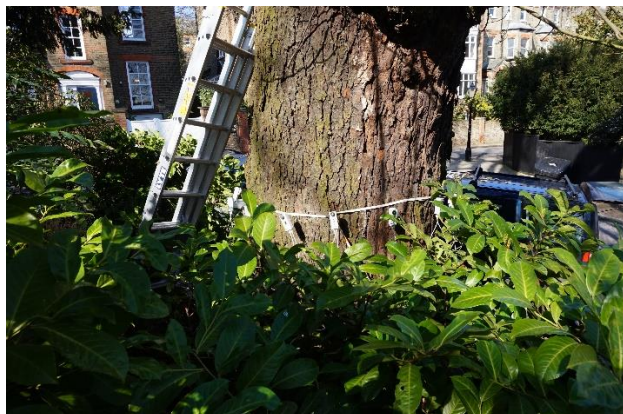
Photo 5: Position of sensors viewed from the south at approx. 1.5 from ground level to the south.

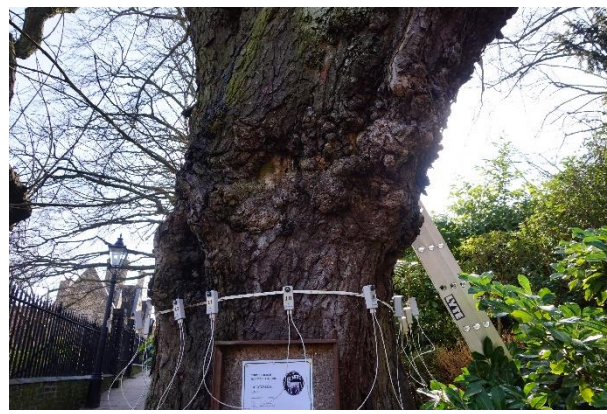
Photo 6: Position of sensors viewed from the north at approx. 1.5 from ground level to the south.

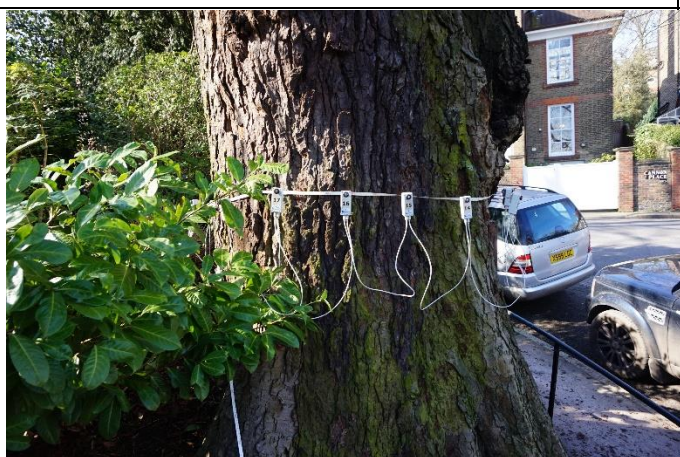
Photo 7: Position of sensors viewed from the east at approx. 1.5 from ground level to the south.

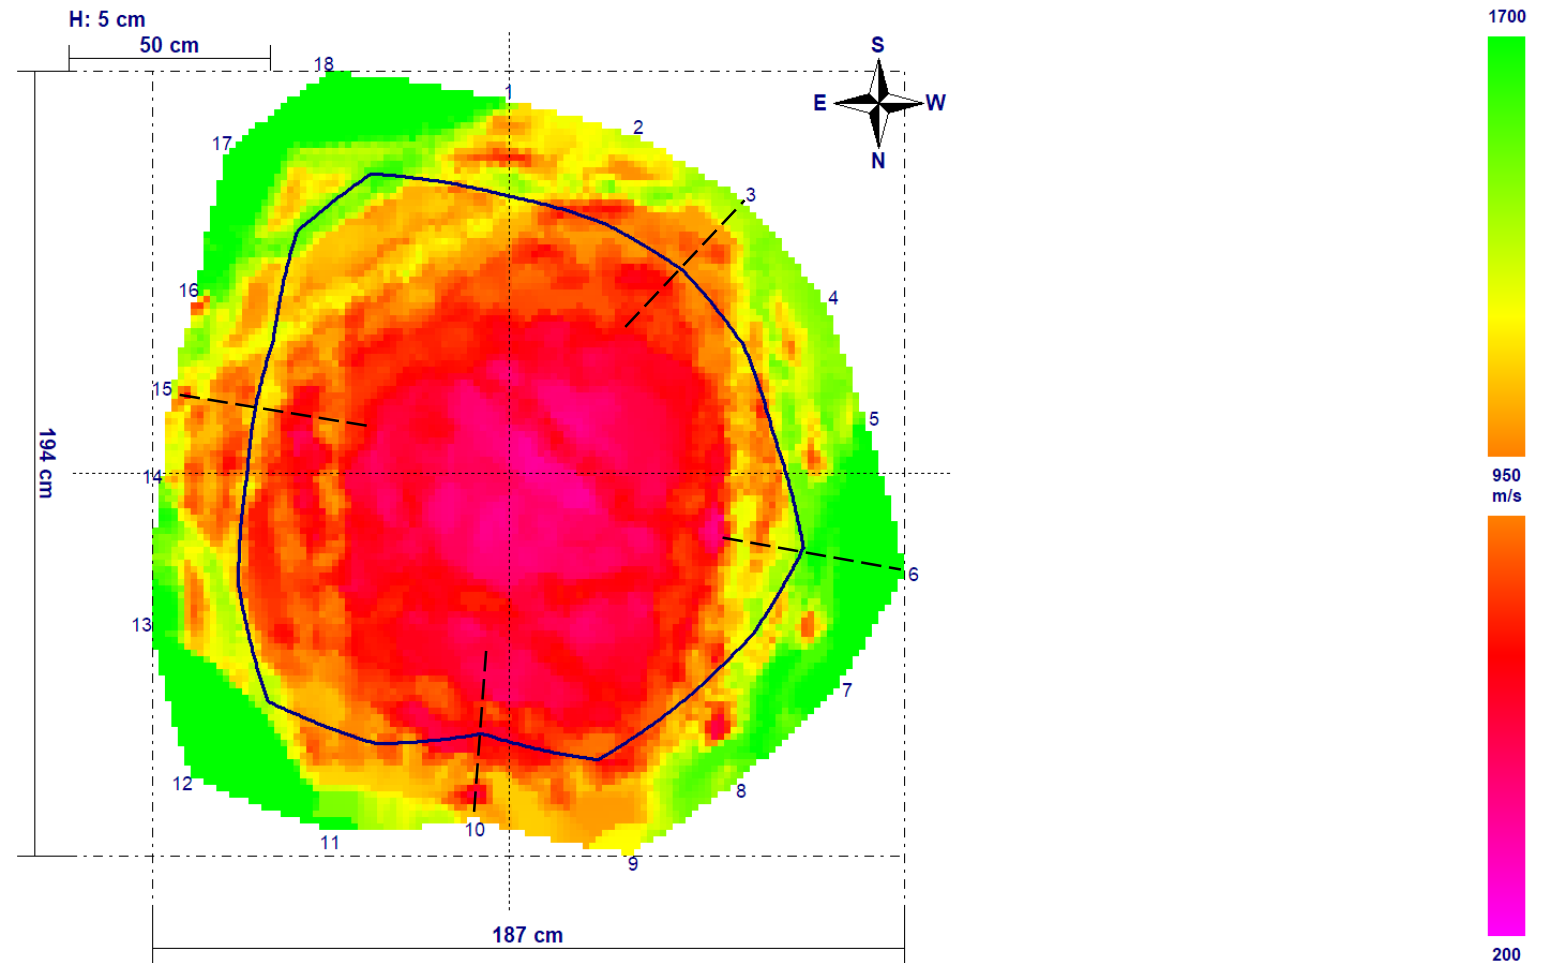
There is decay and strength loss at both areas of the readings on the main stem. (Note: no readings were made to the very base of the tree, to the north, as it was not possible to apply the sensors to achieve a reading across a horizontal plane). The decay and consequent strength loss within the main stem is significant. (The tomogram reading to the base of the tree is substantiated by the drill readings).

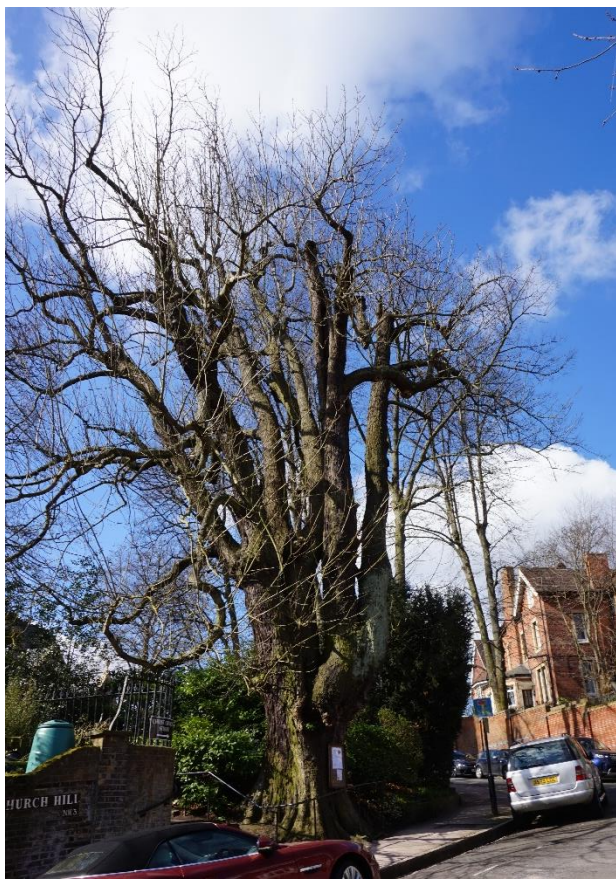
Photo 8: Overview of tree viewed from north east

The tree has approximately 6 main vertical stems, issuing from the presumed historical pollard at 2.5m. All of these stems have been historically reduced in height and decay is suspected at these major reduction wounds. Two of the stems, that exhibited significant decay, were climbed, inspected and subsequently drilled. Decay was found at the wound of the main height reduction.

Recommended works in relation to Structural condition	Time scale
Fell/remove the tree.	Within the next 3 months.

Recommended works in relation to Structural condition	Time scale
Reduce tree by approx. 5m in height and approx. 2m in spread. This will involve cutting back into larger limbs and leaving relatively large wounds, removing decay at previous large reduction points. Installation of non- invasive cable bracing suitable to brace possible failure of vertical stems. (Installation only to reduce impact should failure occur).	Within the next 3 months.
Recommended works in relation to Biological Functioning	Time scale
Monitor for Horse Chestnut Leaf Miner	Within the next 3- 4 months
Install Pheromone traps if presence is found to be currently significant	Within the next 3- 4 months
Introduce Phosphite drench through injection to soils and beneath paving slabs if possible (to improve cell structure in relation to further fungal progression).	Within the next 3- 4 months
Recommended works in relation to Monitoring & Further Inspection	Time scale
