Crown Preservation

Survey report

Date 30.09.19

Property 81 Albany Street London NW1

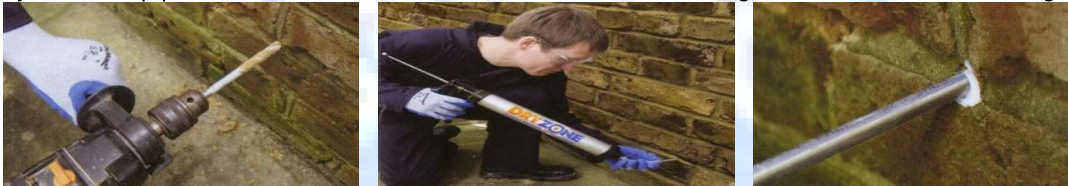
Basement

At the time of the inspection, with the aid of an electronic moisture meter, readings were taken at intermittent points to the walls, these readings suggested rising dampness and dampness from other sources, in the walls as designated on the attached Sketch.

The rising dampness appears to be due to the apparent absence of an effective damp proof course.

Moisture meter readings suggesting rising dampness

Install a chemical damp proof course (DPC) to the area indicated on the attached plan by the red dotted line, supplemented via a vertical damp proof course using dry zone injection cream to form continuity and protect against abutting structures. The dry zone (DPC) will provide a permanent barrier to the treated walls stopping further rise of moisture from the foundations and provide a dry wall. Dry zone cream has **73%** active ingredient for stopping rising dampness as opposed the traditional chemical injected damp proof course which can have as little as **6%** active ingredient the remainder being water.
