## **Tree Inspection Report**

Site 22 Churchill Road, London NW5 1AN

13<sup>th</sup> March 2019

**Ref** TI21021901

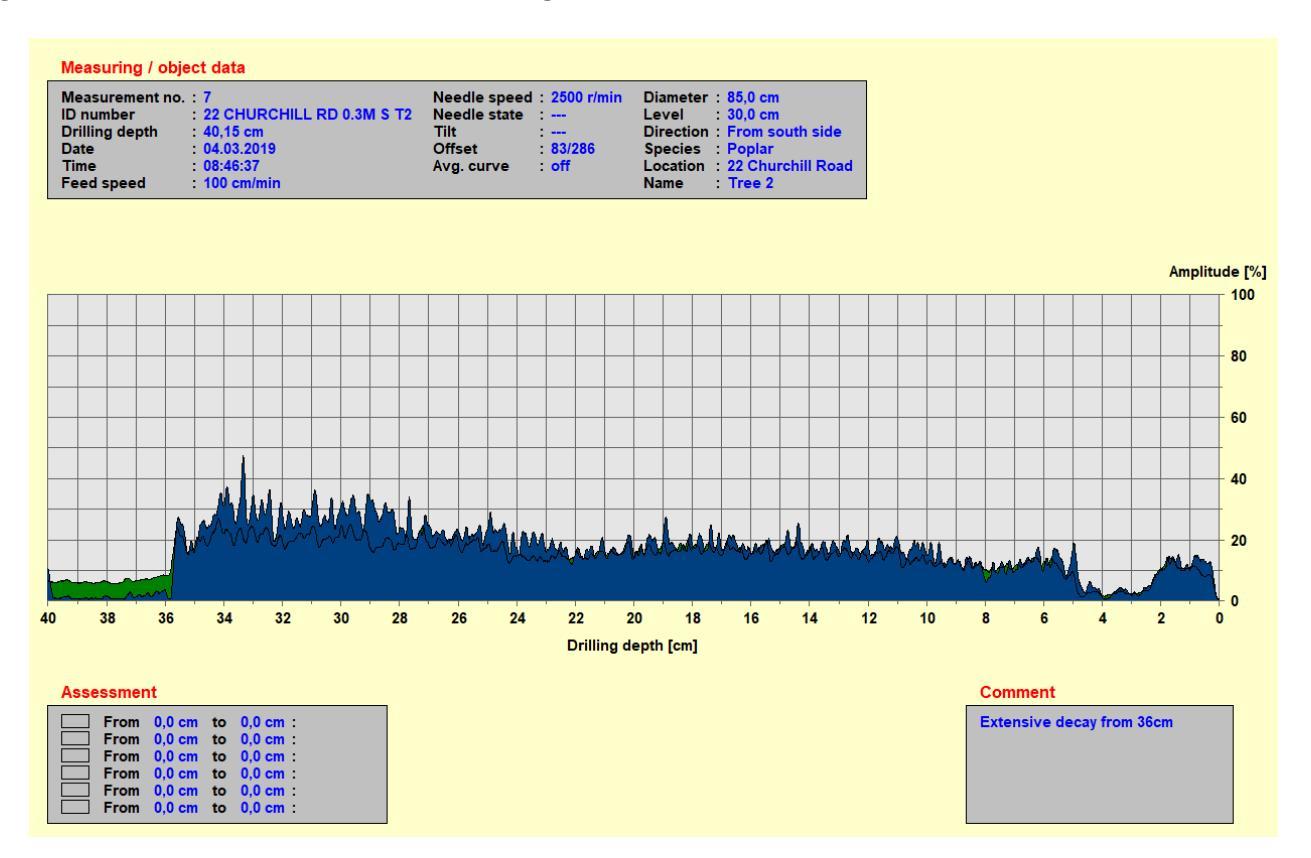
- 6.1 It is apparent that the tree has significant decay on its eastern side; however from the north and south sides it has sound wall thickness of 36 37cm which I consider provides good support, particularly given the tree's small size and upright form.
- 6.2 It is possible that with time the tree's condition might deteriorate to a point where the stem becomes unstable; however this is unlikely to occur for several years at least and I consider that the tree can reasonably be retained on the basis that it is re-pollarded every two to three years.

- 7.1 I recommend that Tree 1 is removed within the next three months.
- 7.2 I recommend that Tree 2 is re-pollarded within the next twelve months, and that this be repeated every 2-3 years.
- 7.3 I recommend that Tree 2 is re-inspected in three years' time.
