Arboricultural Appraisal

66 Aberdare Gardens, NW6 3QD

Report Reference: 206019r_AA001_66ABRDNW6

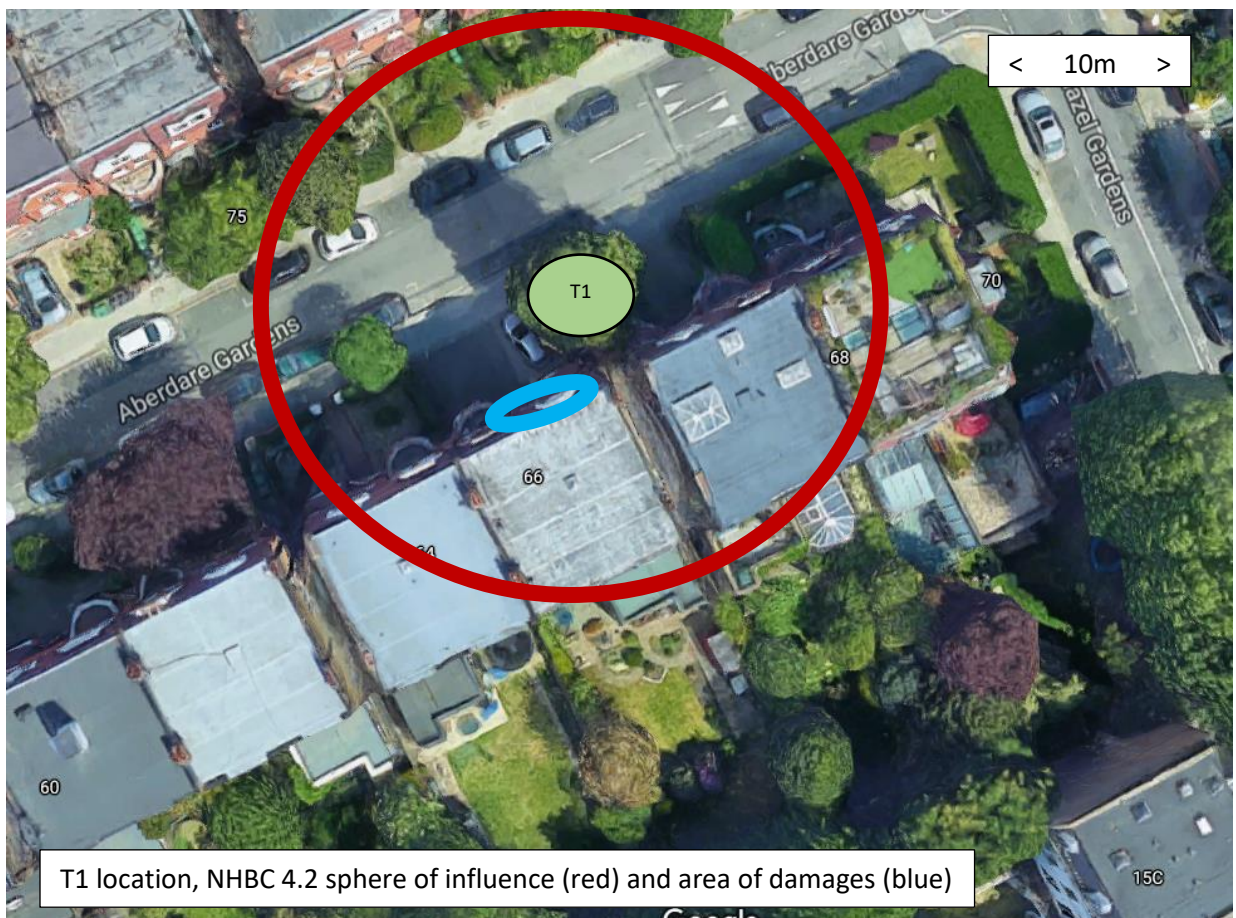
- 3.1 66 Aberdare Gardens is situated within a leafy part of South Hampstead, within a London Borough of Camden conservation area. The site is approximately 800m north-east of Regents Park
- 3.2 There are quite a few significant trees within the area but noticeably there is a cypress within the front garden of 66 Aberdare Gdns.

The features within the area and the site are well manicured, gardening and hedge management is evident in locale.
