Regent's Canal Wall Survey

Revision B 7/5/2021 (projecting jetty removed)

1 St Mark's Crescent London NW1 7TS

October 2020

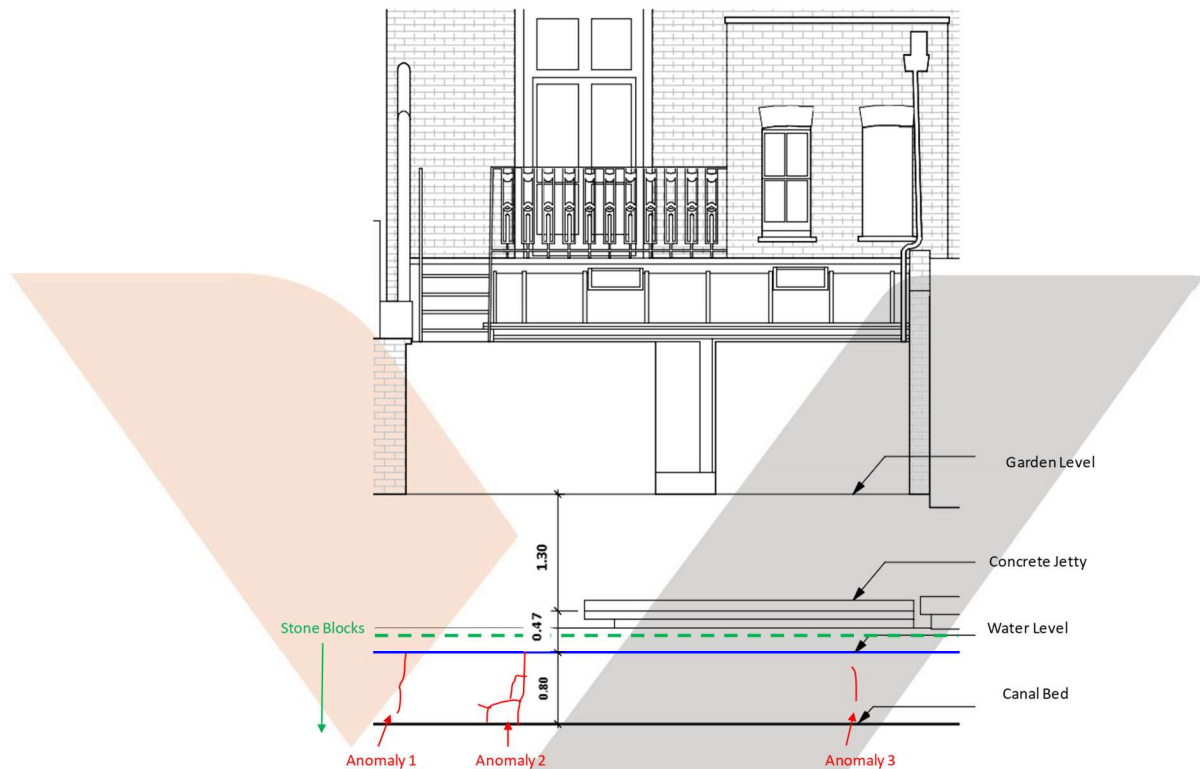
Anomaly 1 was located approximately 1.4 meters to the left of the outer edge of the jetty, this was a vertical crack approximately 5 to 10mm wide.
