18th April 2018

FULL BUILDING SURVEY REPORT

20-22 Wenlock Road, London, N1 7GU

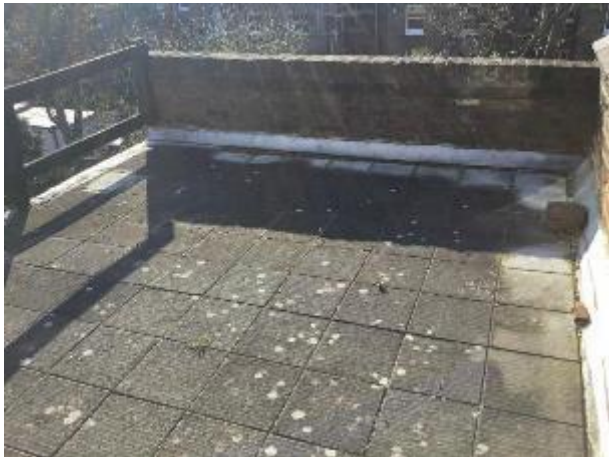
Photo 4

The abutments are sealed with lead, which appeared to be adequate at the time of the survey and requires no repairs. Overall, it is estimated that the remaining life of the roof coverings to this section is 0 years. [Survey Photographs - Photo 4], [Survey Photographs - Photo 5], [Survey Photographs - Photo 6], [Survey Photographs - Photo 7], [Survey Photographs - Photo 8], [Survey Photographs - Photo 9], [Survey Photographs - Photo 10], [Survey Photographs - Photo 11]

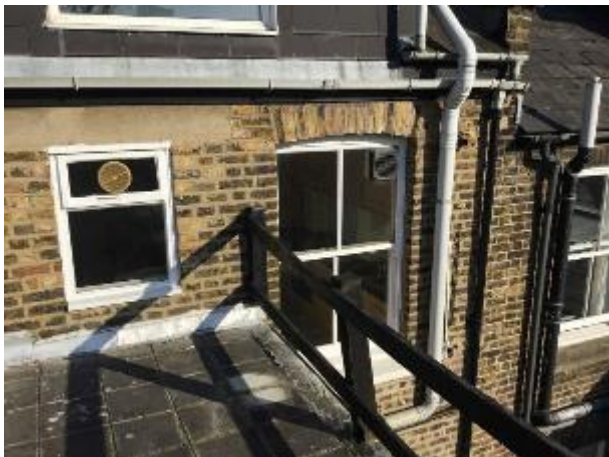
Photo 12

Pointing lime-bedded brickwork in OPC based pointing is an unacceptable method of pointing due to the carbonation process of the underlying natural hydraulic lime mortar. Although it would not be practical to remove all the OPC pointing, it would be the best course of action to ensure that any pointing works are done using a natural hydraulic Lime NHL 5.0. [Survey Photographs - Photo 12], [Survey Photographs - Photo 13]

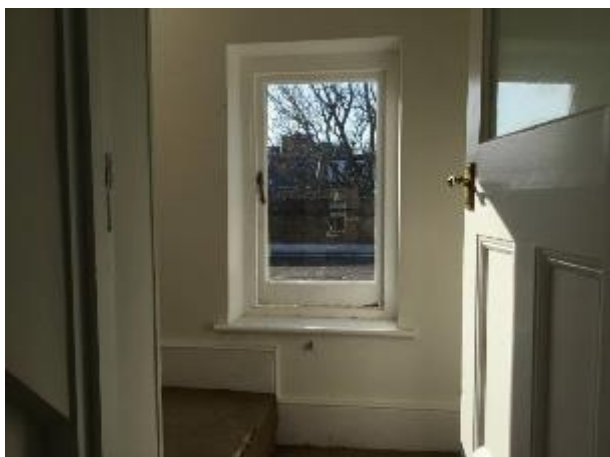
Photo 65

Room Area	Location	Front Rear Centre	Photos and Observations
Bedroom 1	3rd Floor	Front Rear	[Photo 22], [Photo 18], [Photo 21], [Photo 20], [Photo 19]
Hall/Stairs	2nd Floor 1st Floor Ground Floor	Centre	[Photo 30], [Photo 24], [Photo 31], [Photo 26], [Photo 29], [Photo 25], [Photo 27], [Photo 28], [Photo 23]
Reception 1	1st Floor	Front	[Photo 32], [Photo 33], [Photo 34], [Photo 35], [Photo 36], [Photo 37], [Photo 38], [Photo 39], [Photo 40]
Kitchen	1st Floor	Rear	[Photo 41], [Photo 42], [Photo 43], [Photo 44], [Photo 45], [Photo 46], [Photo 47], [Photo 48], [Photo 49], [Photo 50], [Photo 51], [Photo 52], [Photo 53], [Photo 54], [Photo 55]
Bathroom 1	1st Floor	Rear	[Photo 56], [Photo 57], [Photo 58], [Photo 59], [Photo 60], [Photo 61], [Photo 62], [Photo 63], [Photo 64]
Bedroom 2	1st Floor	Rear	High moisture levels were detected to the ceiling. [Photo 65], [Photo 66]
See Survey Photographs

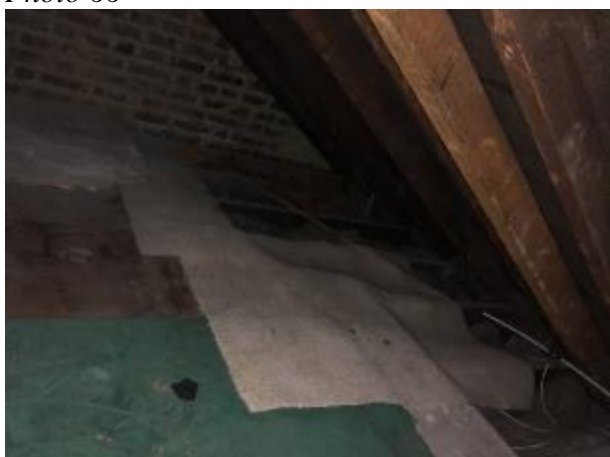
Photo 67

The works appear to have been undertaken in the 1970s prior to the introduction of the current building regulations but appear structurally satisfactory. Although a steel was not identified the floors were sturdy, and the structure appeared satisfactory. [Survey Photographs - Photo 67], [Survey Photographs - Photo 68], [Survey Photographs - Photo 69]
