/ APPENDIX G
// HEYNE TILLET STEEL
STRUCTURAL SURVEY

Grange Central Saint Martins – Site Visit Report No.4

This report summarises the findings of the structural condition survey completed by HTS in the week commencing 17.02.2020. It discusses elements in obviously poor condition or where further investigations are required. A location plan can be found attached.

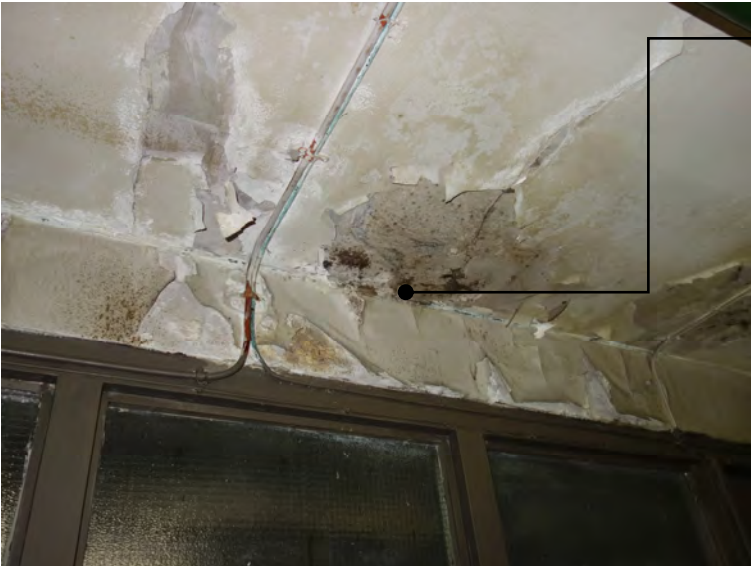
B.2 Significant water ingress is apparent around the beam support.

Remove all cover in areas with obvious water ingress to determine the extent of corrosion.

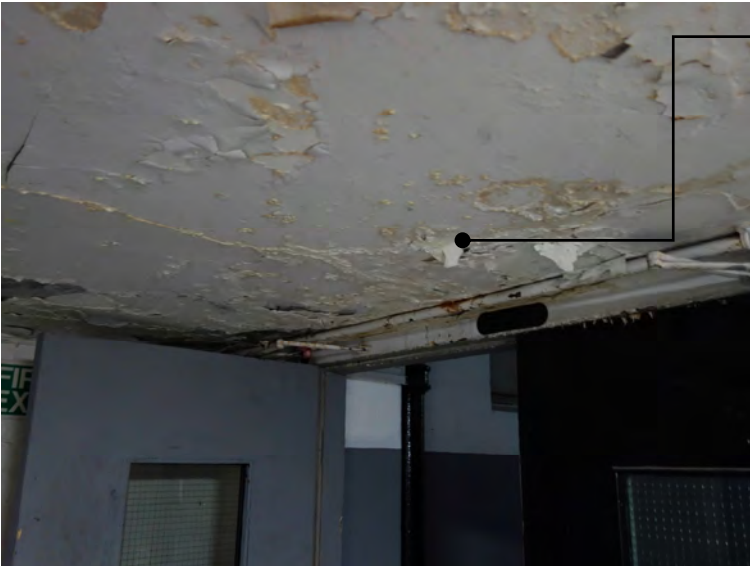
B.8 Water ingress noticeable at high level.

Remove cover to joists in order to determine extent of corrosion.

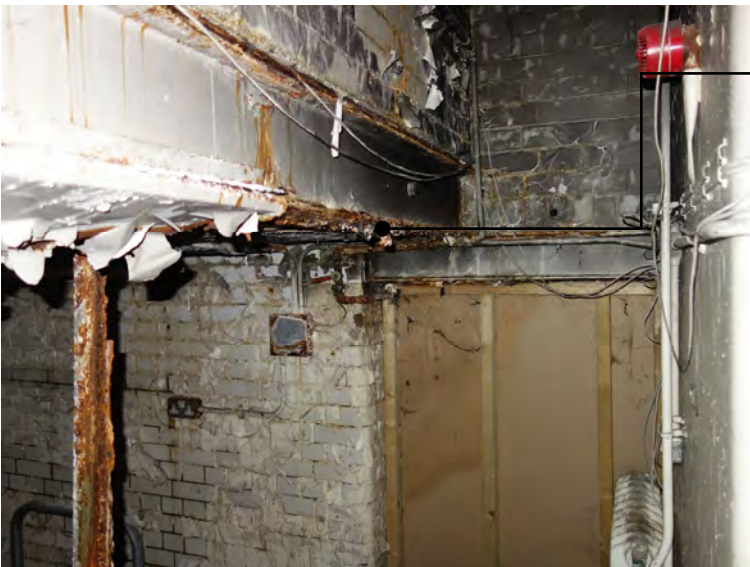
B.10 Water ingress in the vaults had led to significant corrosion and delamination of numerous beams and joists.

Underside of slabs and beams to be propped immediately.

A permanent solution is to be determined.

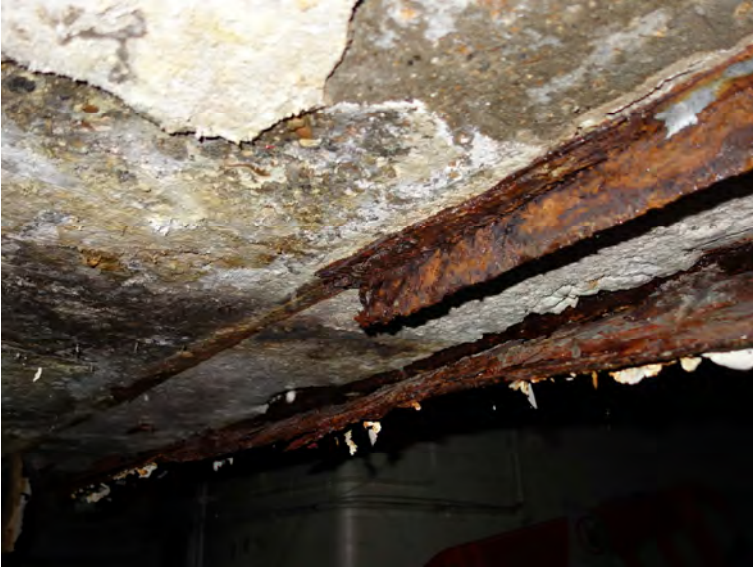
B.10 Continued.

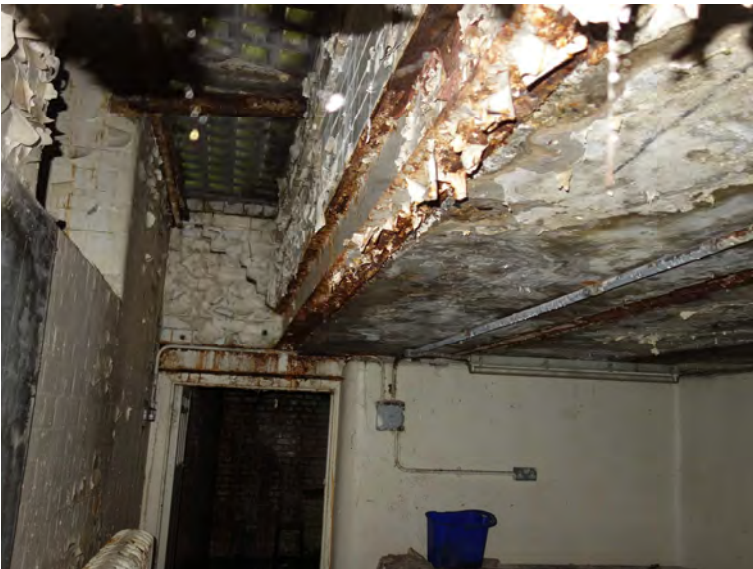
B.10 Continued.

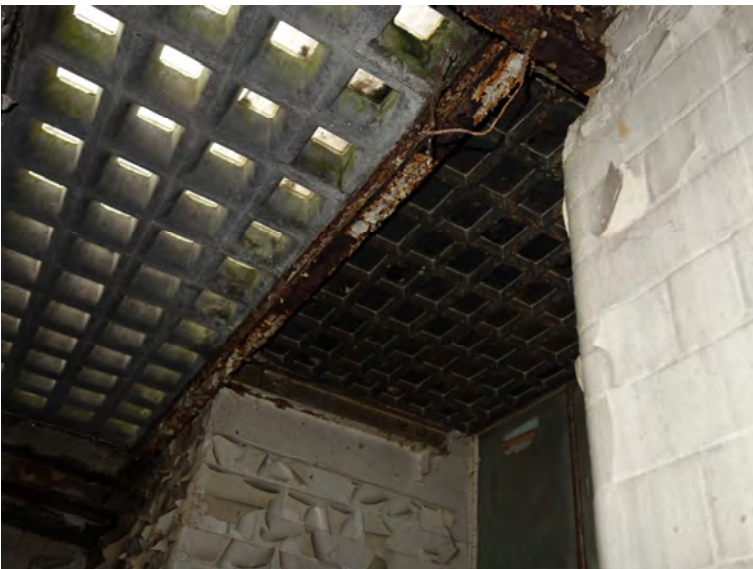
B.10 Continued.

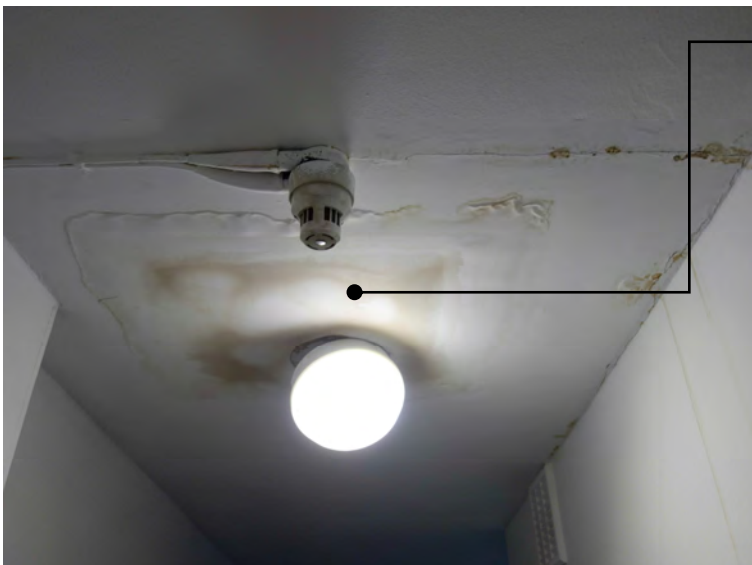
G.1 Water ingress noticeable at high level.

Remove cover to joists in order to determine extent of corrosion.

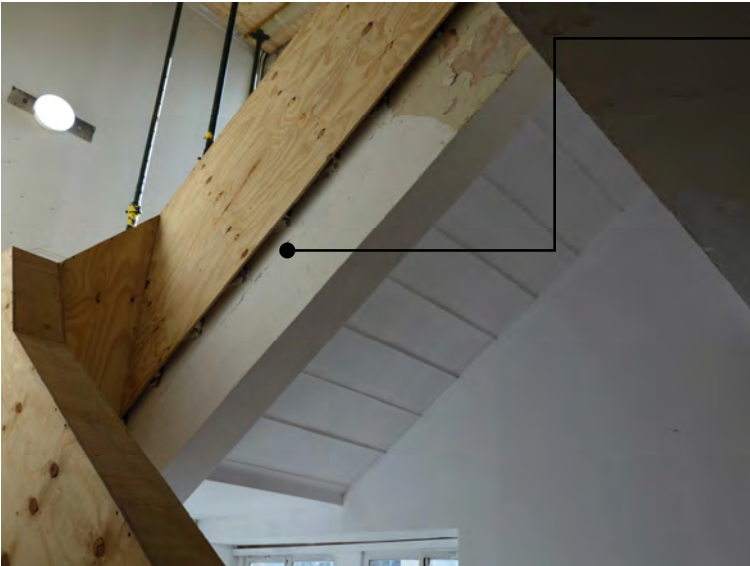
1.3 Cracking can be seen along the side of the stair beam.

Remove plaster and cover to the beam to determine the extent of corrosion within.

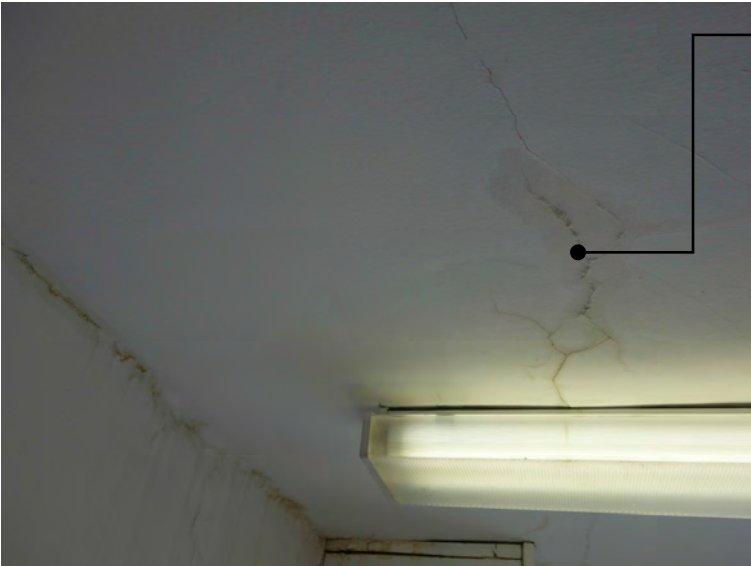
1.6 Water ingress noticeable at high level.

Remove cover to joists in order to determine extent of corrosion.

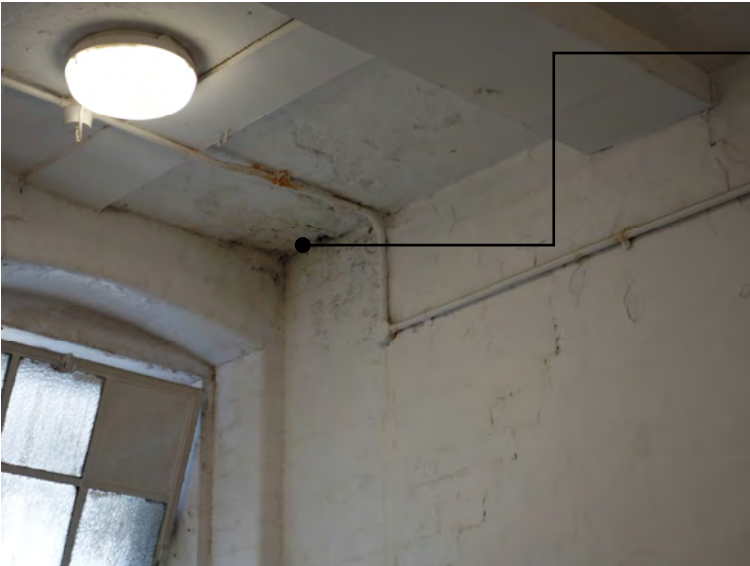
2.5 Water ingress can be seen at the head of the wall and on the bottom of the slab.

Remove finishes and cover to the joists to determine the extent of corrosion.

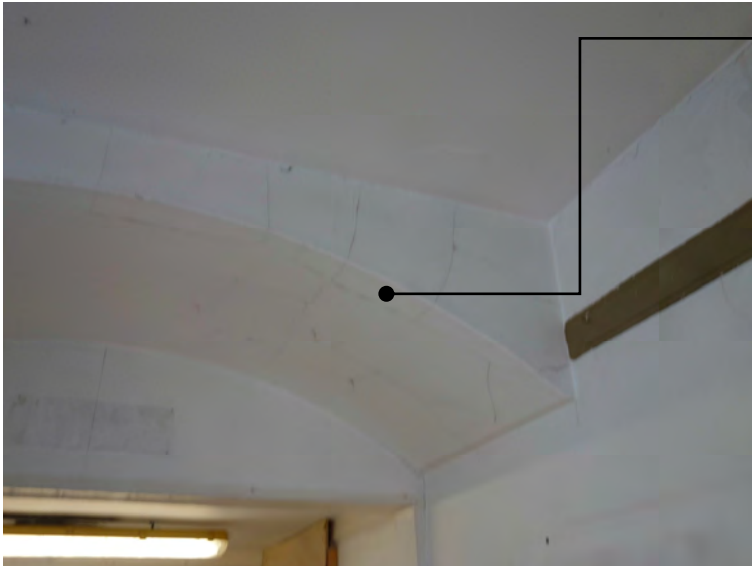
4.5 Cracking is evident on the underside of the arch.

Remove plaster to determine if cracking extends to the structure above.

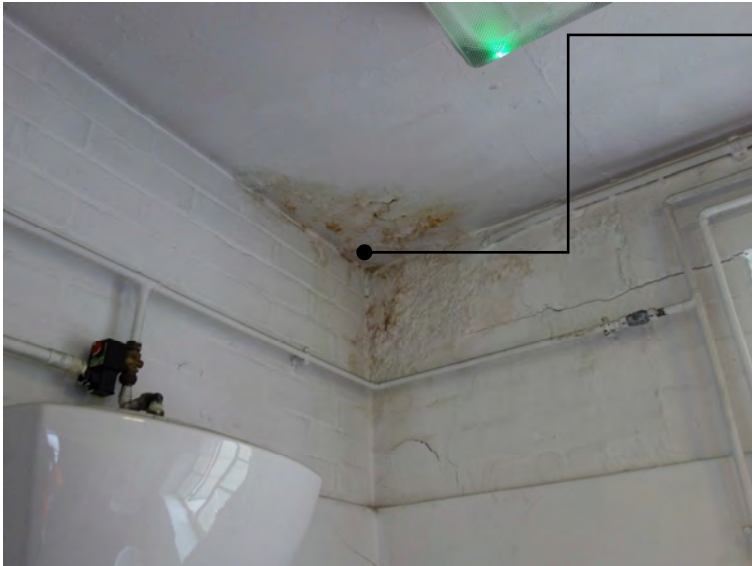
4.8 Water ingress to around slab and wall apparent.

Remove plaster and concrete cover to the underside of the slab to determine extent of corrosion to joist within.

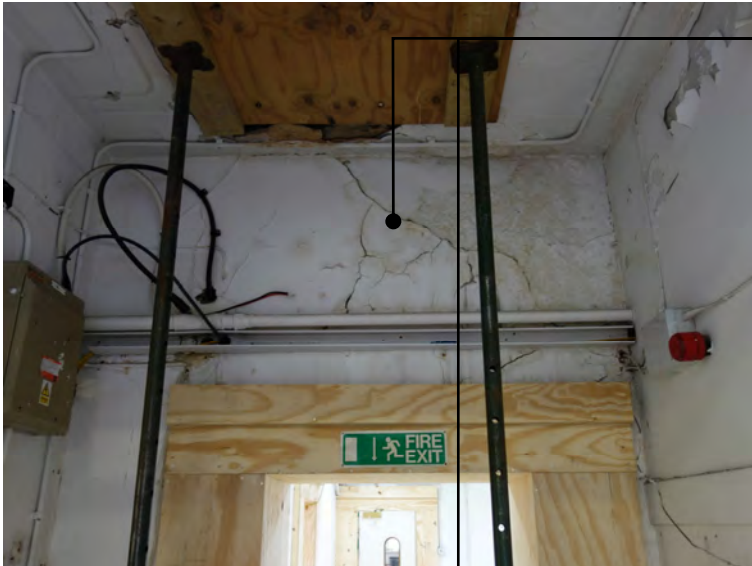
4.11 Significant cracking in plaster due to water ingress apparent.

Remove plaster to determine extent of damage to structure within.

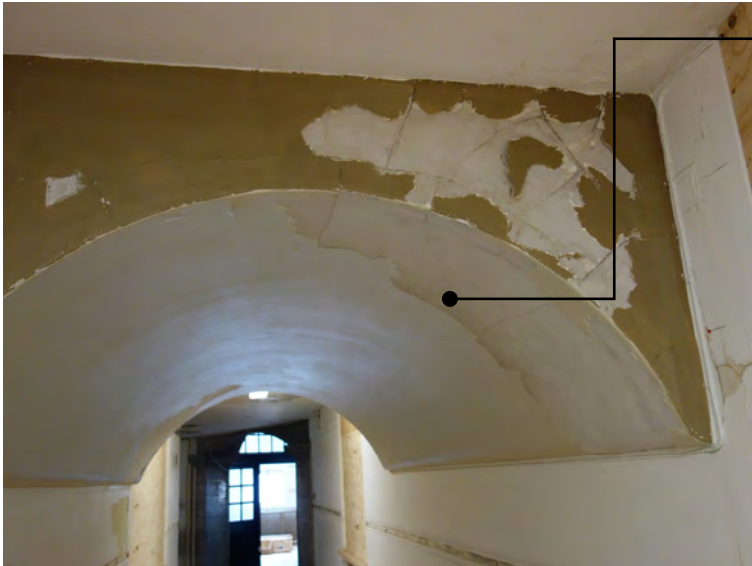
4.13 Cracking is evident on the underside of the arch.

Remove plaster to determine if cracking extends to the structure above.

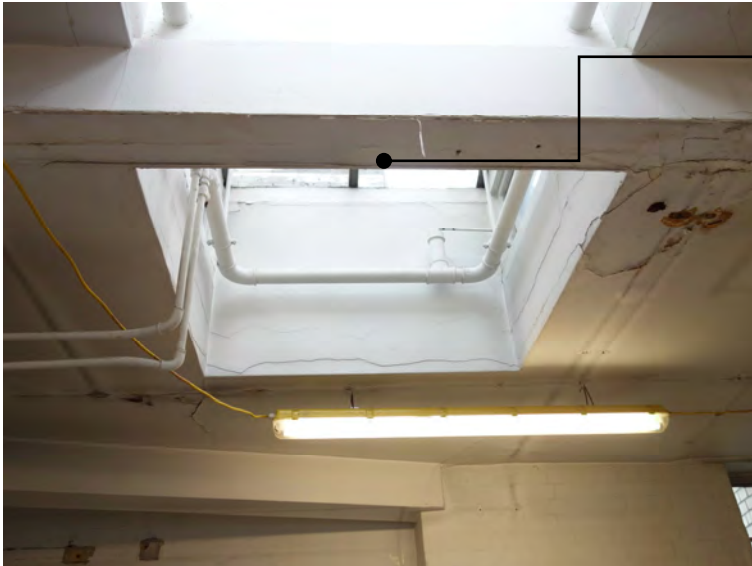
5.6 Cracking can be seen to the bottom of the steel beam running across the roof lights.

Remove plaster and concrete cover to determine the extent of corrosion to the beam within.

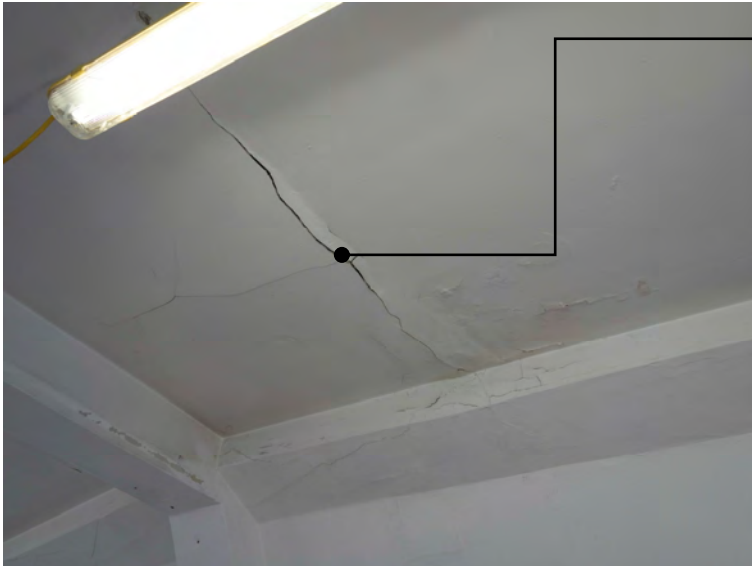
5.10 A large crack is evident beneath an assumed joist location.

Remove plaster and concrete cover to joist to determine the extent of corrosion within.

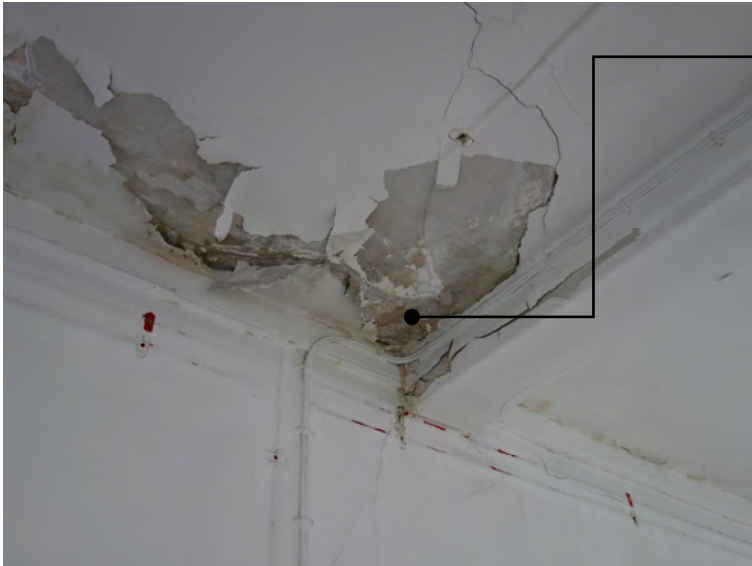
5.13 Plaster swelling and damage seen in slab and adjacent beam indicating water ingress.

Remove plaster in the slab and beam to determine extent of damage to structure and corrosion to steel above.

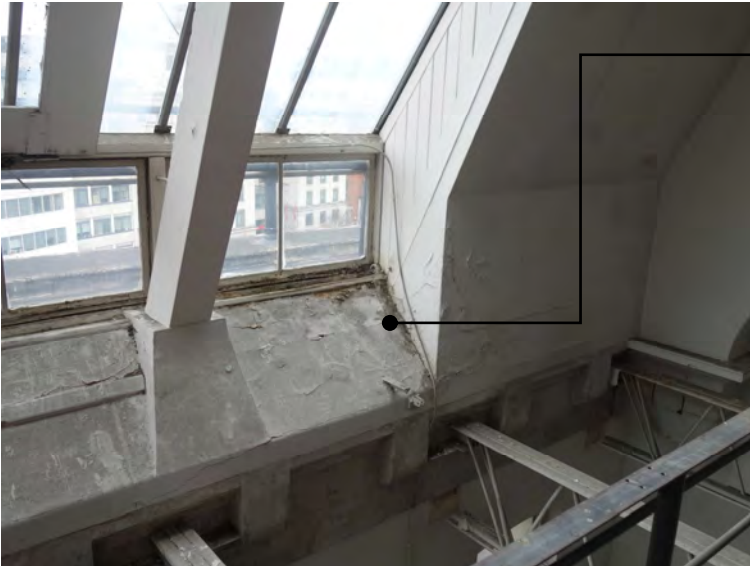
5.16 Swelling and damage to the plaster at the corner of the window suggests water ingress.

Remove plaster to determine extent of damage to structure behind.

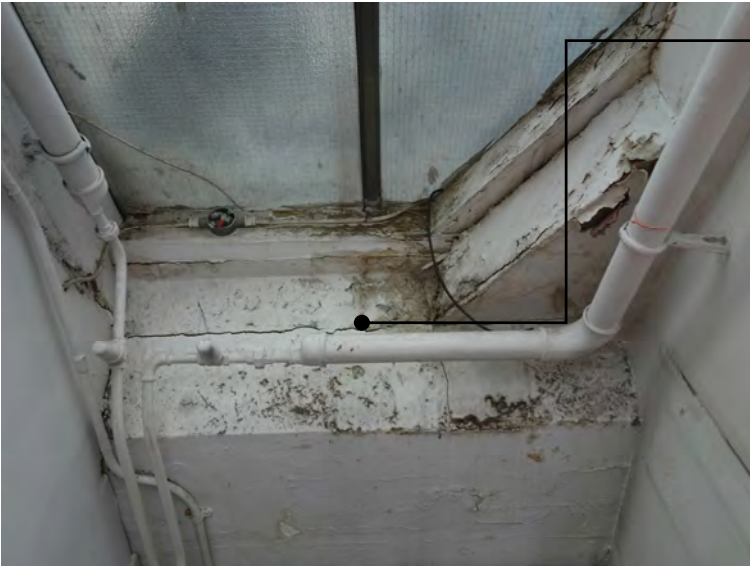
5.18 Water ingress beneath the window is apparent.

Remove plaster to determine extent of damage to structure within.

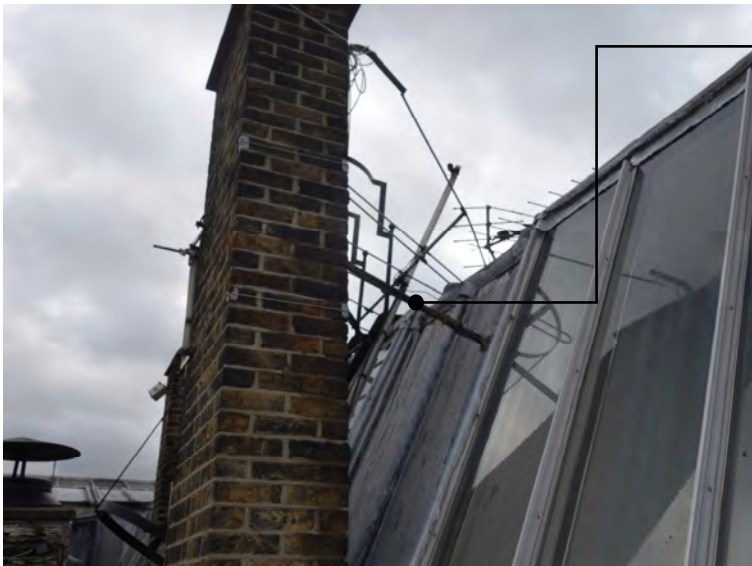
R.2 The chimney support steelwork is heavily corroded.

Steel should be replaced as part of the roof repair works.
