## STRUCTURAL ENGINEER'S REPORT

TO INSPECT THE STABILITY OF THE CERAMIC FRIEZE COPING TILES  
AT THE HEAD OF 18 COLUMNS

PROJECT REF:	M19070/BCS/LS/AY
SUBJECT ADDRESS:	<b>Royal College of General Practitioners 30 Euston Square Kings Cross London, NW1 2FB</b>
COMMISSIONING CLIENT/ ADDRESS:	Lewis Berkeley Limited 92 Banner Street London EC1Y 8JU
DATE OF INSPECTION:	Wednesday 3 <sup>rd</sup> April 2019

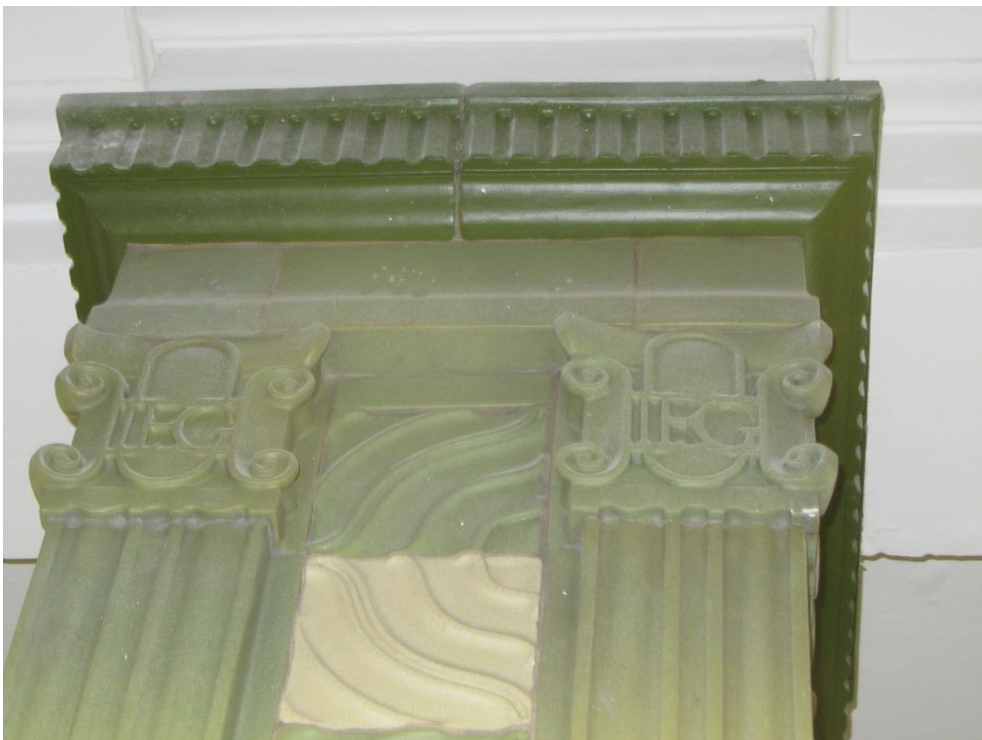
Photo Number	Location (as referenced on drawing)	Type of Frieze Cornice Tile	Comments
Level 2 C3 -1	Column 3	Ceramic	No loose sections identified.
Level 2 C3 -2	Column 3	Ceramic	"
Level 2 C3 -3	Column 3	Ceramic	"
Level 2 C3 -4	Column 3	Ceramic	"
Level 2 C3 -5	Column 3	Ceramic	"
Level 2 C4 -1	Column 4	Ceramic	"
Level 2 C4 -2	Column 4	Ceramic	"
Level 2 C4 -3	Column 4	Ceramic	"
Level 2 C4 -4	Column 4	Ceramic	"
Level 2 C5 -1	Column 5	Part ceramic, with timber sections	Column wrapped and sections missing
Level 2 C5 -2	Column 5	"	"
Level 2 C5 -3	Column 5	"	"
Level 2 C5 -4	Column 5	"	"
Level 2 C5 -5	Column 5	"	"
Level 2 C5 -6	Column 5	"	"
<b>Level 1 - see M19070/SK03</b>			
Level 1 C1 -1	Column 1	Ceramic	No loose sections identified. Paint peeling to beam soffit.
Level 1 C1 -2	Column 1	Ceramic	"
Level 1 C1 -3	Column 1	Ceramic	"
Level 1 C2 -1	Column 2	Ceramic	No loose sections identified.
Level 1 C2 -2	Column 2	Ceramic	"

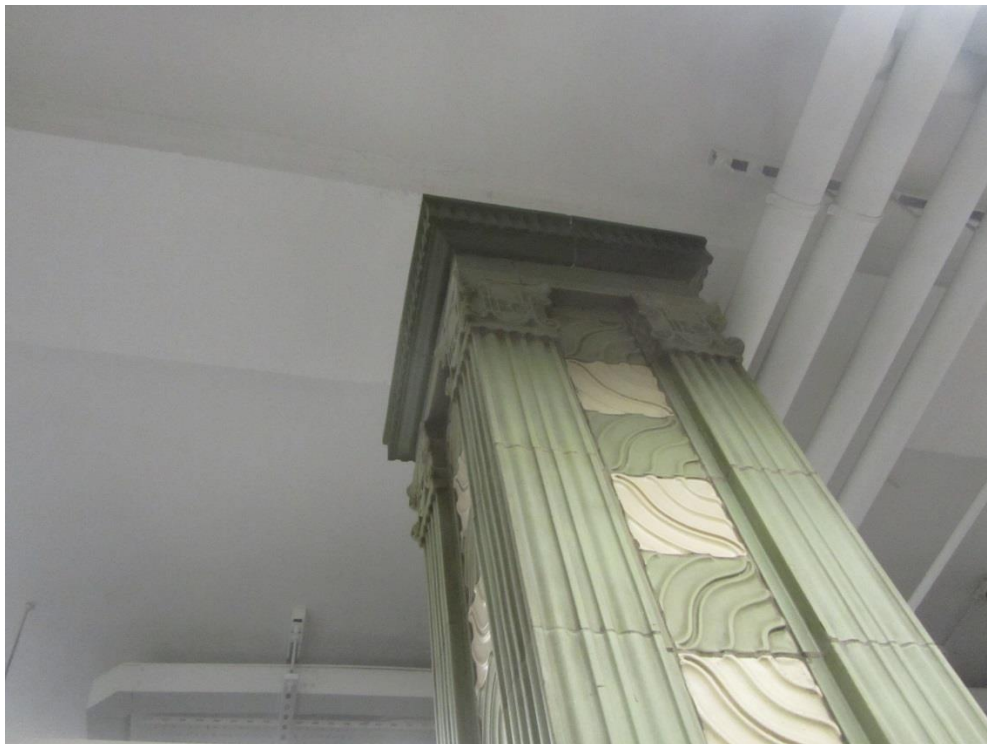
Level 1 C2 -3	Column 2	Ceramic	"
Level 1 C2 -4	Column 2	Ceramic	"
Level 1 C3 -1	Column 3	Ceramic	No loose sections identified.
Level 1 C3 -2	Column 3	Ceramic	"
Level 1 C3 -3	Column 3	Ceramic	"
Level 1 C3 -4	Column 3	Ceramic	"

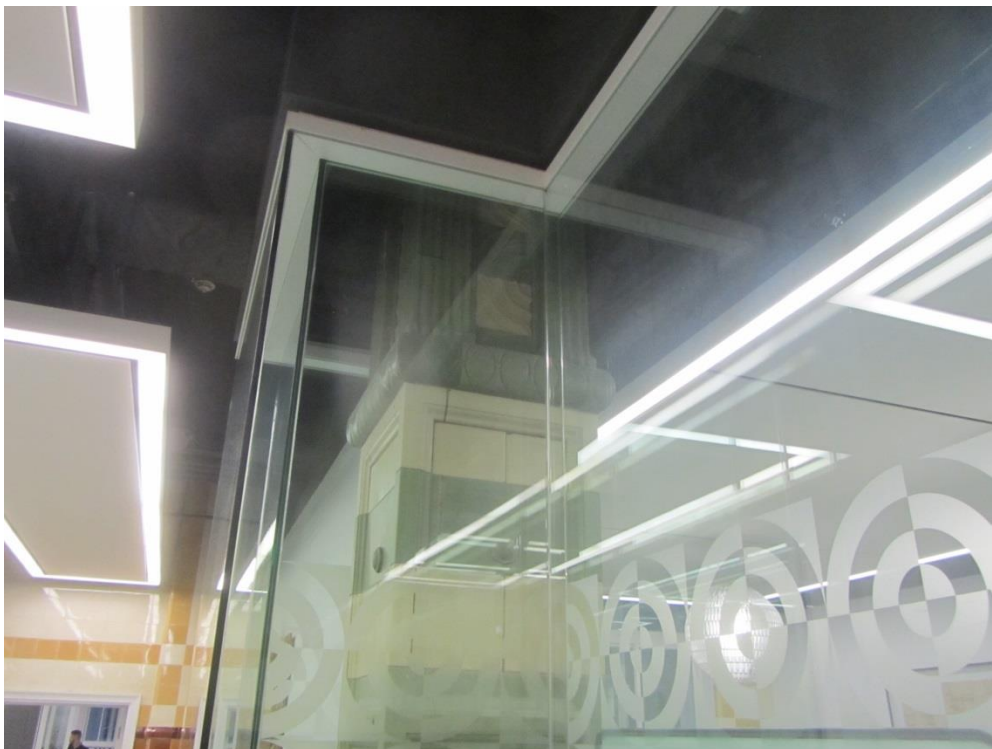
Photo Number	Location (as referenced on drawing)	Type of Frieze Cornice Tile	Comments
Ground floor level – see M19070/SK04			
Ground C1 -1	Column 1	Ceramic	No loose sections identified. Restricted access due to glazed panel
Ground C1 -2	Column 1	Ceramic	“
Ground C1 -3	Column 1	Ceramic	“
Ground C1 -4	Column 1	Ceramic	“
Ground C1 -5	Column 1	Ceramic	“
Ground C2 -1	Column 2	Ceramic	No loose sections identified. Restricted access due to glazed panel
Ground C2 -2	Column 2	Ceramic	“
Ground C2 -3	Column 2	Ceramic	“
Ground C3 -1	Column 3	Ceramic	No loose sections identified. Access restricted due to service counter
Ground C3 -2	Column 3	Ceramic	“
Ground C3 -3	Column 3	Ceramic	“
Ground C4 -1	Column 4	Ceramic	No loose sections identified.
Ground C4 -2	Column 4	Ceramic	“
Ground C4 -3	Column 4	Ceramic	“
Ground C5 -1	Column 5	Ceramic	“
Ground C5 -2	Column 5	Ceramic	“
Ground C5 -3	Column 5	Ceramic	“
