CHAN + EAYRS 111 Frogmal, Hampstead NW3 6XR

Zoe Chan Eayrs and Merlin Eayrs			
Project : 111 Frogmal			
TITLE : BLOCK AND SITE PLAN (EXISTING AND : PROPOSED - NO CHANGE)			
Date 04/08/21	Scale 1:50 @A0	Drawing No. BP__	Rev.01

Zoe Chan Eayrs and Merlin Eayrs		
Project : 111 Frogna		
TITLE : CELLAR PLAN EXISTING AND BUILT :		
Date 04/08/21	Scale 1:50 @A0	Drawing No. CRP
		Rev.02
<div><div>0</div><div>1</div><div>2</div><div>3</div><div>4</div><div>5</div><div>6</div><div>7</div><div>8</div><div>9</div><div>10</div></div>

Rose and Associates Sectional Detail of structural retaining wall and slab

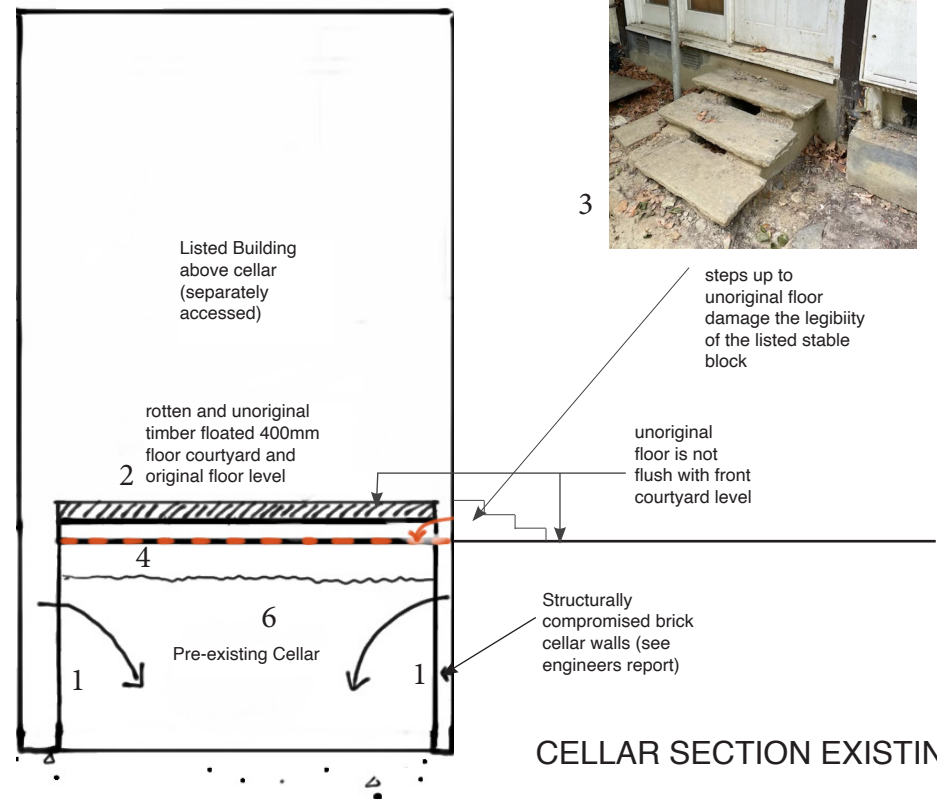
steps up to unoriginal floor damage the legibility of the listed stable block

2. 20TH CENTURY DAMAGE: ROTTEN FLOATED GROUND FLOOR- unoriginal 20th century ground floor was rotten and floated 400mm above the original ground floor. This damaged the visual character of the above ground listed building and the legibility of the historic building's use as a stable block to Froggnal Grove.

1. HERITAGE BENEFIT: STABILISED FROM COLLAPSE- All brick cellar walls retained with structural reinforced concrete walls and slab inserted within the historic fabric. Historic cellar walls which were hidden in their preexisting state are left in situ for their historic value within the ground.
 2. HERITAGE BENEFIT: ORIGINAL GROUND FLOOR REINSTATED. - Pre-existing rotten timber ground floor removed and new beam and block floor reinstated at original ground level, flush with front courtyard
 3. HERITAGE BENEFIT: BACKFILLED PART OF CELLAR REINSTATED: backfill earth and rubble removed and lost volume reinstated
 4. MODERN EXTERNAL ACCESS UNCHANGED: Via hatch and ladder from the front courtyard
- USE UNCHANGED: NOT HABITABLE SPACE
- VISIBILITY UNCHANGED: NOT VISIBLE FROM MAIN HOUSE OR ABOVE GROUND
