Subsidence Tree Report

For B Maule & Co Ltd

4 Downshire Hill, London, NW3 1NR

Insured:	Mrs. Z Hersov
Insurer:	TBC
Insurer Ref:	TBC
Maule & Co Ref:	20195429
Our Reference:	03229Rv2
Consultant:	Keiron Hart (BSc Hons, C.Env, F.Arbor.A, MICFor, MEWI)
Visit Date:	14.1.2020
Report Date:	20.1.2020

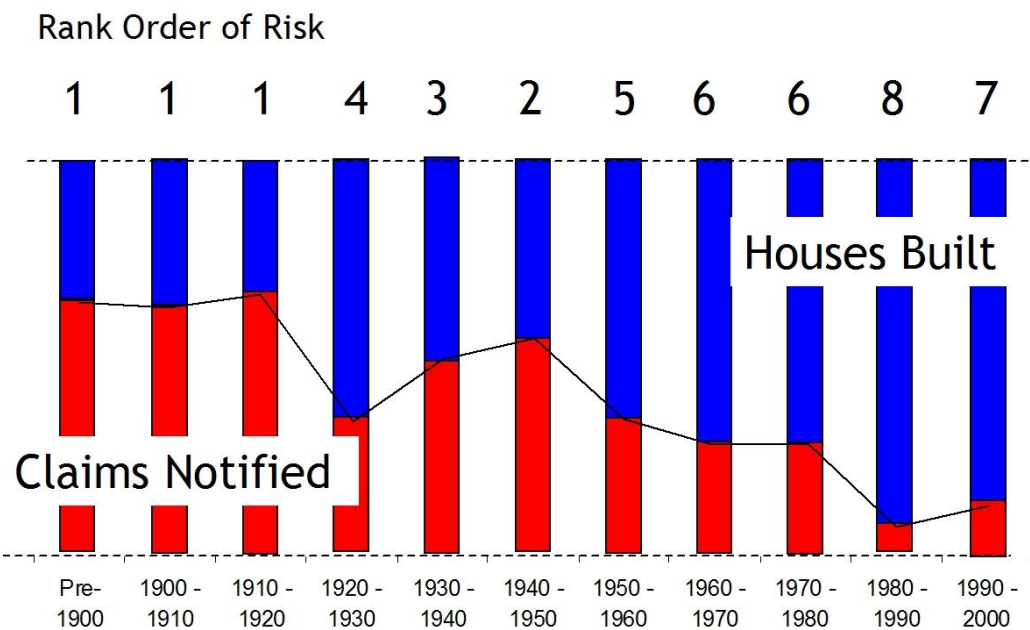
**Fig 1 – A properties age can influence the risk of subsidence damage. The property is advised to date from in the 1820's
(Source: Clay Research Group)**

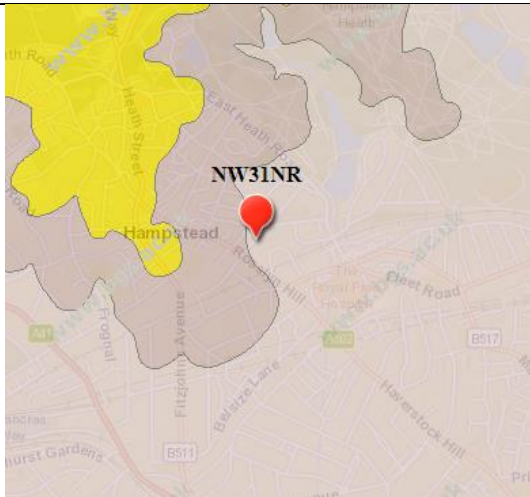
Soil Description

<p>London Clay Formation</p> <p>Clay And Silt. Sedimentary Bedrock formed approximately 48 to 56 million years ago in the Palaeogene Period. Local environment previously dominated by deep seas.</p>

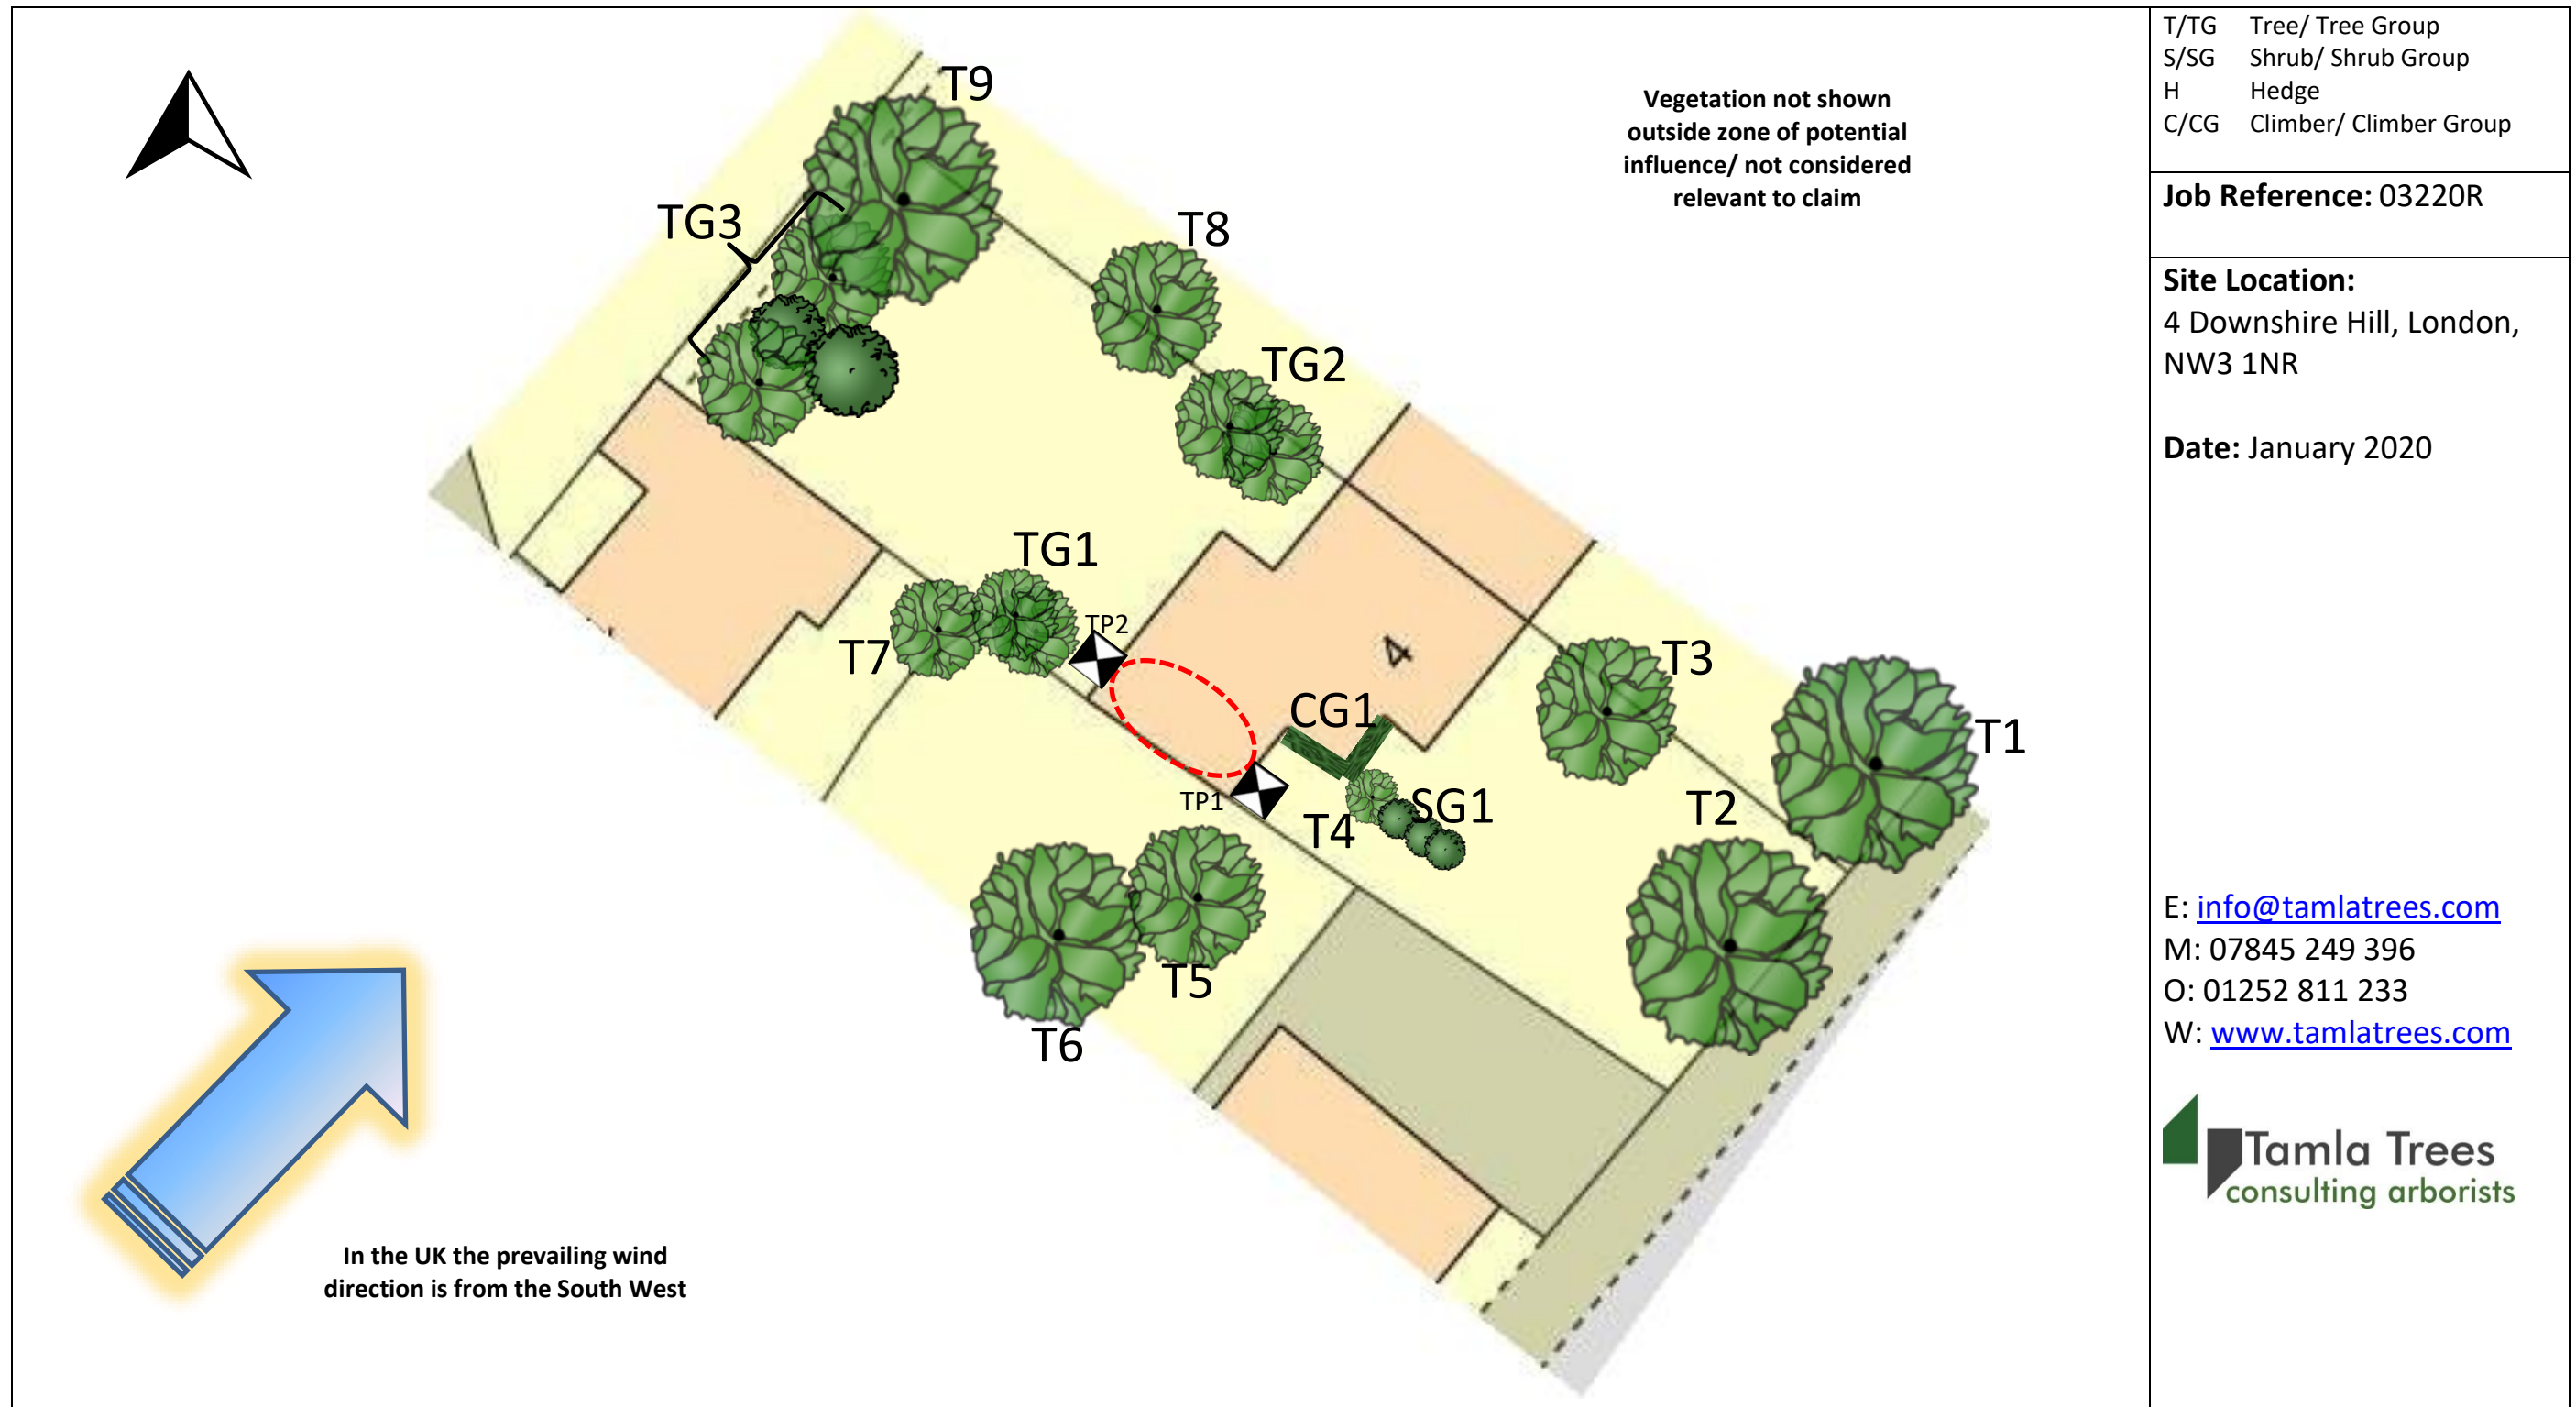
7. Site Plan

T6 (Cypress) will be the dominant causes in the movement. It is also possible that TG1 (Magnolia & Sweet Bay) and T7 (Cypress) are also causal in the movement given their size relative to the affected part of the building.

Tree No.	Species	Age Cat	Approx. Height (m)*	Distance to Building (m)	Ownership	Observations	Subsidence Risk Action	Recommended Tree Work
T5	Purple Leaf Plum	A	14	4.5	Unknown	Established 3rd party tree	Current Claim	Remove and treat stump to inhibit regrowth
T6	Cypress	A	20	9	Unknown	Large 3rd party tree.	Current Claim	Remove
T7	Cypress	A	16	7.1	Unknown	Large 3rd party tree.	Current Claim	Remove
TG1	Magnolia and Sweet Bay	A	6	2.7	No 4	Established trees	Current Claim	Remove and treat stumps to inhibit regrowth
