## Dartmouth Park Hill Service Tunnel Report

C&I New In-Patient Facility

Camden and Islington NHS Foundation Trust

## INVESTIGATIVE WORKS TO INSPECTION CHAMBER AND TUNNELS AT DARTMOUTH PARK HILL MENTAL HEALTH UNIT TO PEDESTRIAN RAMP PLUS PEDESTRIAN RAMP TO FORMER GENERATOR FUEL TANK REPORT No. WI/WH/0016

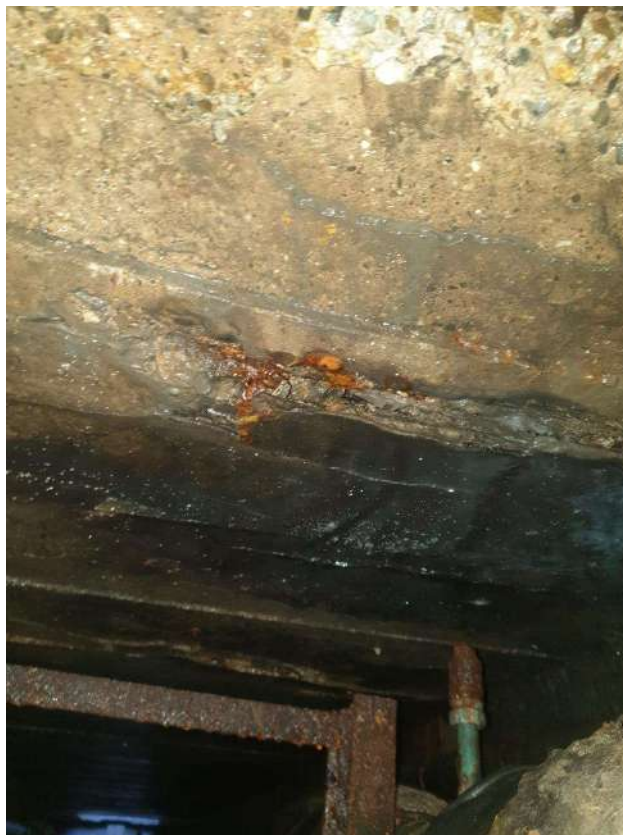
**CORROSION BEGINS 2 METRES FROM MH3  
TOWARDS MH2**
