**TREE PROTECTION &
CONSTRUCTION METHOD STATEMENT
FOR REDEVELOPMENT OF
KINGS CROSS COMMUNITY HUB
51 ARGYLE ST,
LONDON
WC1H 8EF**

ARBORICULTURAL SOLUTIONS LLP

ORIGINAL – DECEMBER 2020.

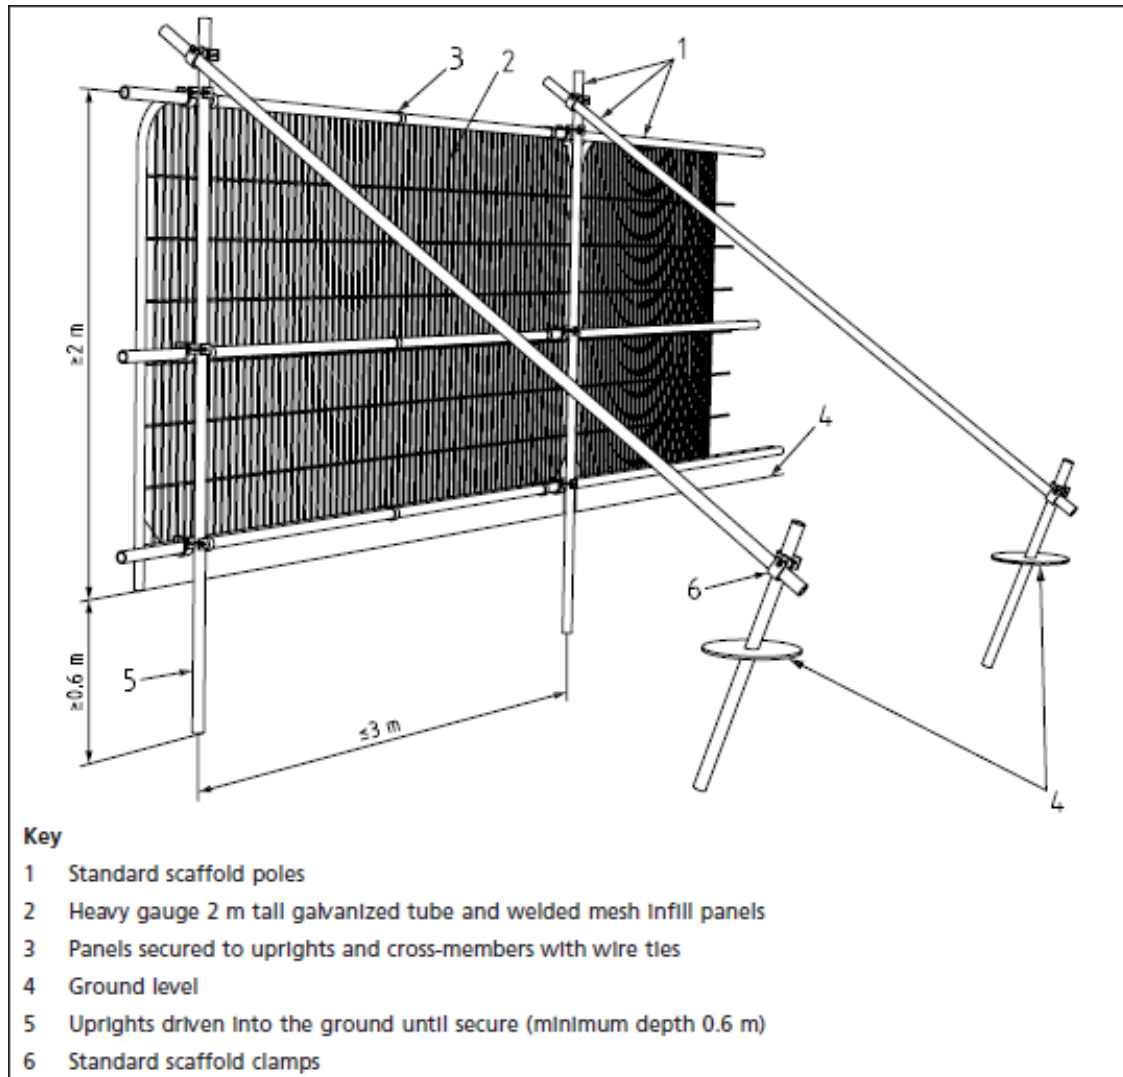
Figure 1: Tree Protective fencing

1.2.3. The barrier is to comprise of a vertical and horizontal framework (Figure 1 below), well braced to resist impacts, with vertical tubes spaced at a maximum interval of 3m. Weldmesh panels, such as Heras, should be securely fixed with wire or scaffold clamps to this framework. Weldmesh panels on rubber or concrete feet are not resistant to impact and should not be used. Care should be exercised when locating the vertical poles to avoid underground services and, in the case of the bracing poles, also to avoid contact with structural roots. If the presence of underground services precludes the use of driven poles, an alternative specification should be prepared in conjunction with the project arboriculturist that provides an equal level of protection. Such alternatives could include the attachment of the panels to a freestanding scaffold support framework.

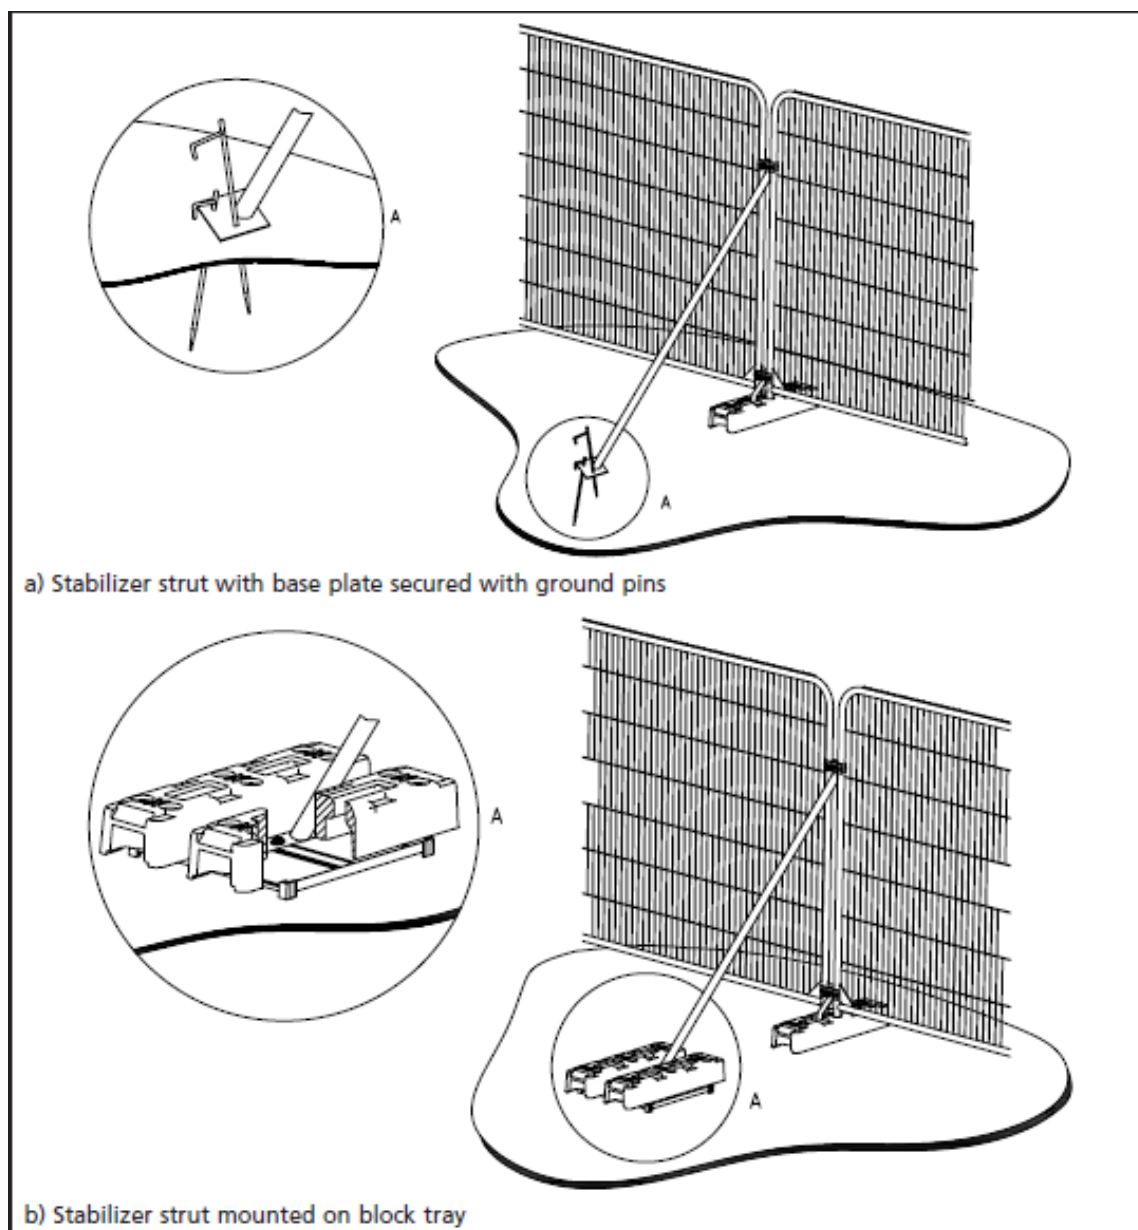
Figure 2: Tree Protective fencing (alternative)

a base plate secured with ground pins (Figure 2 below). Where the fencing is to be erected on retained hard surfacing or it is otherwise unfeasible to use ground pins, e.g., due to the presence of underground services, the stabilizer struts should be mounted on a block tray

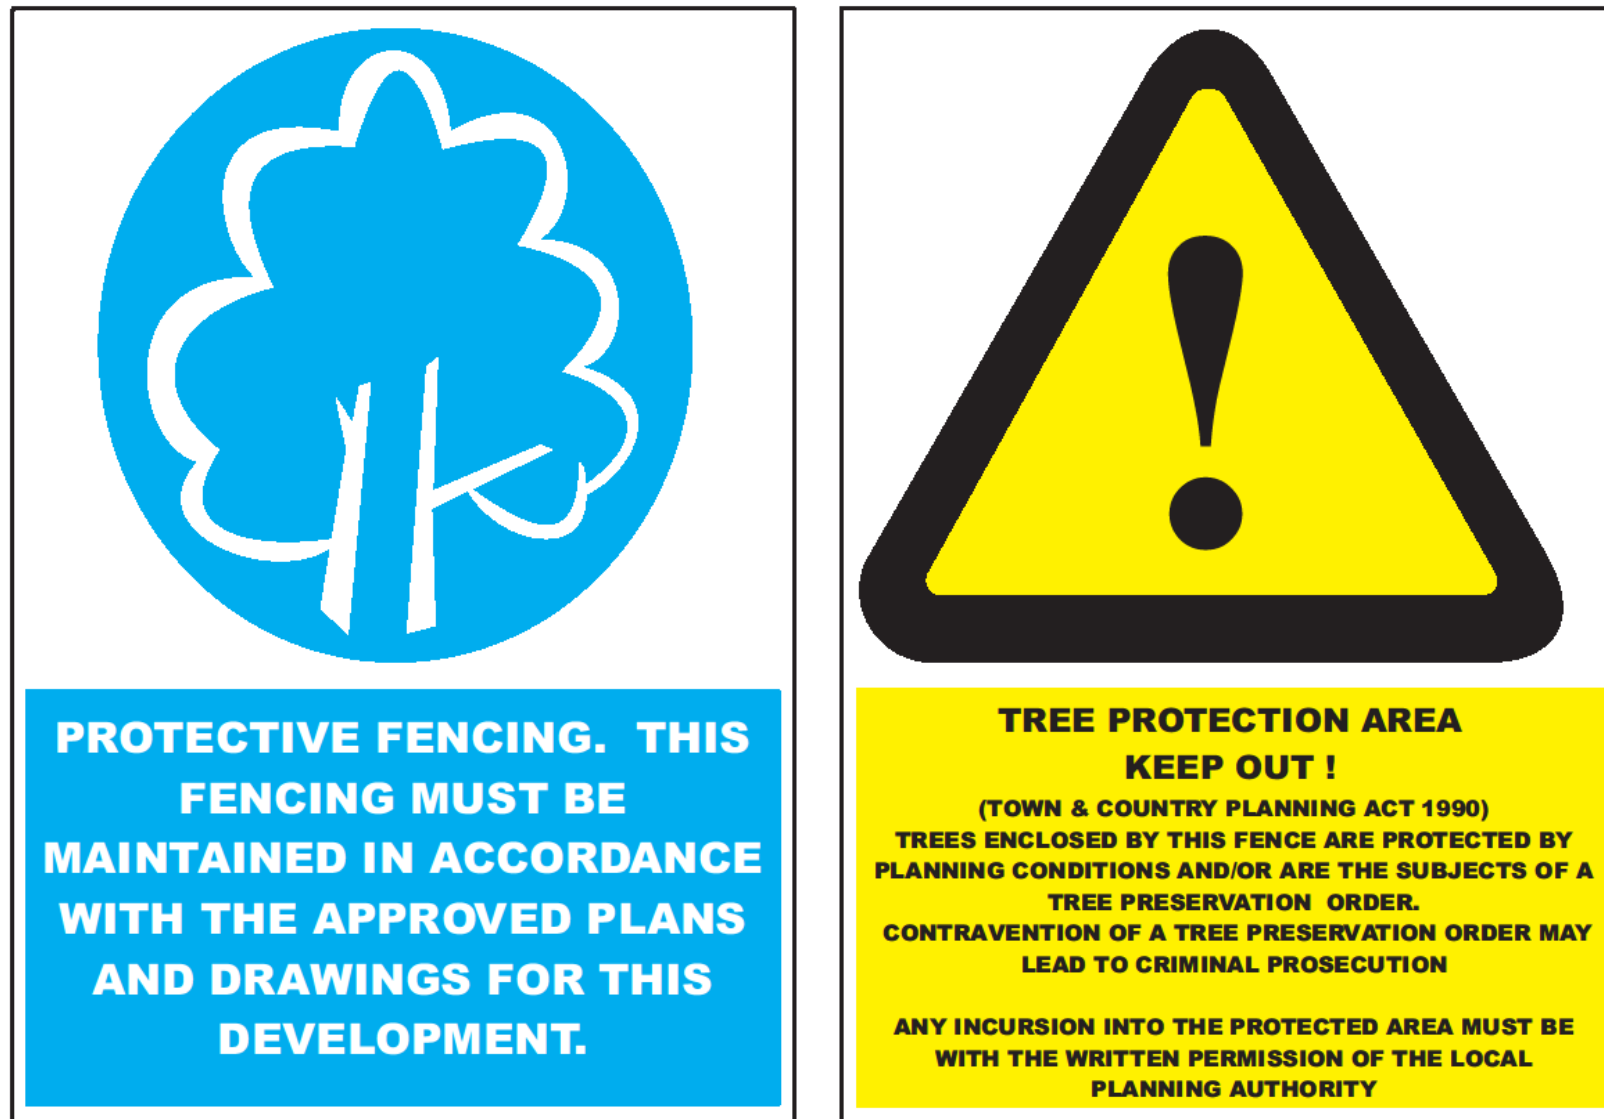
Figure 3: Example of warning notice

8.1.5. Protective fencing must be clearly marked using a warning sign such as the example shown in Fig 3. If a protective fence requires temporary repositioning, ground protection must be used within the exposed RPAs unless there is existing hard surfacing. The use of a proprietary ground protection system such as Eve Trakway or Groundtrax would be suitable as temporary ground protection and provides flexibility in positioning panels.

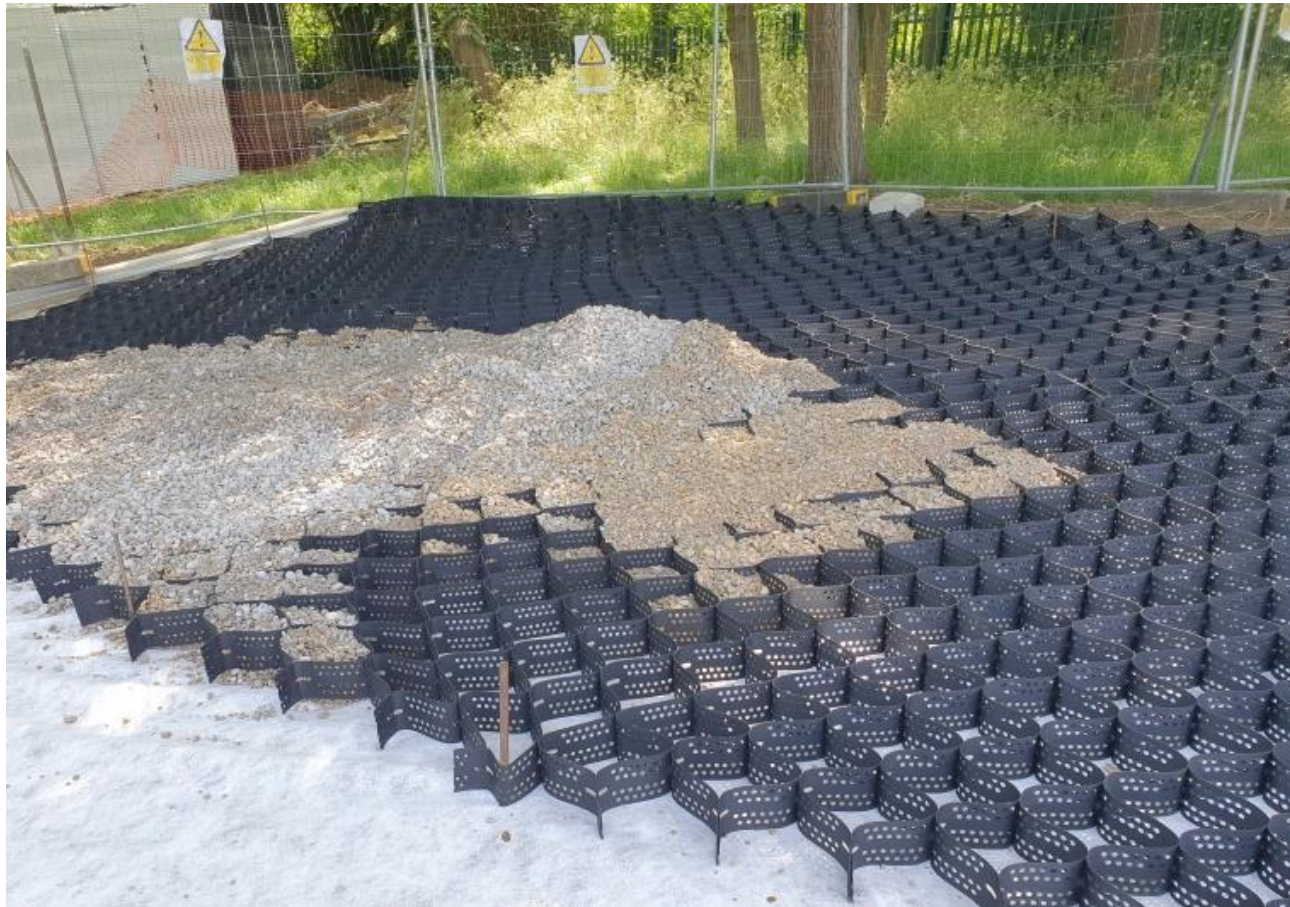
FIGURE 4: CELLULAR CONFINEMENT SYSTEM

8.7.3. A cellular confinement system is a series of geocells arranged in a honeycomb-like formation that is combined with an underlying geotextile and angular stone to spread loads in such a way as to minimise compaction of underlying soil. Due to its 3-dimensional structure, a geocell mat offers all-round confinement to the encapsulated material, which provides a long-term improvement in the performance of the sub-base. When a surface is reinforced in this way the load is distributed over a larger area of the subgrade-base interface, leading to lower vertical stress and reduced deformation of the subgrade. (Refer to Appendix B Fig 4. for an example of this phase of construction).

Refer to Fig 4 for a general overview of a typical installation with porous tarmac (illustration courtesy of Geosynthetics Ltd). The depth of CellWeb will be dependent on the expected loads and should be based on the manufacturer's recommendation.
