5 Elm Row, Hampstead Level 3Plus Condition Report

Level 3Plus Condition Report

5 Elm Row
Hampstead
London
NW3 1AA

19th May 2021

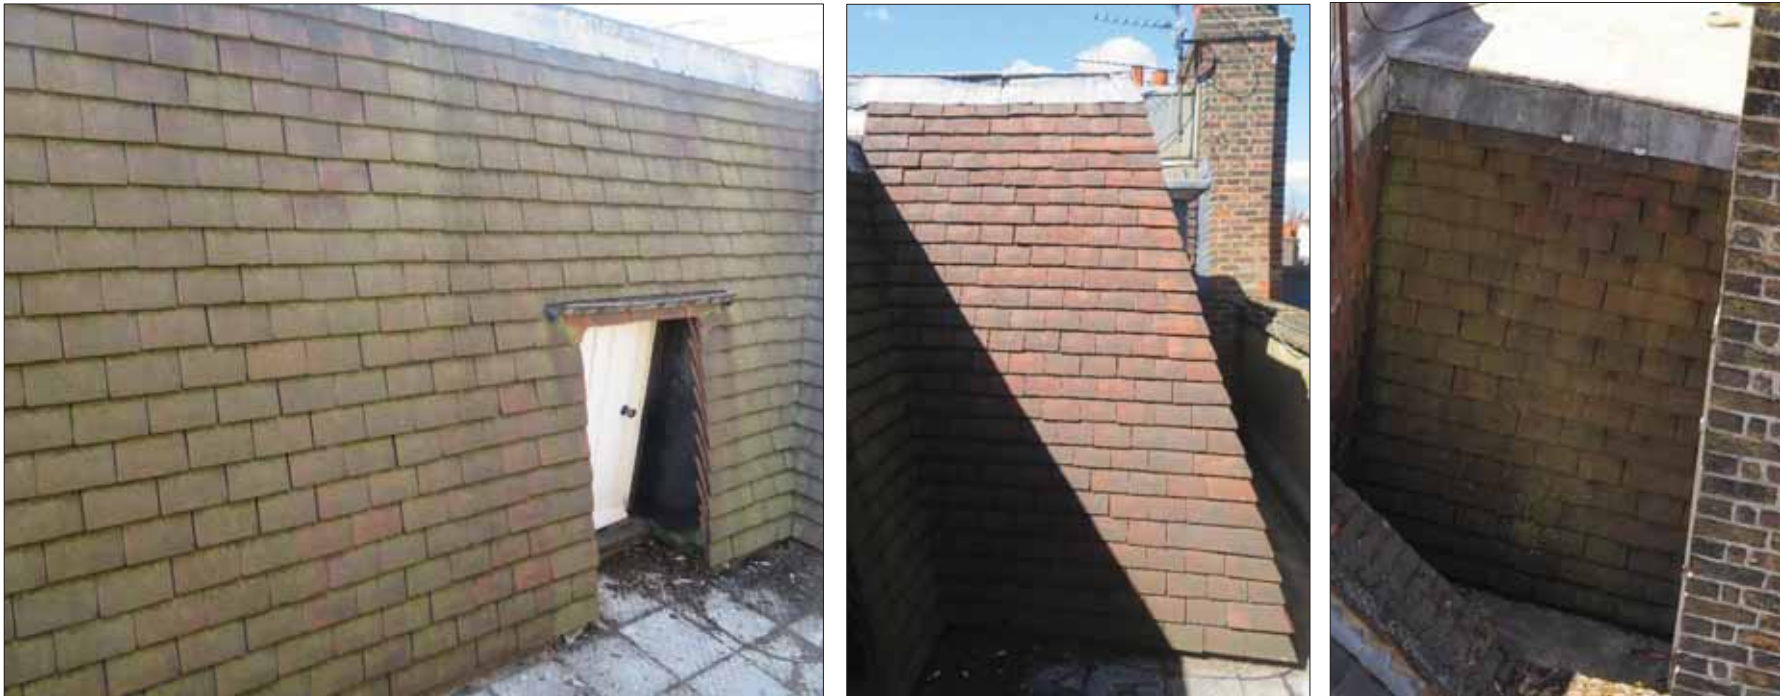
Image 4 -5: Rear Pitches of Roof 1 In Generally Good Condition.

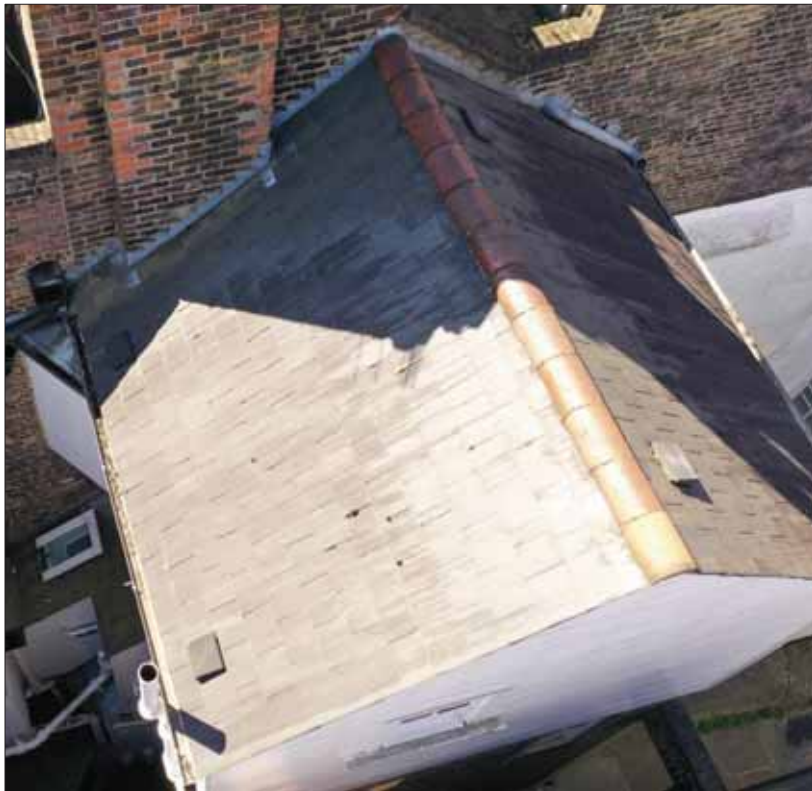
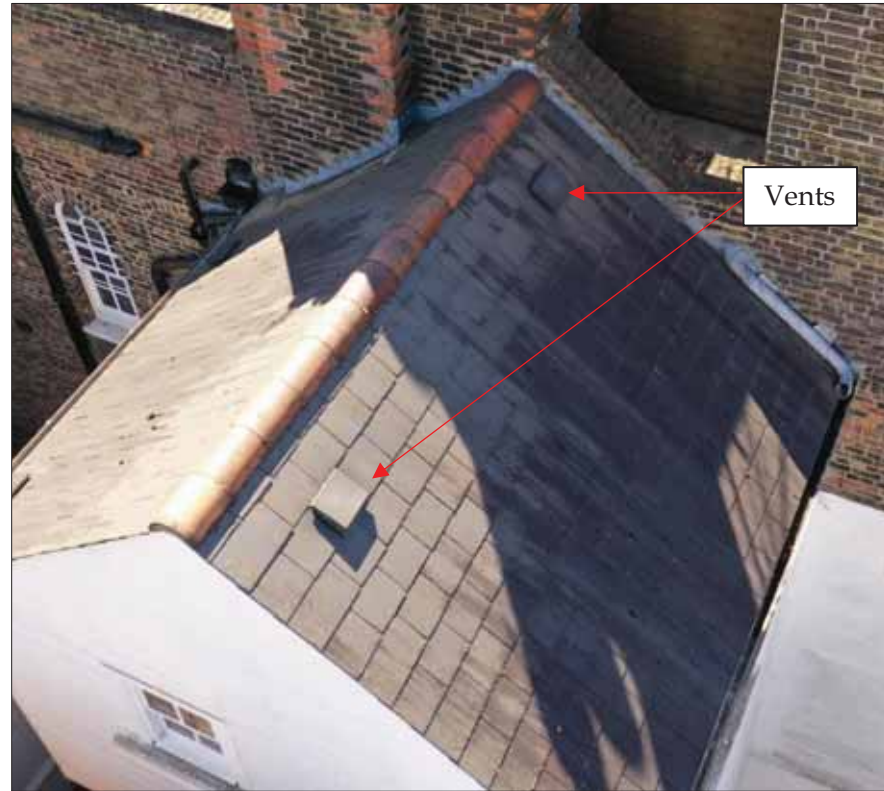
Element: Roof Coverings - Roofs 5 & 6 - Natural Slate	Category: D
Defect or Significant Observations: 7.19 Roofs 5 & 6 are covered with natural slate. Both are in generally good condition with no evidence of broken slates and only a single slipped slate, which has been previously repaired with a lead tingle, to Roof 6. 7.20 Roof timbers were not accessible, but happily the roof structure of Roof 5 is presumably well ventilated as it has been fitted with proprietary vent slates and there was no visual evidence of structural defect to either Roof 5 or 6.	
Recommendations: 7.21 No specific works currently required.

Images 12 & 13: East & West Pitches of Roof 5, Respectively.

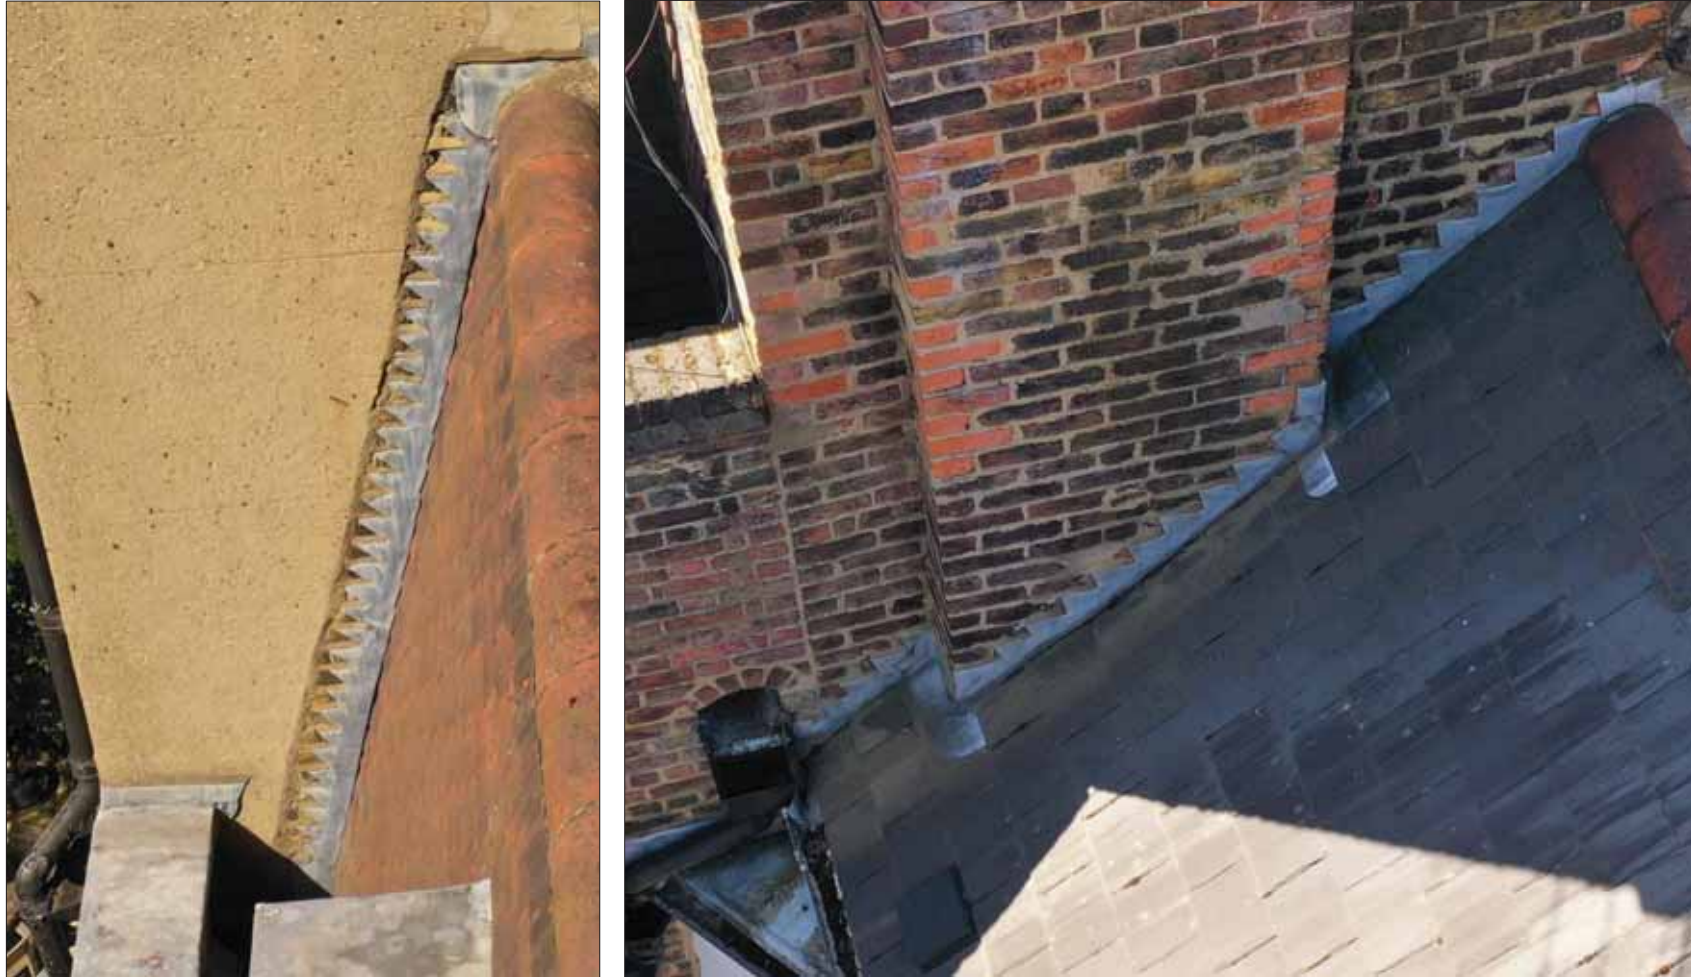
Element: Weather Flashings – Lead Flashings & Abutments	Category: C
Defect or Significant Observations:	
<p>8.1 Based on condition and observed level of patina, leadwork appears to differ in age which is indicative of a piecemeal approach to maintenance which is quite common and is generally an economically led decision. However, there was no evidence internally of water ingress attributable to failed flashings and abutments.</p> <p>8.2 Lead flashings associated with the flat top of the mansard roof as well as the party wall to the east appear to be of significant age, whereas other areas of leadwork is in a better overall condition.</p> <p>8.3 For example, the surface patina to leadwork associated with the west party wall, Roof 5, and Roof 6 suggests that the lead is no more than around 30 years old. For reference, the life expectancy of lead roofing material in the UK is around 80 – 100 years.</p> <p>8.4 However, the detailing is often fairly clumsy and is beginning to show its age in places. A number of clips have also become loose.</p>

Images 19 & 20: Newer Leadwork Elements to the West Party Wall & Roof 5.

Recommendations:	
<p>8.5 The leadwork would benefit at this juncture from some routine maintenance from a lead worker. Clips should be returned to their former positions and any loose detailing re-bossed.</p> <p>8.6 It would be prudent to replace the older leadwork to the top of the mansard at the same time as its recovering. See Roof Coverings.</p> <p>8.7 For information, all new leadwork should follow the codes and details as set out by the Lead Sheet Training Academy.</p> <p>8.8 See also Lead Roofs above.</p>

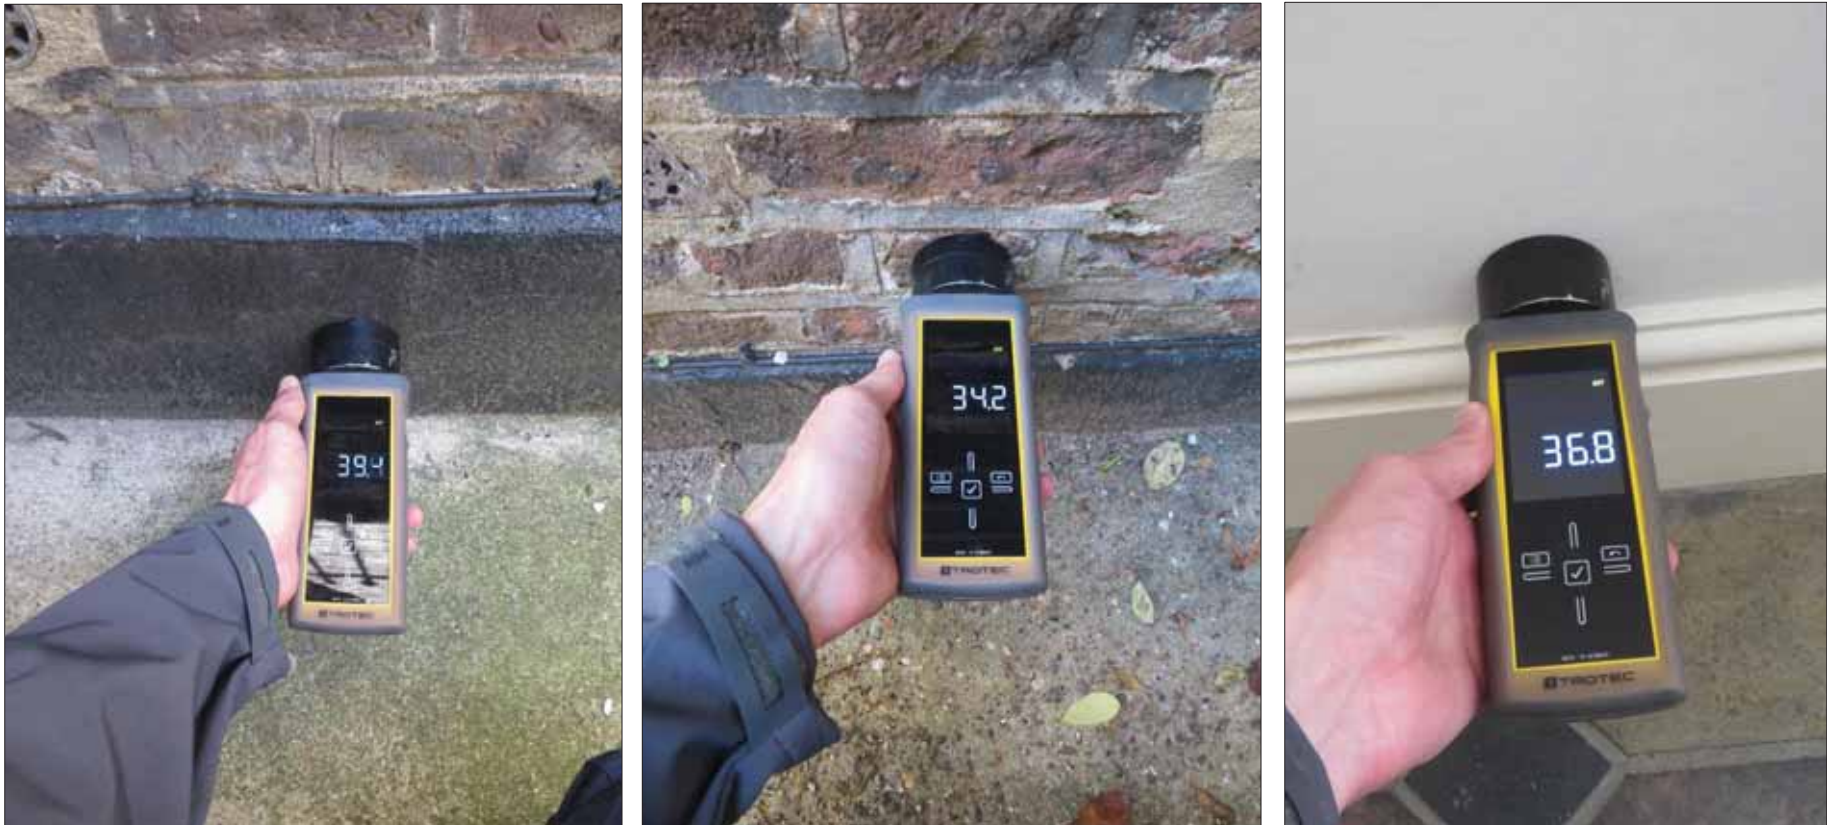
Images 37 - 39: Range of Acceptable Masonry Moisture Meter Readings to the Lower Ground Floor.

Recommendations:	
<p>13.5 No works currently required, but the area beneath the north west ground floor window should be monitored for damp.</p>

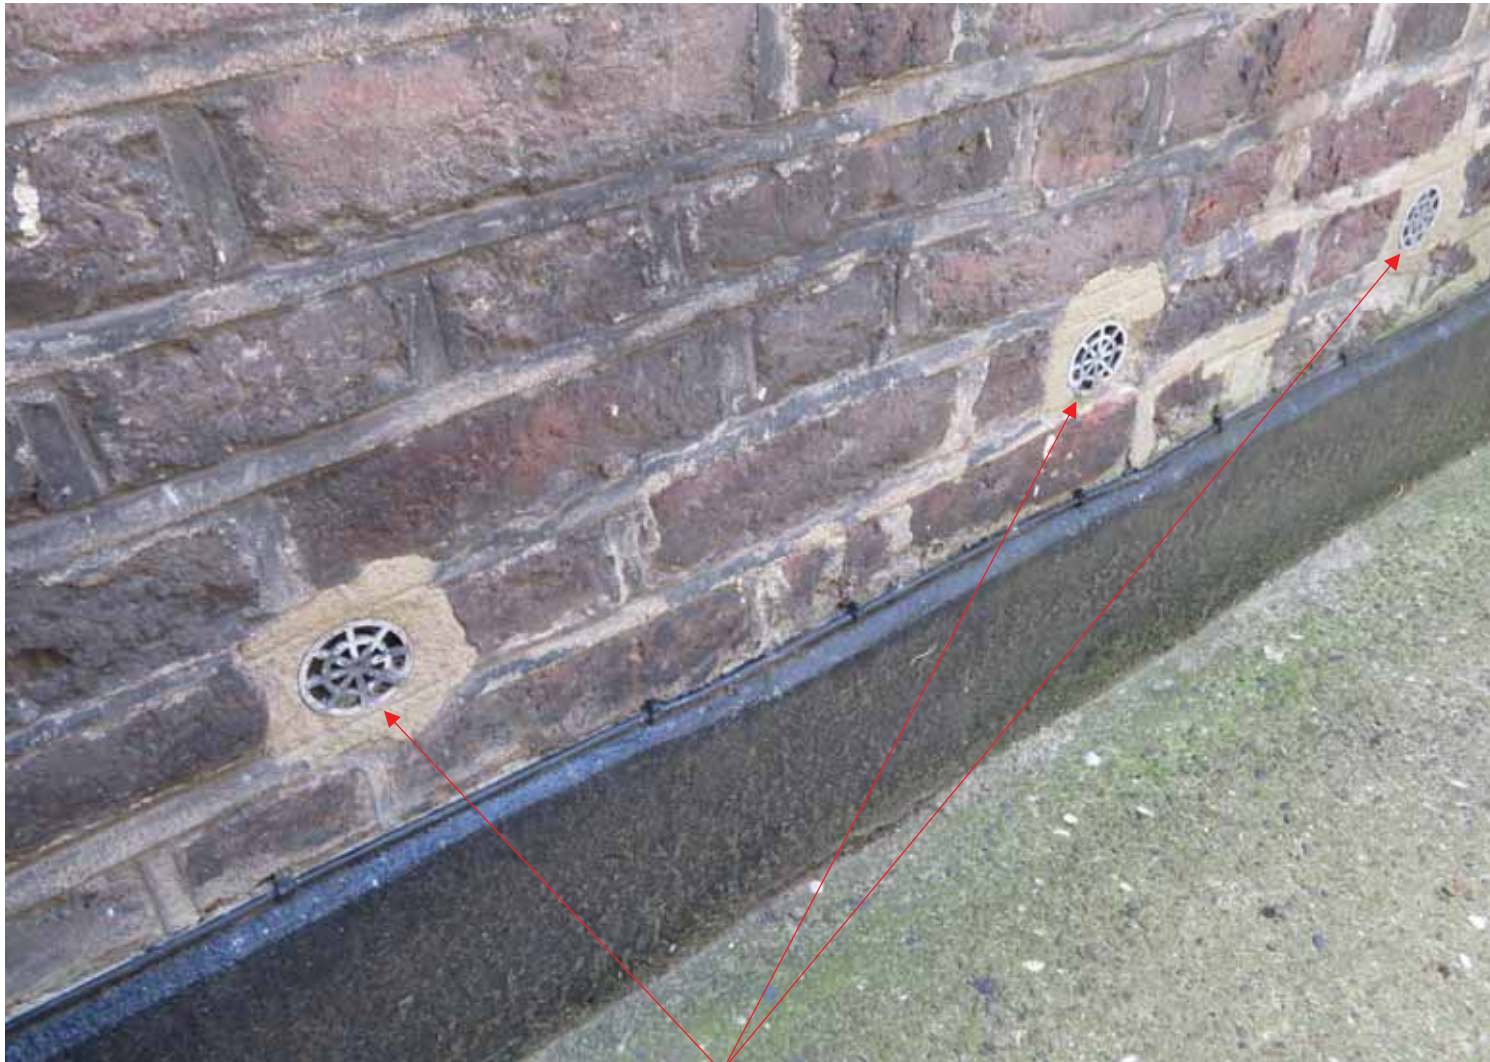
Image 40: Doulton Tubes to the Front Elevation.
