5 Elm Row  
London  
NW3 1AA

## DRAINAGE INSTALLATION

## MECHANICAL & ELECTRICAL APPRAISAL

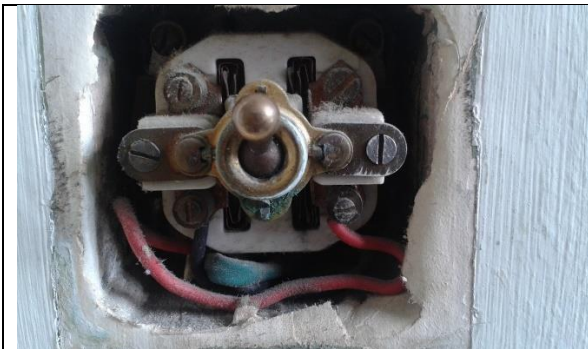
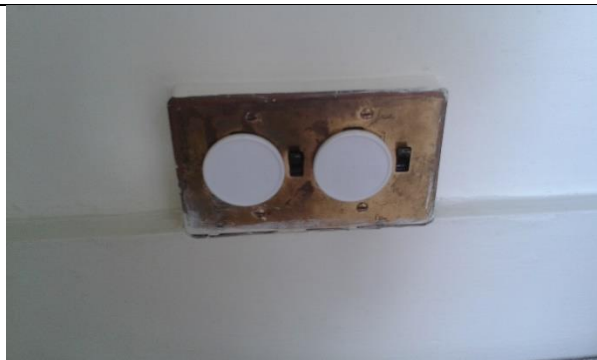
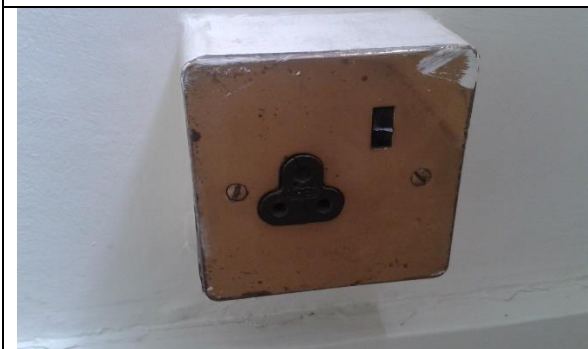
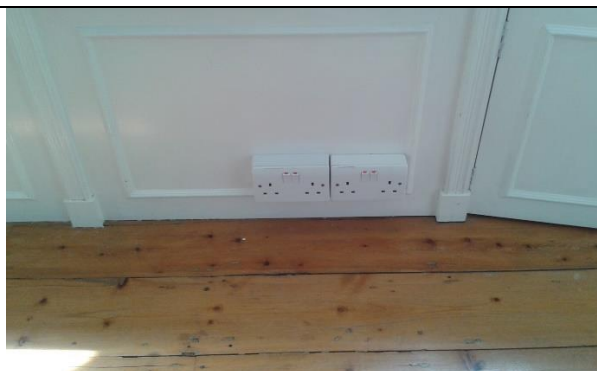
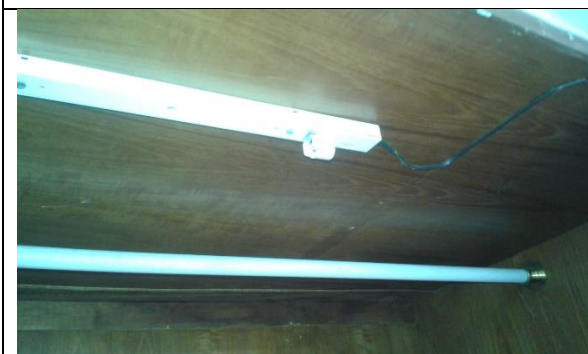
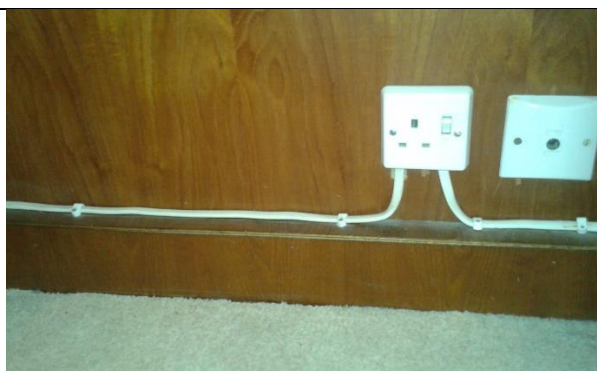
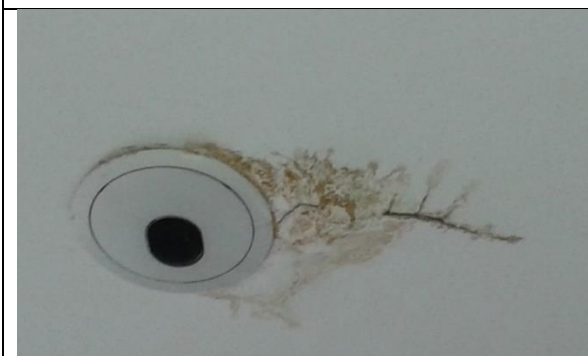
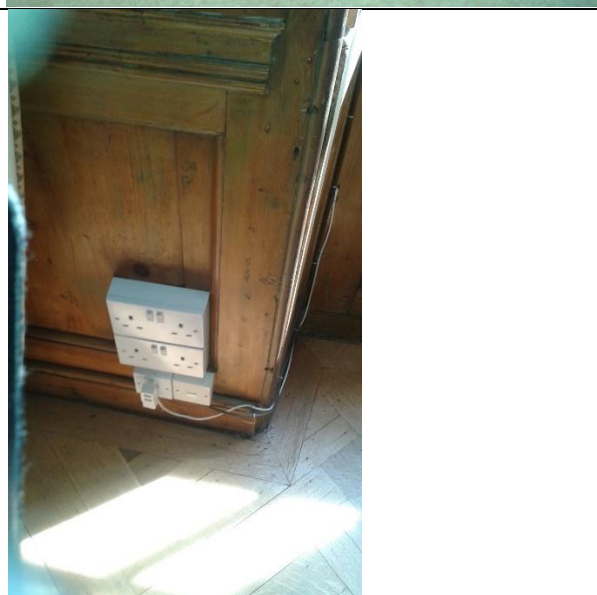
### Electrical Installation

Within the area of the main intake there is a high level of cabling which is not contained, untidily installed and without suitable containment is prone of impact damage, snagging etc. There is also noted to be a high degree of disused cabling and data cabling throughout the premises where during any additional works redundant services have not been removed.

There is clear evidence of inadequate encapsulation of connections provided to the wiring installation in a number of areas and we suggest within concealed areas which were not visible and we are unable to gain access. Such connections would be prolific where various extensions have been made in the premises in the past.

Fixtures and fittings are predominantly older pattern toggle units. A number of these are showing internal corrosion and showing wear to switching mechanisms, although generally still functional where additional modern white plastic has been installed these appear to be relatively random installed on a 'as needed' basis only and located in areas where access can easily be established without affecting the grading of the premises.

The original rewireable fuses have had replacement MCB's provided. These are not considered to be satisfactory for modern day end user protection. RCD RCBO's and surge protection should be afforded to the installation.
