Arboricultural Appraisal Report

Subsidence Damage Investigation at:

151 Gloucester Avenue
London
NW1 8LA

CLIENT:	Crawford & Company
CLIENT REF:	<div style="background-color: black; width: 150px; height: 20px;"></div>
MWA REF:	
MWA CONSULTANT:	Giles Mercer (BSc Hons)
REPORT DATE:	11/02/2020

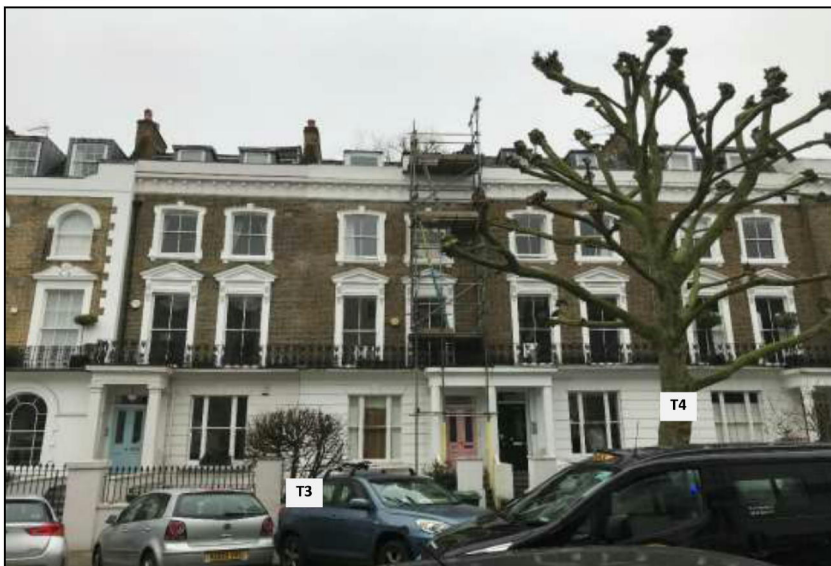
Damage is noted throughout the property with internal cracks on several levels and external cracking to the front and rear elevations.

View of Front elevation
