# Site Investigation Report

Job Information	
Client	Crawford & Co
Client ref	
Visit date	26/08/2021
Report date	01/09/2021

Overview	
Brief	Auger were commissioned by Crawford & Co to undertake a site investigation and CCTV inspection of the underground drainage within the area of concern at the property.
Findings	
Drain Survey	<p><b>Line 1 - From WG1 downstream to MH1</b> Our CCTV survey revealed joint displacements and root ingress, in addition we would like to note WG1 appears to be half recessed, meaning half of the gully is exposed the other half is situated under the property steps (refer to the images below)</p> <p><b>Line 2 - From WG1 upstream to Unknown</b> Our CCTV survey was abandoned less than 1m upstream due to encountering mass root ingress. We unsuccessfully attempted to clear these roots, hence the end location of the pipe is unknown. However we do believe that the rainwater downpipe that serves the customer and the neighbour is the final destination of line 2. This will not be determined until our further investigations.</p> <p>The above mentioned defects to the below ground drainage system have been caused by ground movement.</p>

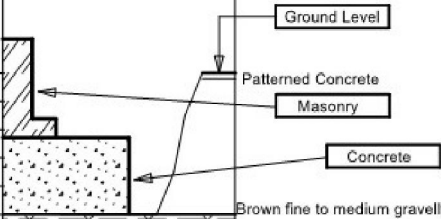
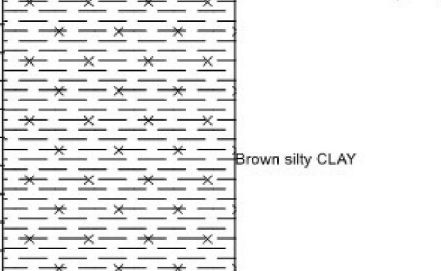
## Trial Hole Log No.1

Ground Level				
		Patterned Concrete				
		Masonry				
		Concrete				
0.5		Brown fine to medium gravelly silty CLAY	132kpa		Soil @ 0.5m	Root @ 0.5m
1.0

Brown silty CLAY	140kpa		Soil @ 1m	
1.5		Brown fine to medium gravelly silty CLAY	140kpa		Soil @ 1.5m	
2.0		Brown silty CLAY	140kpa		Soil @ 2m	
2.5		Brown silty CLAY	140kpa		Soil @ 2.5m	
3.0		Brown silty CLAY	140kpa		Soil @ 3m	
		TRIAL HOLE TERMINATED
