Site Investigation Report

Job Information	
Client	Crawford & Co
Client ref	
Visit date	07/06/2021
Report date	11/06/2021

Auger were commissioned by Crawford & Co to undertake a site investigation and CCTV inspection of the underground drainage within the area of concern at the property.

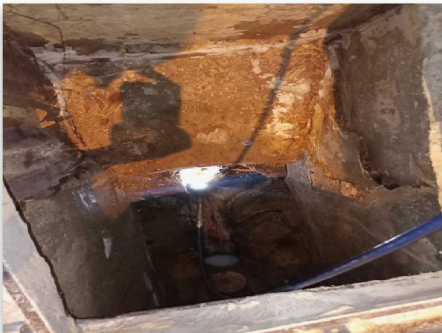
Fig 3.1: MH1

We were unable to survey this line due to the tight restricted access, entrance into the manhole will be required to survey this line

Line 1 - Auger recommend to attempt to survey from within MH1. Assess condition of channelling and benching within MH

Deep manhole entry will be required to survey Line 1 and for the repairs to Line 2.
