16-19 Southampton Place, London WC1A 2AJ

Appendix A.1 - Gazetteer Review

9802.4 - 18 Southampton Place

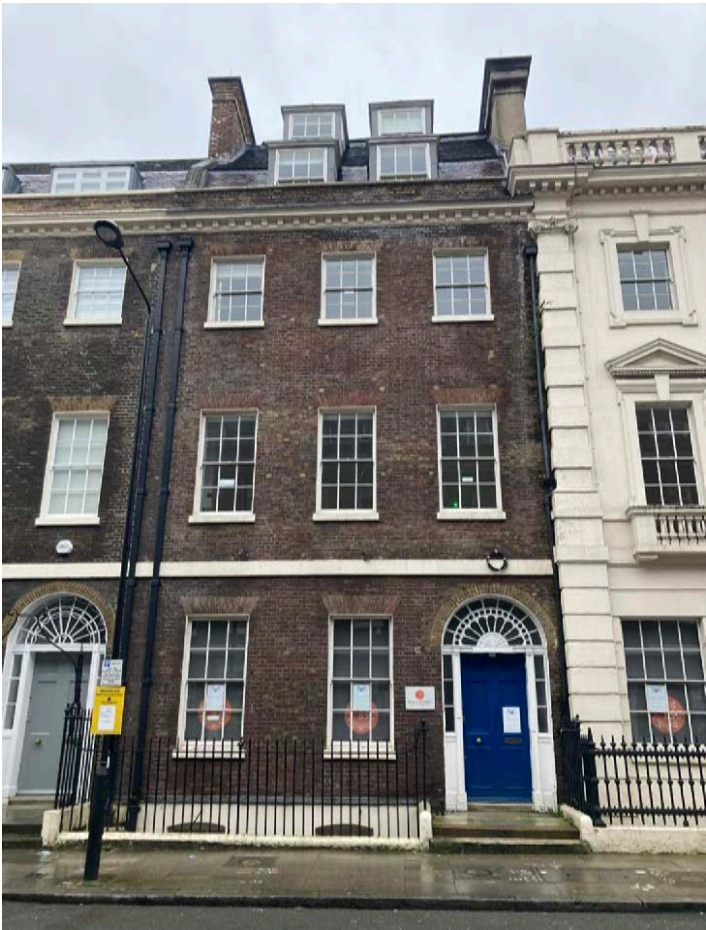
Figure 72 (Left) - The facade of Number 18 Southampton Place.

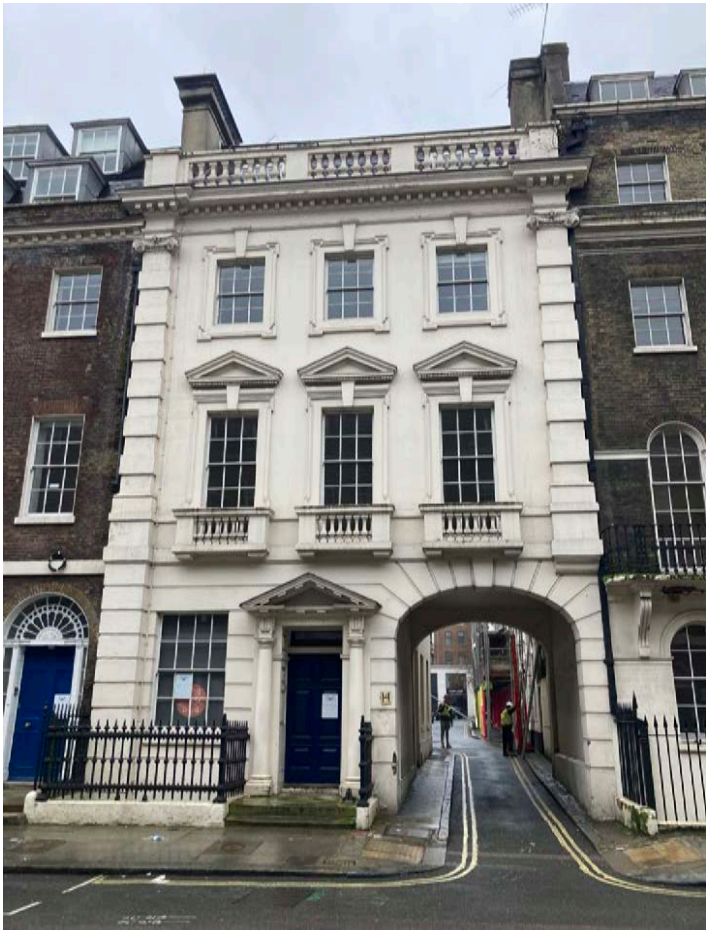
Figure 73 (Right) - The stucco facade of Number 19 Southampton Place.

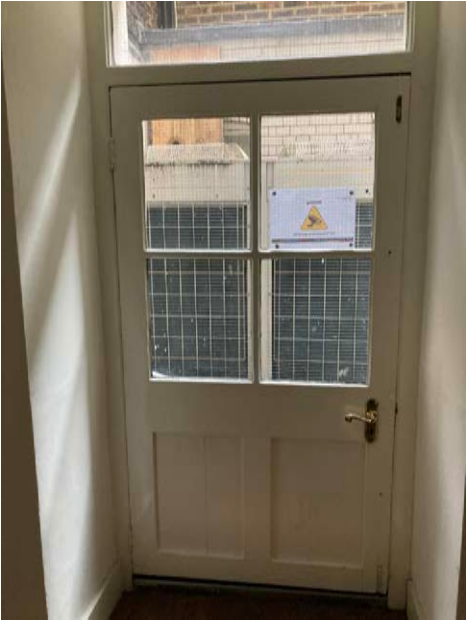
Figure 92, Top - There is an external door to the back of the building, but this is a modern insertion.
Figure 93, Bottom - The window however is historic, though some items were likely added in from elsewhere.

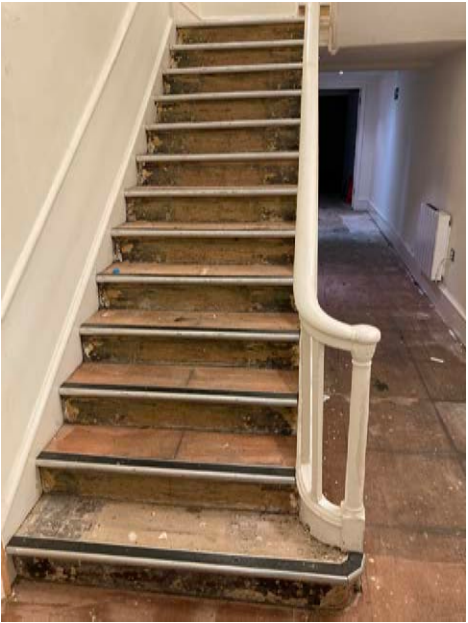
The stairwell houses the original stair, which has a painted handrail and square spindles. The stair maintains a closed stringer, even at ground level. The treads have been supplemented with a modern tread piece which has evidently damaged the stair. Between the 3rd and 4th levels where the new floor has been added, the original stair makes way for an Edwardian stair, which has turned spindles. In places there is also Victorian panelling.

Figure 95, Top - The staircase at ground level unusually is quite austere.

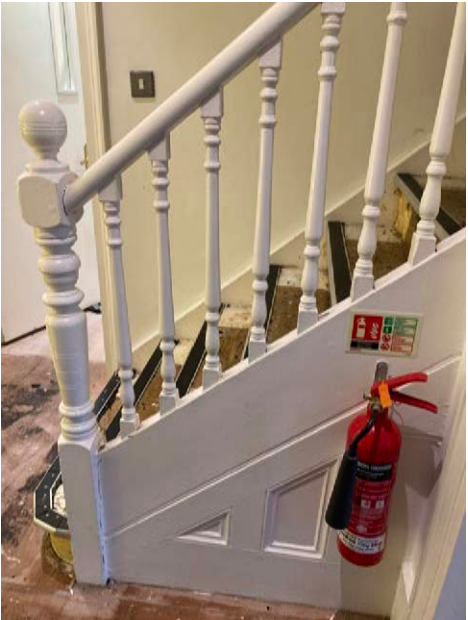
Figure 96, Bottom - Between the 3rd and 4th floor there is an Edwardian stair inserted into the building.

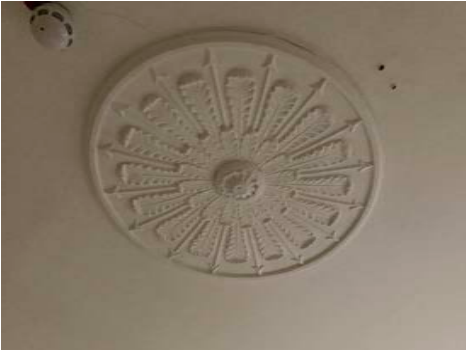
Figure 101, Top - A modern ceiling rose.
Figure 102, Upper Middle - The dado is original, and maintains its original panelling.
Figure 103, Lower Middle - The cornice appears to be authentic, though it may have been re-run.
Figure 104, Bottom - The windows to this room are historic.

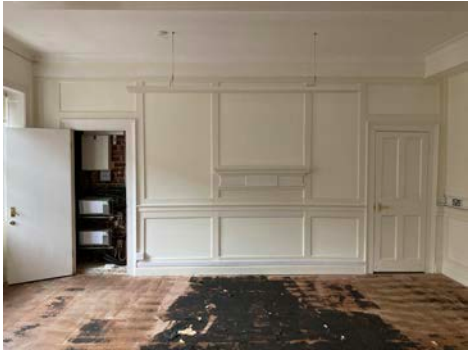
Figure 111, Top - The cupboards here feature modern doors, and have been filled with electrical plant.
Figure 112, Middle - The fireplace mantle has been blocked up and left in-situ.
Figure 113, Bottom - The windows maintain their original shutters and panelling..

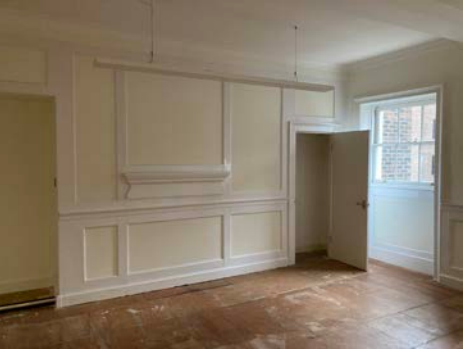
The fireplace has been filled in, though the original mantle remains in-situ.

Figure 114, Top - A general view of the room, showing the fireplace mantle left in-situ.
Figure 115, Middle - The windows retain much of their historic joinery, and the dado encircling the room is also historic.
Figure 116, Bottom - Another view of the historic windows, with their historic joinery.

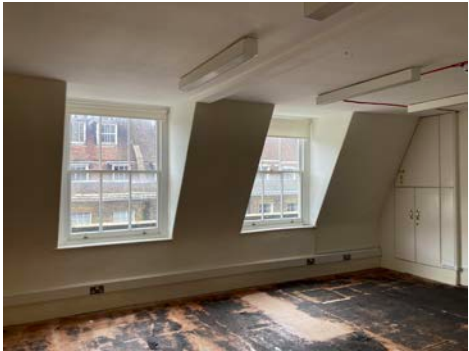
Figure 117, Top - The double mansard is an Edwardian introduction.
Figure 118, Bottom - A general view of the 3rd floor.

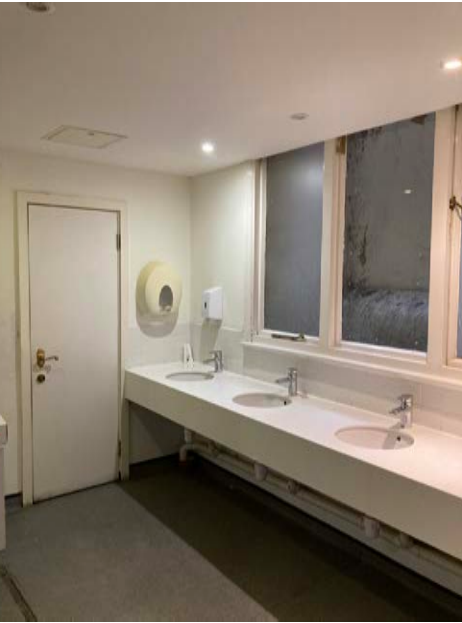
Figure 119 - The rear room to the basement of Number 19 has been converted into modern toilet facilities.

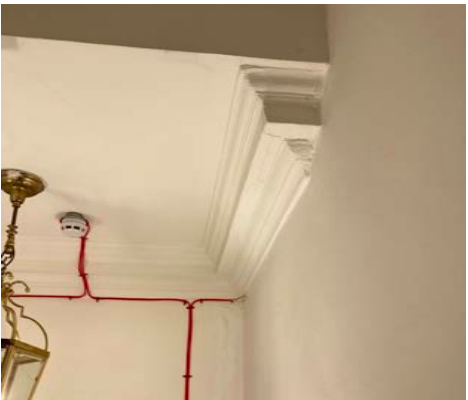
Figure 121, Top - The stair is original, though with modern nosing strips.
Figure 122, Middle - The side door is a modern addition.
Figure 123, Bottom - The original cornice is retained within the stairwell.

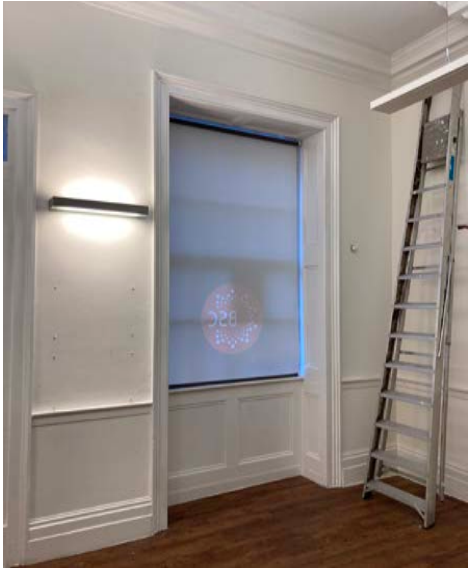
Figure 126, Bottom - The walls, and the amount of fixing marks, highlight how much these rooms have been altered.

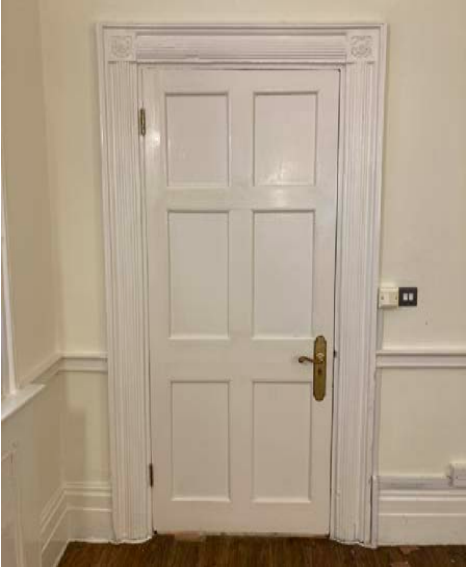
Figure 129, Bottom - The door to the hall has a likely 19th century architrave.

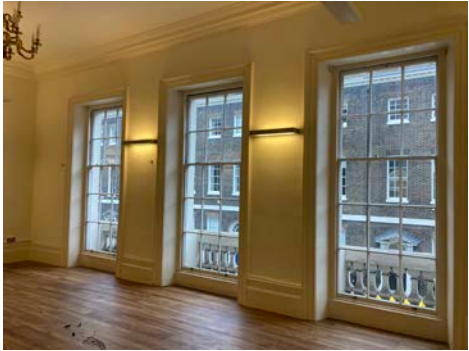
Figure 130, Top - A general view of the room.
Figure 131, Middle - The carved marble fireplace is a grand insertion to the room.
Figure 132, Bottom - The Victorian rose, whilst not original, is a historic addition to the room.

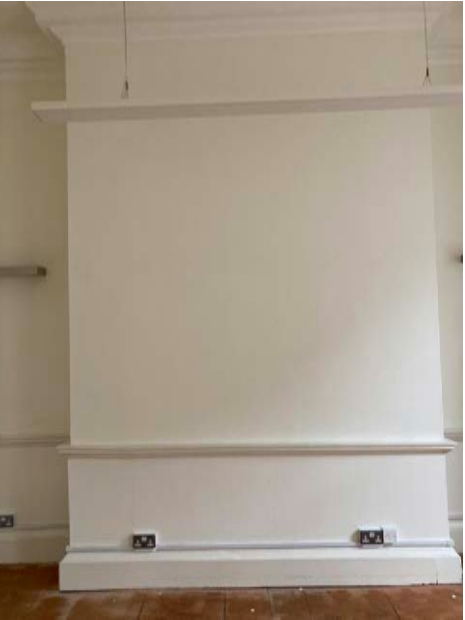
The fireplace has been removed from this room.

Figure 133, Top - Although the chimney breast remains to this room, the fireplace has been removed.
Figure 134, Bottom - The windows have a strange proportion with their current 3 on 3 pattern.

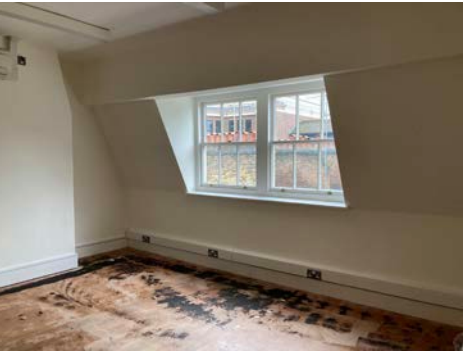
Figure 143, Top - A general view of the mansard level that was added in the Edwardian period.
