## Arboricultural Appraisal Report

### Damage Investigation at:

28 Park Village East  
London  
NW1 7PZ

| REPORT DATE: | 17/03/2021 |

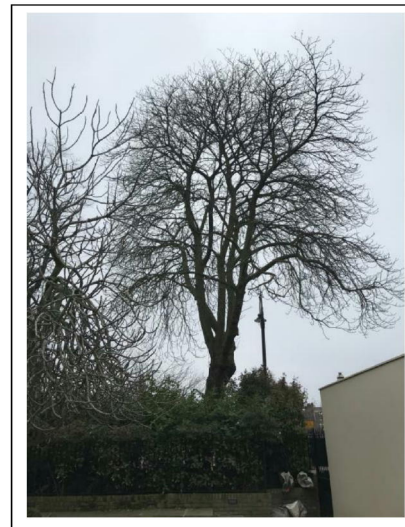
View of Lime (T2)

- 4.6 T2 is an early mature lime which has been the subject of historic pruning (crown reduced circa 4-5 years ago).
- 4.7 No significant defects were observed and the tree appears to be in good health.

- 4.8 Both the Horse Chestnut (T1) and the Lime (T2) are located in very close proximity to the boundary wall and the deflection / distortion and cracking noted to the boundary wall is the result of direct damage caused by the incremental growth of the tree stem and by the secondary thickening of the tree roots.
