### Hutton + Rostron Environmental Investigations Limited

# 55 Cumberland Terrace, Mews: Timber condition investigation

Site note 1 for 25 June 2021, job no. 154.11

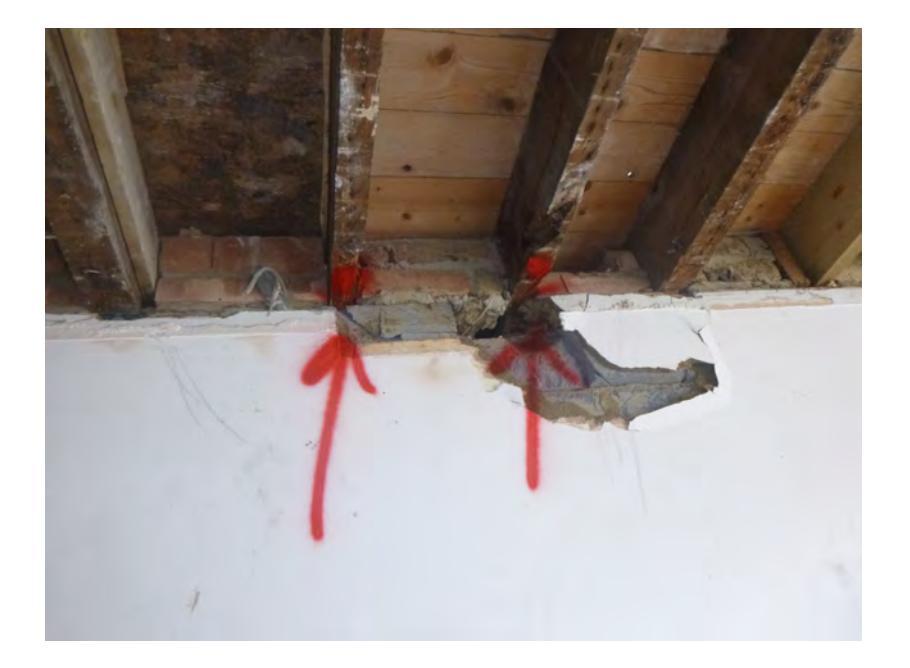
### Fig 28:

Floor structure; showing 2 no. floor joists at the centre towards the east which had significant notches and were no longer structurally adequate

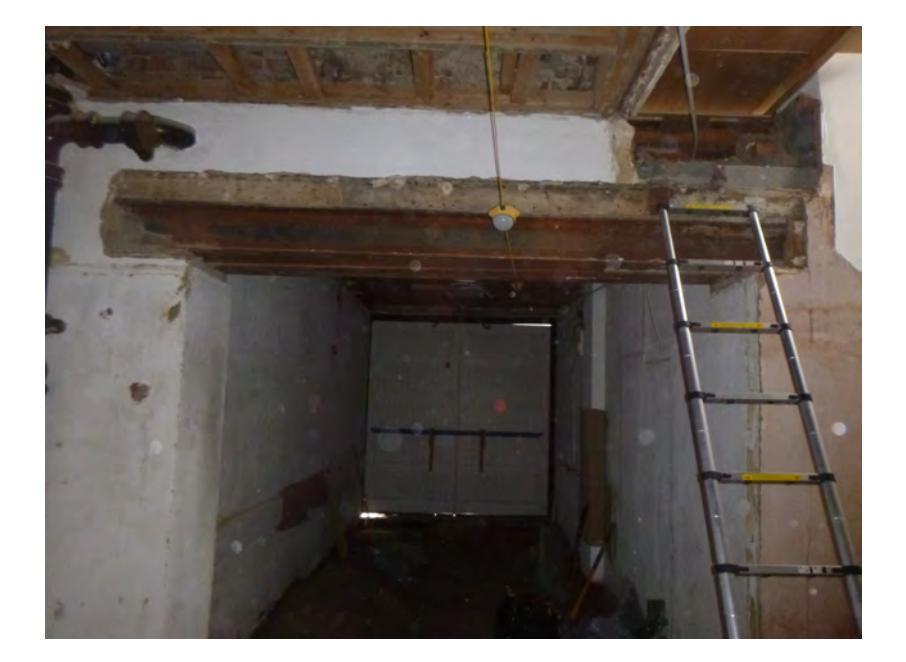
#### Fig 30:

Floor structure; showing steel lintels carrying opening within masonry. Note timber packers had been used above the lintels to support masonry

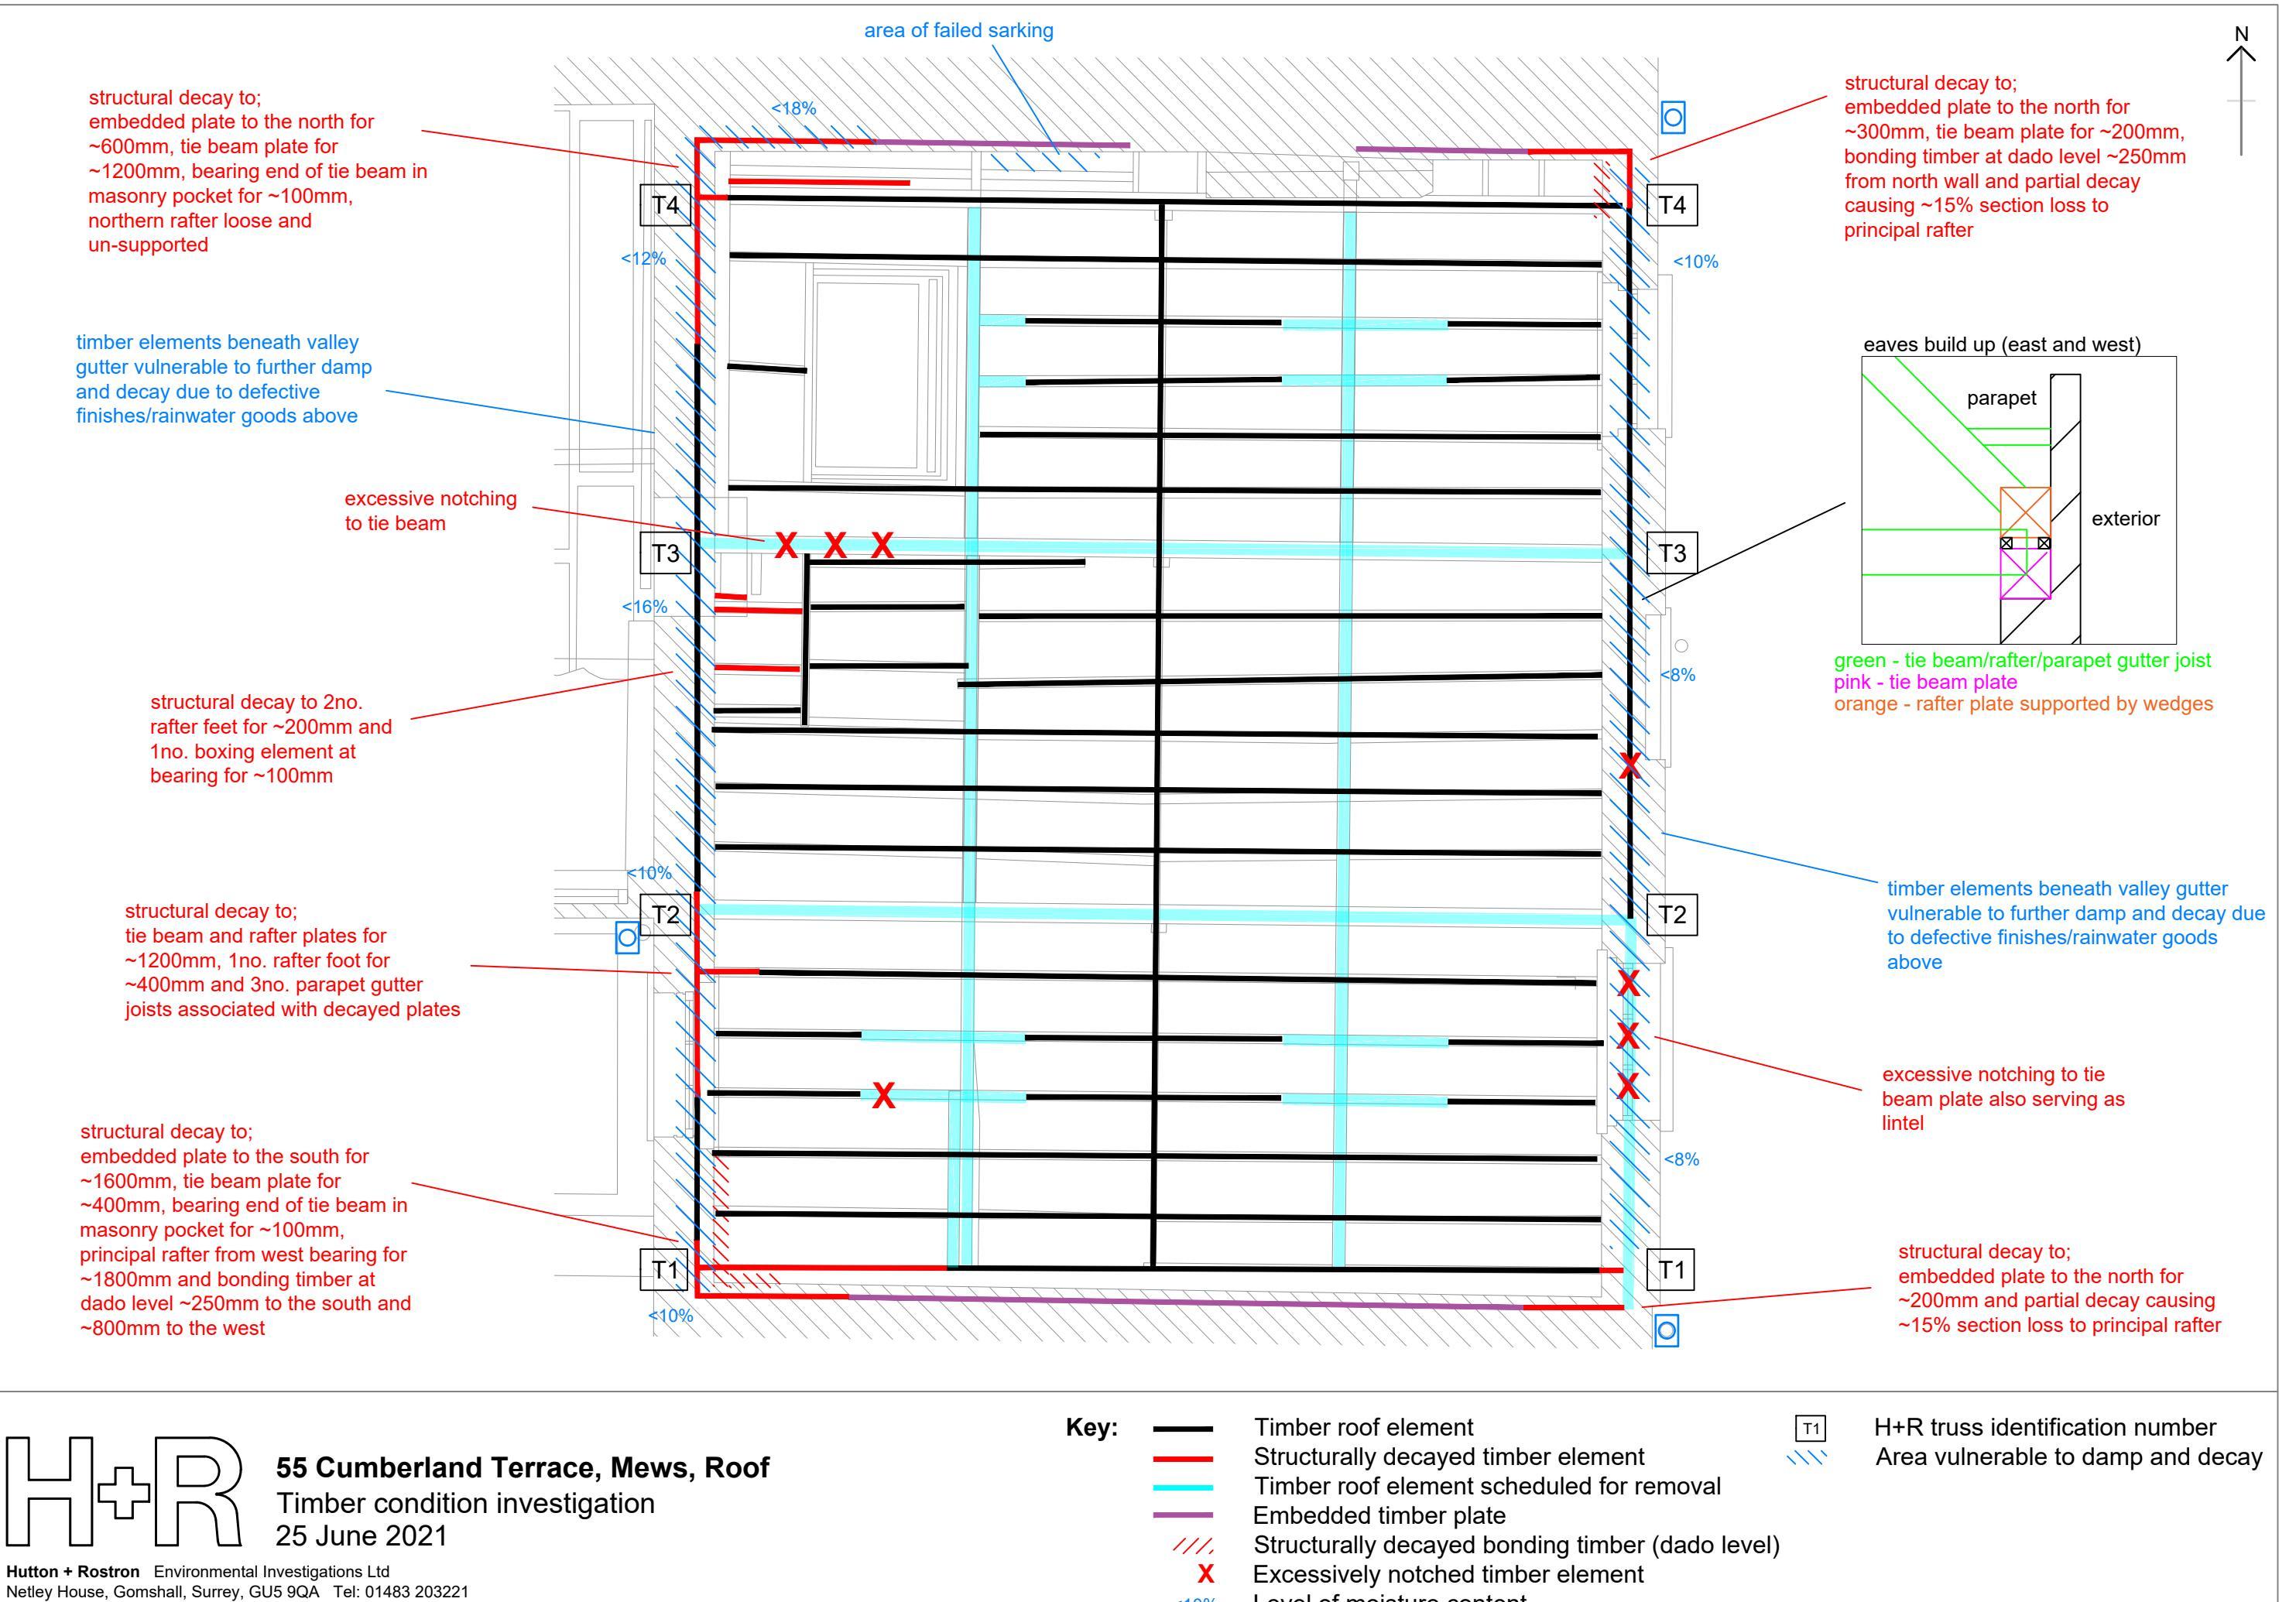
# Attachment B

embedded joist plate structurally decayed for

3no. joists and 1no. trimmer elements had been excessively notched and were no longer structurally adequate. See drawings in attachments for locations	timber
