Hutton + Rostron Environmental Investigations Limited

55 Cumberland Terrace, Mews: Timber Visual Strength Grading

Site note 2 for 25 June 2021, job no. 154.11

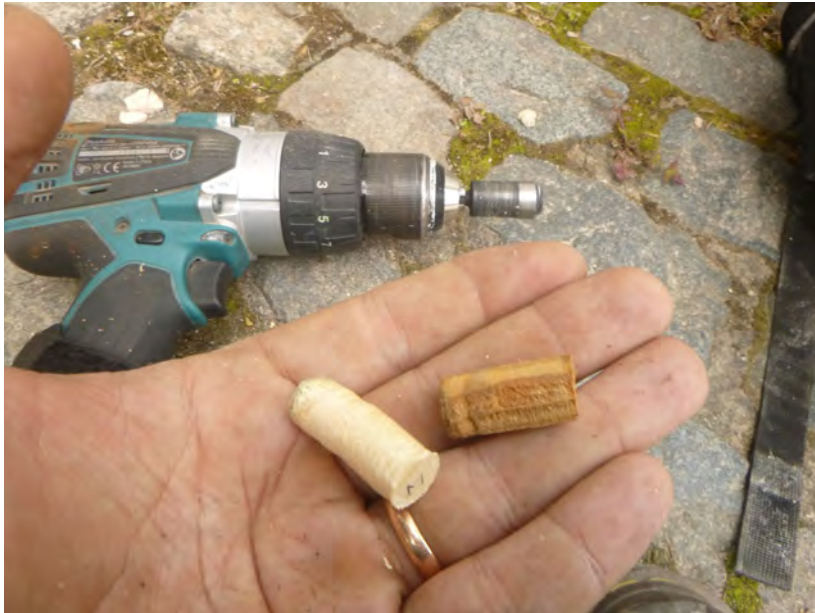
Fig 29:

Visual strength-grading, first floor structures; showing core samples taken from historic and modern floor joists for microscope analysis and species identification back at H+R laboratories

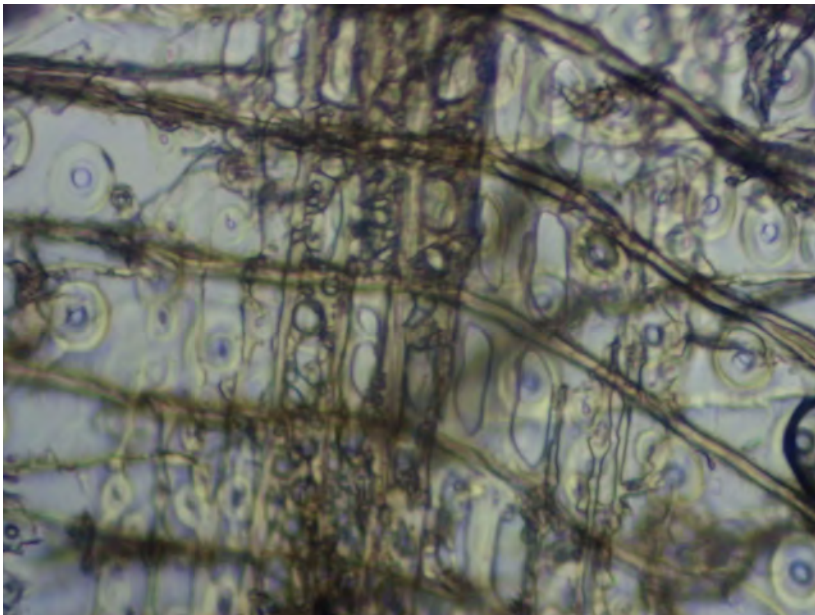
Fig 30:

Laboratory image; showing a microscopic radial image of a sample retrieved from a tie-beam at the time of survey from Roof Truss 1

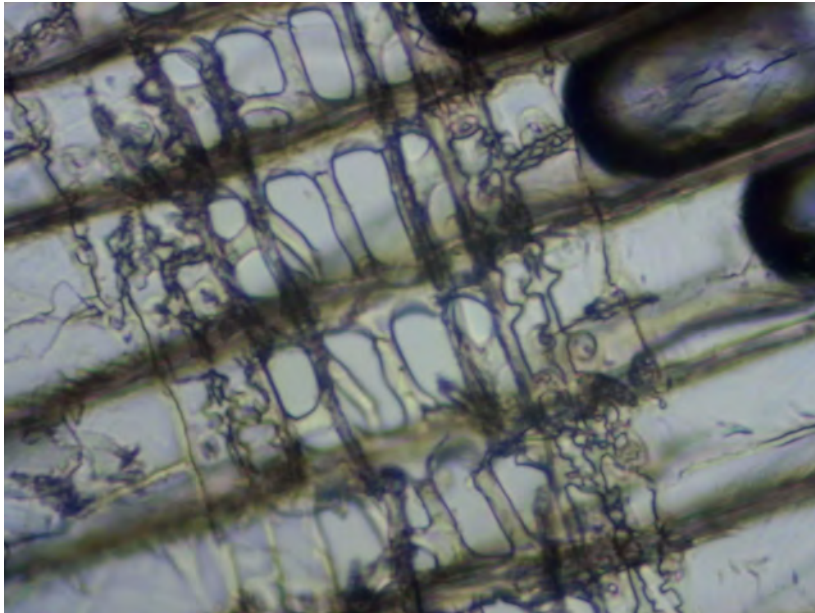
Fig 31:

Laboratory image; showing a microscopic radial image of a sample retrieved from a principal rafter at the time of survey from Roof

The large window-like openings in the cross-field pitting, and the dentate ray tracheids, are both characteristics associated with relevant literature and library samples relating to European redwood (*Pinus sylvestris*, or Scots Pine)

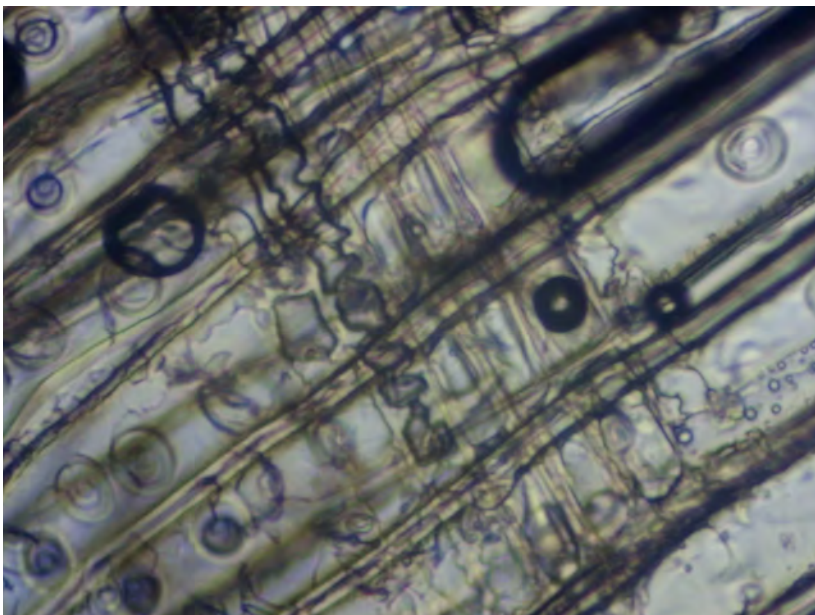
Fig 32:

Laboratory image; showing a microscopic radial image of a sample retrieved from a new common rafter at the time of survey from a roof purlin element

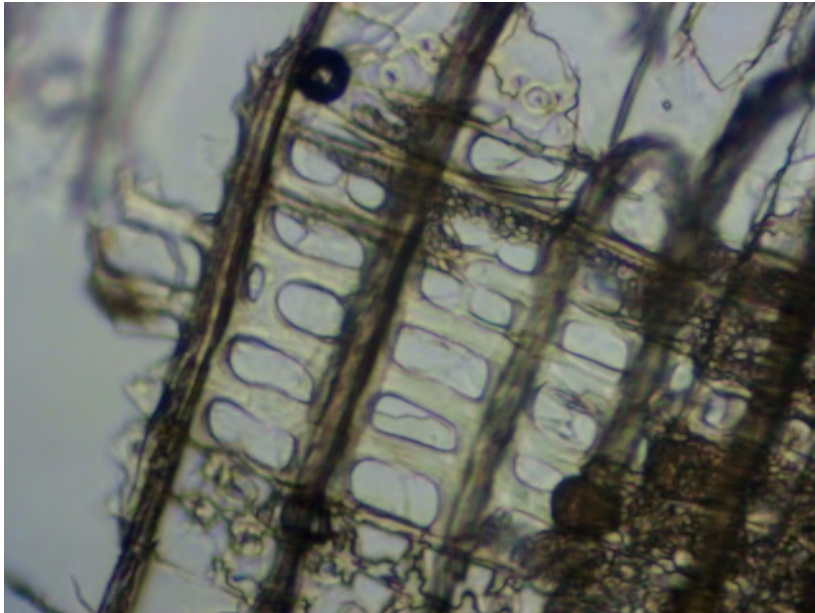
Fig 33:

Laboratory image; showing a microscopic radial image of a sample retrieved from a historic floor joist at first floor level
