## BS5837 Arboricultural Impact Assessment

38 Hillfield Road, London, NW6 1PZ

Job Reference: 03725R

February 2022

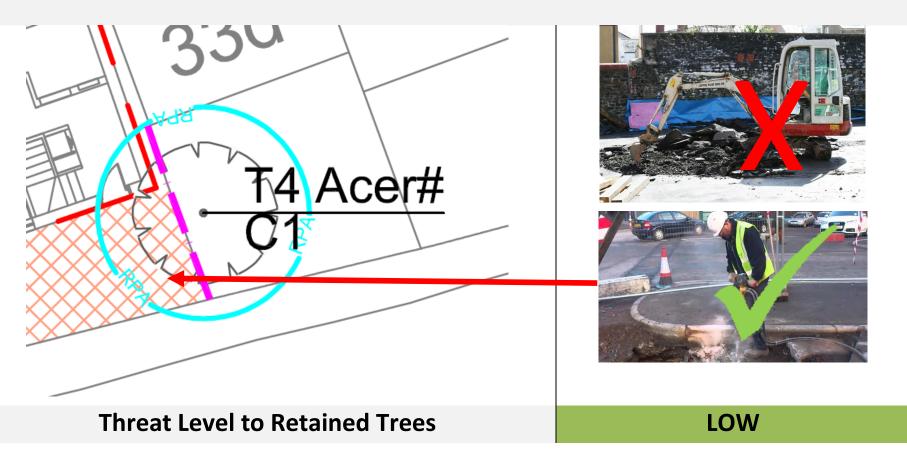
#### **Surface Removal Works within Protected Area of T4**

5.4.5 Existing surfacing within the protected area of T4 will be broken out at the end of the main construction project and prior to landscaping. This limits the risk of tracking of exposed ground and contamination from undertaking the work earlier in the development cycle.
