**COMPARTMENTATION AND FIRE DOOR SURVEY**

**CENTRE POINT HOUSE,  
St Giles High Street,  
London WC2H 8LW**

**Project Number**  
I045302

**Date**  
04.01.21 and 31.03.21

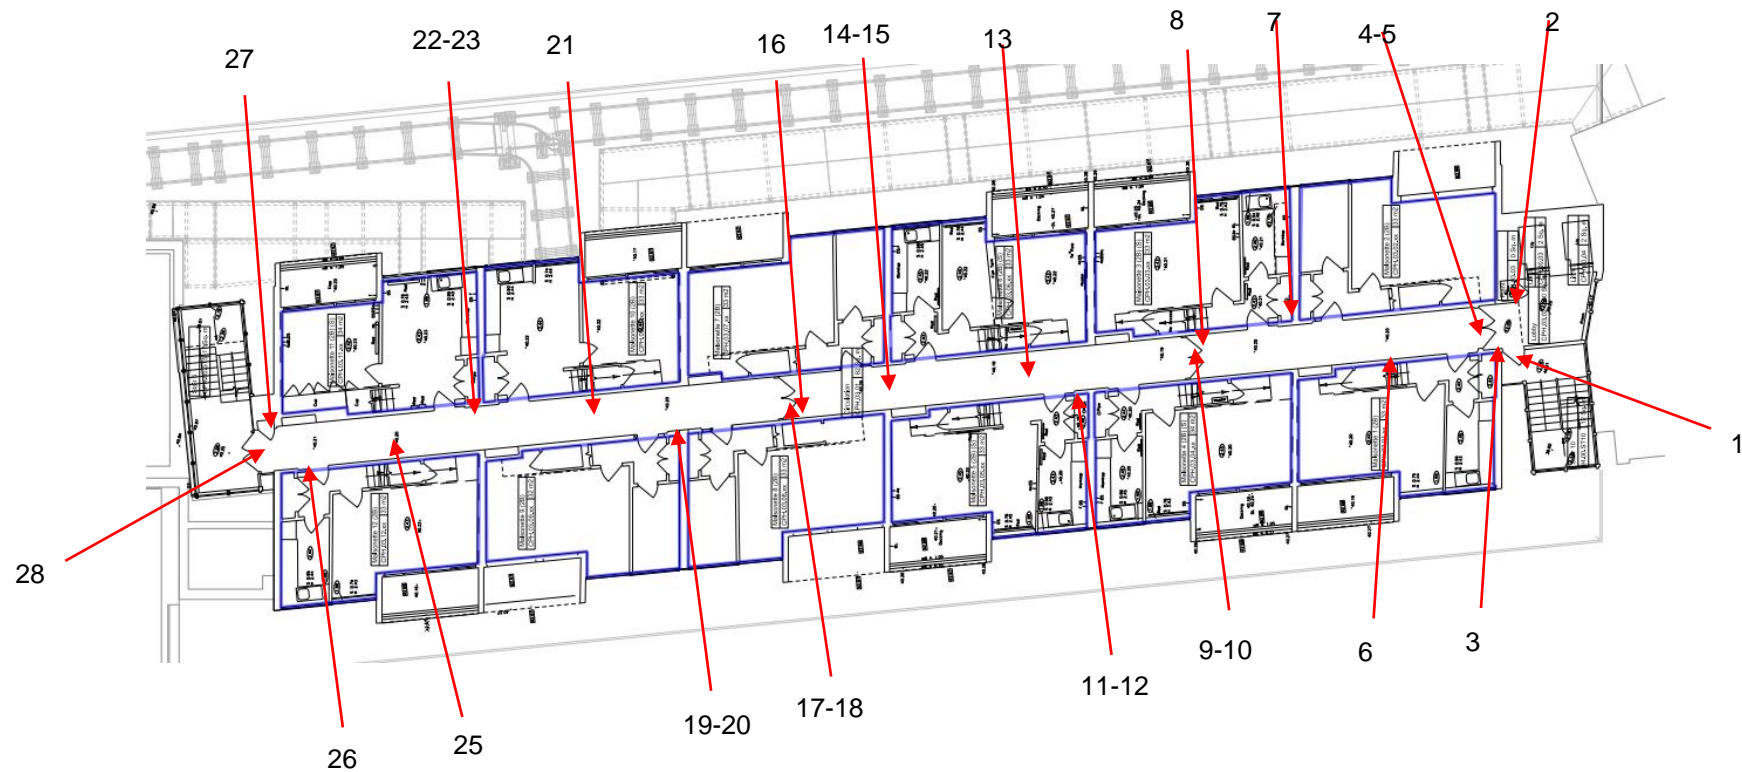
**Third Floor:**

*Figure 1 – Location of identified breaches and issues on the 3rd Floor*

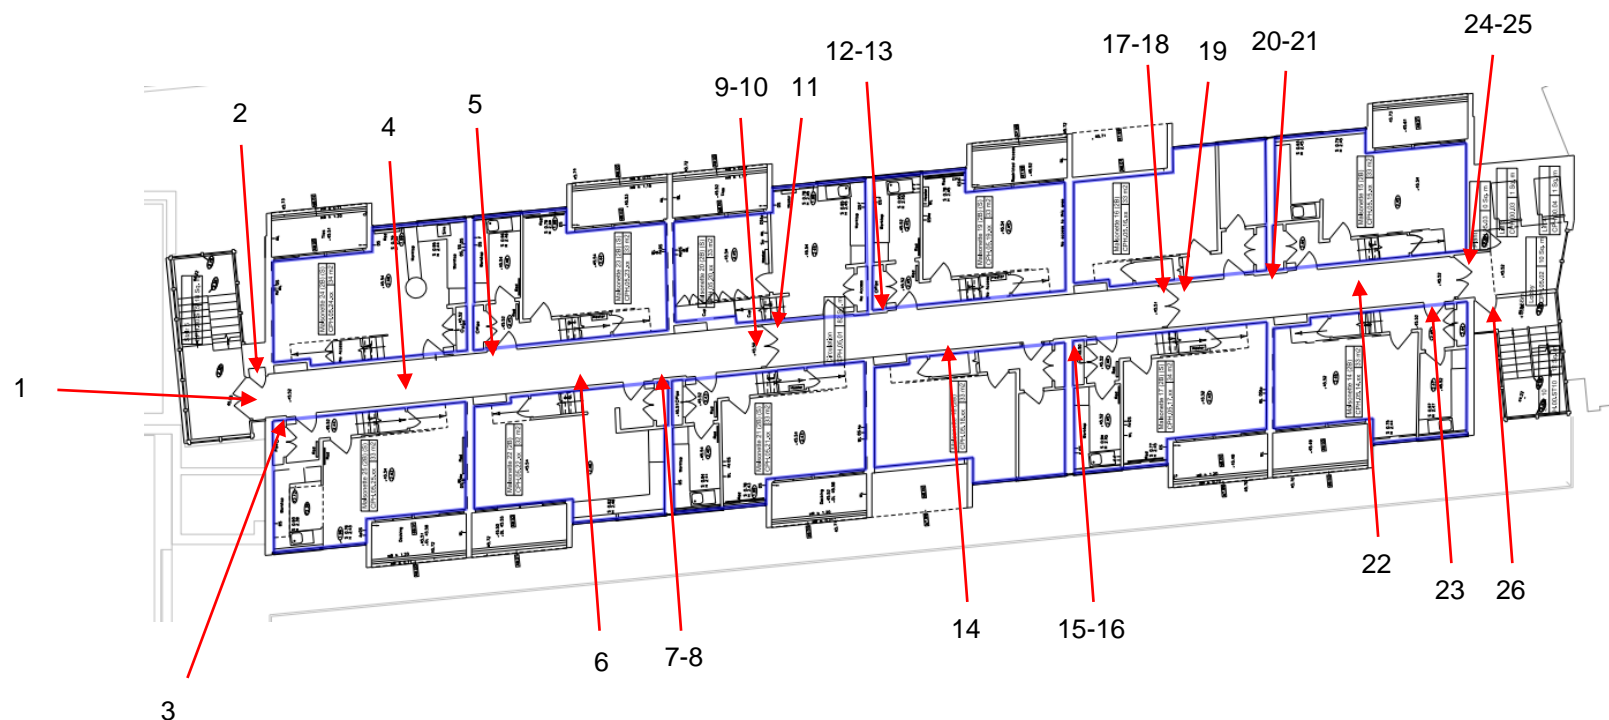
**Fifth Floor:**

Figure 2 – Location of identified breaches and issues on the 5th Floor

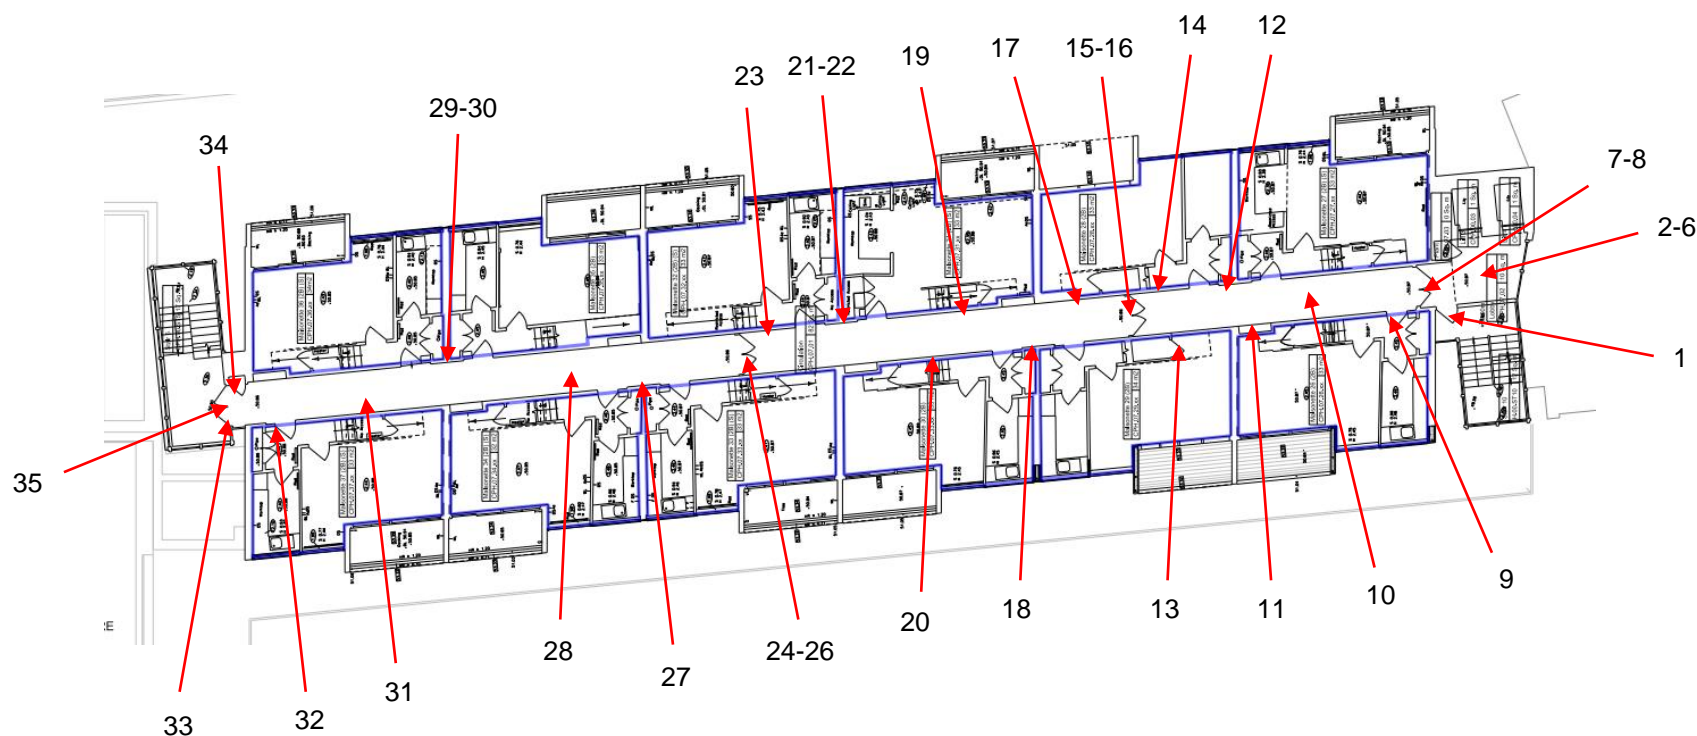
## Seventh Floor:

Figure 3 – Location of identified breaches and issues on the 7th Floor

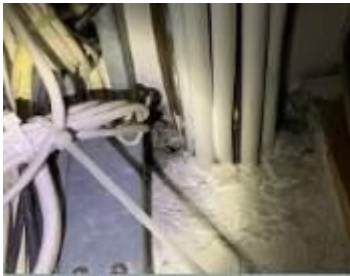
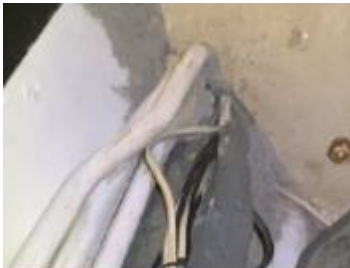
THIRD FLOOR					
Survey Report ID#	Survey Description and Recommendation	Report and	Status	Photograph	Comment
1	<b>South Stairs (Fire door)</b> 			n/a	<p>Only 2 hinges fitted.</p> <p><i>Recommendation - It is recommended that the door is repaired (including adding further fire resisting hinges) etc.</i></p>
2	<b>Riser cupboard by South stairs</b> Unsealed cable penetrations through floor slab

<p>Unsealed cable penetrations through floor slab require suitable mastic seal, with correct width to depth ratio.</p> <p><i>Recommendation - It is recommended that these areas are fire-stopped and sealed providing a minimum of 90mins fire resistance.</i></p>

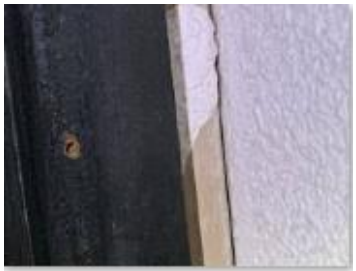
<p>Door frame unsealed – requires an intumescent mastic seal with sufficient width to depth ratio.</p> <p><i>Recommendation - It is recommended that these areas are sealed with a suitable fire-resistant sealant providing a minimum of 60mins fire resistance.</i></p>
5	<b>Cross corridor to lift lobby.</b> Wall header unsealed with incomplete plasterboard separation

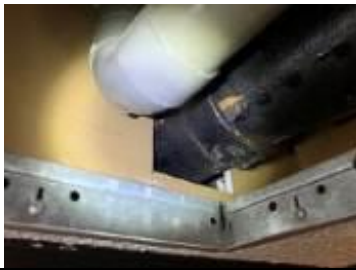
<p>Plasterboard partitions inadequately fitted and unsealed. No intumescent material around combustible pipework.</p> <p><i>Recommendation - It is recommended that these areas are fire-stopped and sealed providing a minimum of 60mins fire resistance.</i></p>

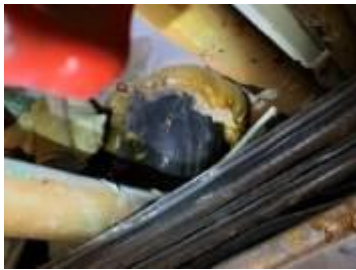
6	<b>Corridor vertically between flats 1/2</b> Non-compliant foam used to seal vertical openings through floor slab

<p>PU foam provides inadequate fire resistance and should be replaced by suitable fire resisting materials.</p> <p><i>Recommendation - It is recommended that the PU foam in these areas is removed and subsequently fire-stopped and sealed providing a minimum of 90mins fire resistance.</i></p>

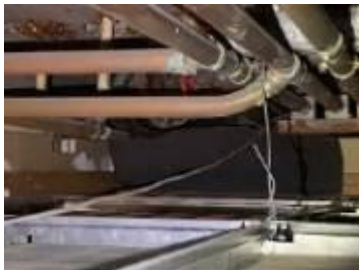
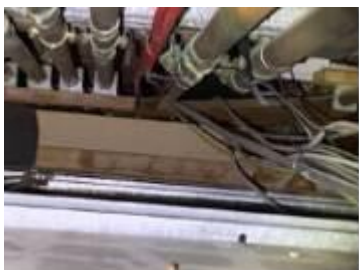
PU foam provides inadequate fire resistance and should be replaced by suitable fire resisting materials.  <i>Recommendation - It is recommended that the PU foam in these areas is removed and subsequently fire-stopped and sealed providing a minimum of 90mins fire resistance.</i>
9	<b>Above cross corridor</b>  Wall header unsealed with incomplete plasterboard separation

Plasterboard partitions inadequately fitted and unsealed. No intumescent material around combustible pipework.  <i>Recommendation - It is recommended that these areas are fire-stopped and sealed providing a minimum of 60mins fire resistance.</i>
10	<b>Cross corridor (Fire door)</b>		n/a	Doors does not close flush into frame and unknown beading used (not believed to be fire rated).  <i>Recommendation – It is recommended that either the door is repaired,</i>

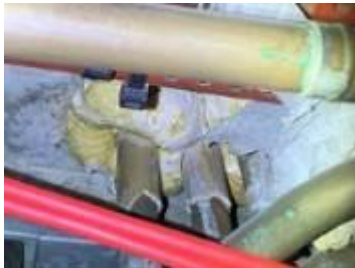
Combustible pipes unsealed and missing intumescent mastic seals to allow closing during a fire situation.  <i>Recommendation - It is recommended that these areas are fire-stopped and sealed providing a minimum of 90mins fire resistance.</i>
12	<b>Vertical openings between flats 4/5</b>  Non-compliant foam used to seal vertical openings through floor slab

PU foam provides inadequate fire resistance and should be replaced by suitable fire resisting materials.  <i>Recommendation - It is recommended that the PU foam in these areas is removed and subsequently fire-stopped and sealed providing a minimum of 90mins fire resistance.</i>

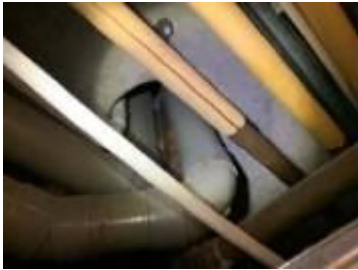
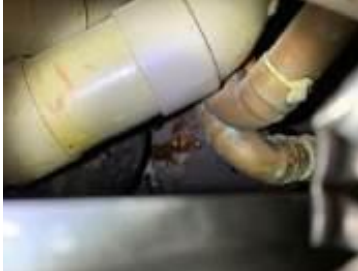
13	<p><b>Vertical openings between flats 5/6</b></p> <p>Unsealed opening and non-compliant foam used to seal vertical openings through floor slab</p>

<p>PU foam provides inadequate fire resistance and should be replaced by suitable fire resisting materials.</p> <p><i>Recommendation - It is recommended that the PU foam in these areas is removed and subsequently fire-stopped and sealed providing a minimum of 90mins fire resistance.</i></p>
14	<p><b>Corridor leading into flats 6/7</b></p> <p>Unsealed services and combustible pipework leading into flat without intumescent device fitted</p>

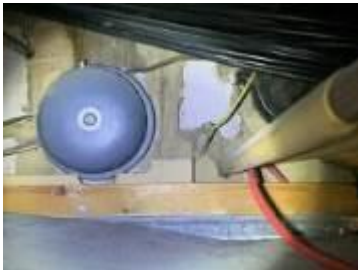
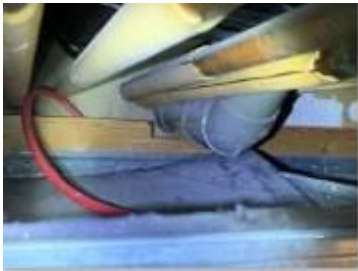
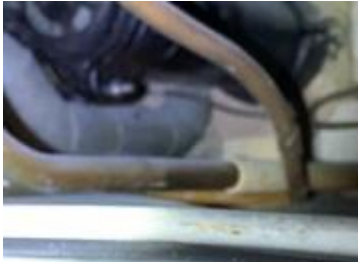
<p>Combustible pipes unsealed and missing intumescent mastic seals to allow closing during a fire situation.</p> <p><i>Recommendation - It is recommended that these areas are fire-stopped and sealed providing a minimum of 90mins fire resistance.</i></p>

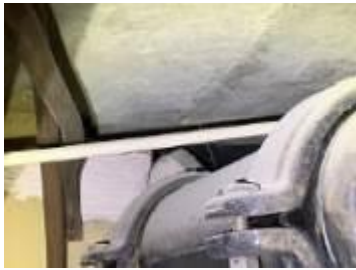
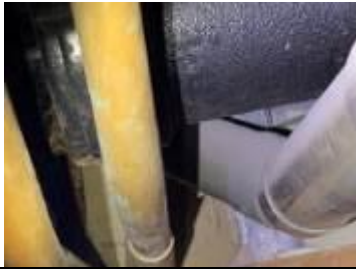
19	<p><b>Corridor leading into flats 8/9</b></p> <p>Unsealed services and combustible pipework leading into flat without intumescent device fitted</p>

<p>Combustible pipes unsealed and missing intumescent mastic seals to allow closing during a fire situation.</p> <p><i>Recommendation - It is recommended that these areas are fire-stopped and sealed providing a minimum of 90mins fire resistance.</i></p>
20	<p><b>Vertical openings between flats 8/9</b></p> <p>Non-compliant foam used to seal vertical openings through floor slab</p>

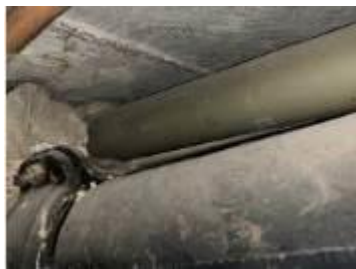
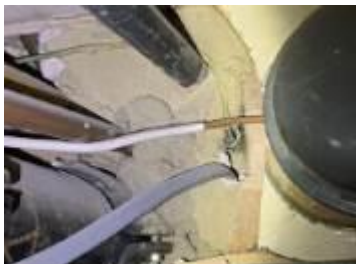
<p>fire-stopped and sealed providing a minimum of 90mins fire resistance.</p>
22	<p><b>Corridor leading into flats 10/11</b></p> <p>Unsealed services and combustible pipework leading into flat without intumescent device fitted</p>

<p>Combustible pipes unsealed and missing intumescent mastic seals to allow closing during a fire situation.</p> <p><i>Recommendation - It is recommended that these areas are fire-stopped and sealed providing a minimum of 90mins fire resistance.</i></p>

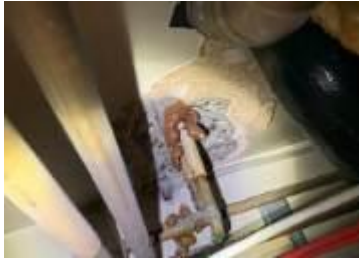
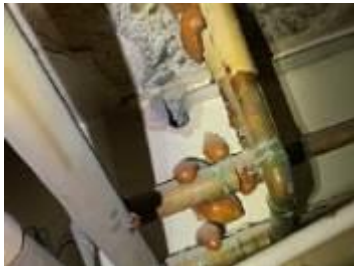
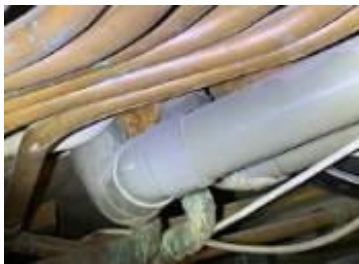
4	<p><b>Corridor vertically between flats 25/24</b></p> <p>Non-compliant foam used to seal vertical openings through floor slab</p>

<p>PU foam provides inadequate fire resistance and should be replaced by suitable fire resisting materials.</p> <p><i>Recommendation - It is recommended that the PU foam in these areas is removed and subsequently fire-stopped and sealed providing a minimum of 90mins fire resistance.</i></p>

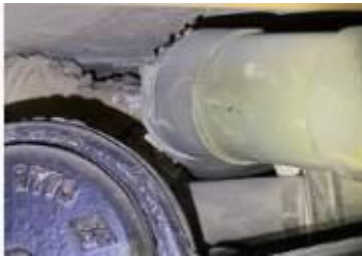
5	<p><b>Corridor leading into flat 23.</b></p> <p>Combustible pipework leading into flat without intumescent device fitted</p>

<p>Combustible pipes unsealed and missing intumescent mastic seals to allow closing during a fire situation.</p> <p><i>Recommendation - It is recommended that these areas are fire-stopped and sealed providing a minimum of 90mins fire resistance.</i></p>
6	<p><b>Corridor vertically between flats 23/22</b></p> <p>Non-compliant foam used to seal vertical openings through floor slab</p>

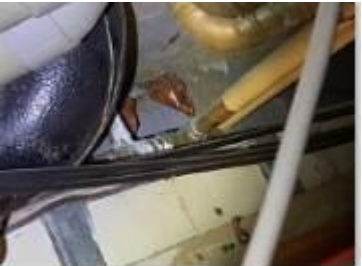
<p>PU foam provides inadequate fire resistance and should be replaced by suitable fire resisting materials.</p> <p><i>Recommendation - It is recommended that the PU foam in these areas is removed and subsequently fire-stopped and sealed providing a minimum of 90mins fire resistance.</i></p>

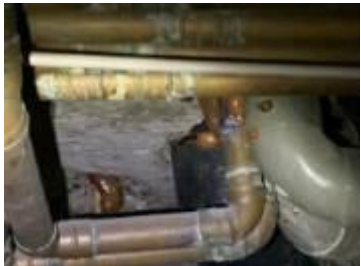
door)			<p>closing flush, unknown material used for beading (not believed to be fire rated) and doors showing signs of damage.</p> <p><i>Recommendation – Due to the nature of the issues noted it is recommended that this door is replaced with a FD60S rated door set.</i></p>
11	<p><b>Vertical pipes by cross corridor</b></p> <p>Non-compliant foam used to seal vertical openings through floor slab</p>

<p>PU foam provides inadequate fire resistance and should be replaced by suitable fire resisting materials.</p> <p><i>Recommendation - It is recommended that the PU foam in these areas is removed and subsequently fire-stopped and sealed providing a minimum of 60mins fire resistance.</i></p>

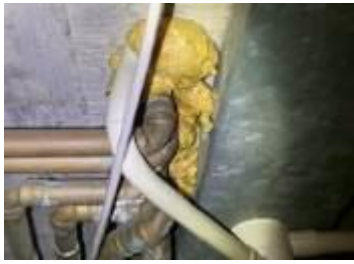
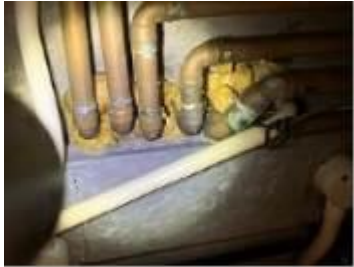
12	<p><b>Corridor vertically between flats 20/19</b></p> <p>Non-compliant foam used to seal vertical openings through floor slab</p>

<p>PU foam provides inadequate fire resistance and should be replaced by suitable fire resisting materials.</p> <p><i>Recommendation - It is recommended that the PU foam in these areas is removed and subsequently fire-stopped and sealed providing a minimum of 90mins fire resistance.</i></p>
13	<p><b>Corridor leading into flat 20/19</b></p> <p>Unsealed services and combustible pipework leading into flat without intumescent device fitted</p>

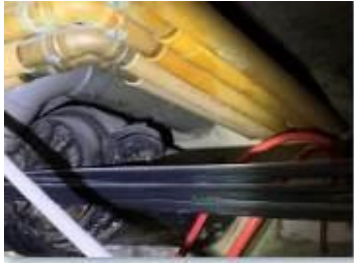
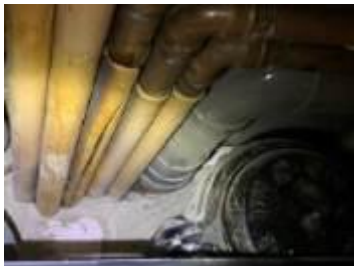
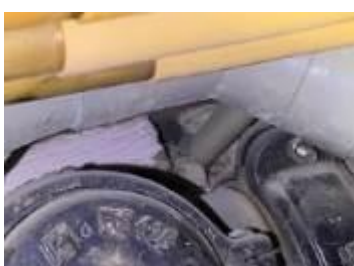
<p>Combustible pipes unsealed and missing intumescent mastic seals to allow closing during a fire situation.</p> <p><i>Recommendation - It is recommended that these areas are fire-stopped and sealed providing a minimum of 90mins fire resistance.</i></p>
14	<p><b>Corridor vertically between flats 18/19</b></p> <p>Non-compliant foam used to seal vertical openings through floor slab</p>

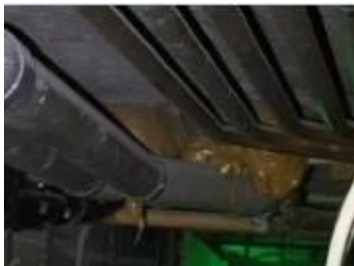
<p>PU foam provides inadequate fire resistance and should be replaced by suitable fire resisting materials.</p> <p><i>Recommendation - It is recommended that the PU foam in these areas is removed and subsequently fire-stopped and sealed</i></p>

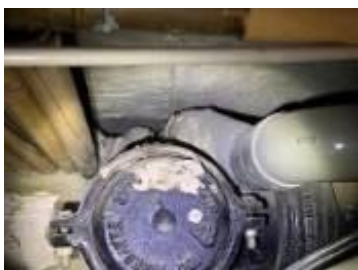
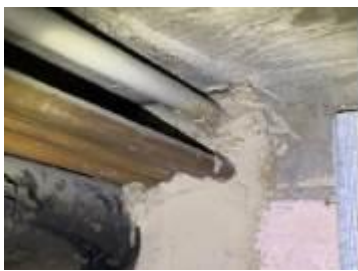
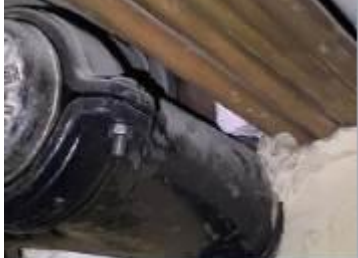
<p>providing a minimum of 90mins fire resistance.</p>
15	<p><b>Corridor leading into flat 17/18</b></p> <p>Unsealed services and combustible pipework leading into flat without intumescent device fitted</p>

<p>Combustible pipes unsealed and missing intumescent mastic seals to allow closing during a fire situation.</p> <p><i>Recommendation - It is recommended that these areas are fire-stopped and sealed providing a minimum of 90mins fire resistance.</i></p>

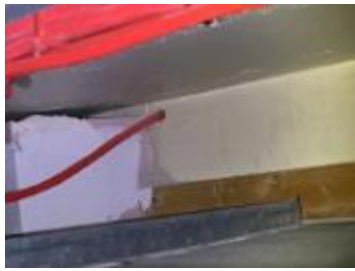
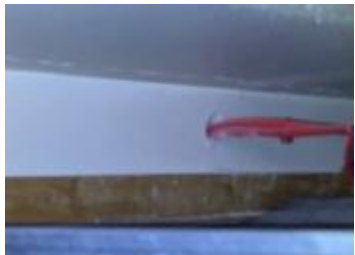
SEVENTH FLOOR					
Survey Report ID#	Survey Description and Recommendation	Report and	Status	Photograph	Comment
I	<b>South Stairs (Fire Door)</b>			n/a	<p>The door does not close flush into its frame, it has only two hinges, unknown fire rating of door set.</p> <p><i>Recommendation – It is recommended that the doors are either repaired to ensure that they fit flush or replaced with a new FD60S and are provided with 3 fire rated hinges per door.</i></p>
2-3	<b>Lift lobby</b> Unsealed cable penetrations leading into stairwell.

<p>Unsealed openings through plaster walls into means of escape stairwell.</p> <p><i>Recommendation – It is recommended that these areas are fire-stopped and sealed providing a minimum of 90mins fire resistance.</i></p>

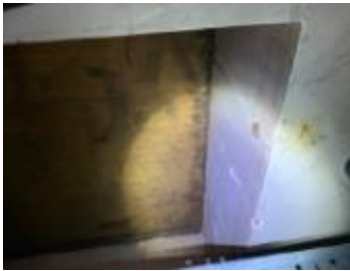
4	<b>Lift lobby</b> Unknown timber hatch above false ceiling,

<p>Unknown timber hatch above false ceiling believed to lead into lift motor room. Intrusive inspection required to identify fire resistance above.</p> <p><i>Recommendation – It is recommended that further intrusive investigations are undertaken to determine the sub-strata construction and ensure that a minimum period of fire resistance of 90mins is provided.</i></p>
5	<b>Lift lobby</b> Unsealed cable penetrations leading into stairwell.

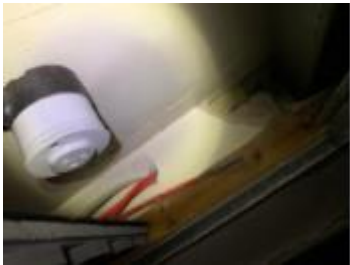
<p>Unsealed openings through plaster walls into means of escape stairwell.</p> <p><i>Recommendation - It is recommended that these areas are fire-stopped and sealed providing a minimum of 90mins fire resistance.</i></p>
6	<b>Lift lobby</b> Duct work sealed with paper through wall

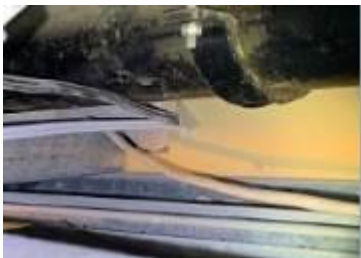
<p>fixed in position or sealed.</p> <p><i>Recommendation - It is recommended that these areas are fire-stopped and sealed providing a minimum of 90mins fire resistance and the damper fixed in position and sealed.</i></p>
9	<b>Entrance to flat 26</b>  Unsealed cable penetration

<p>Unsealed opening into flat entrance.</p> <p><i>Recommendation - It is recommended that this area is fire-stopped and sealed providing a minimum of 90mins fire resistance.</i></p>
10	<b>Corridor between flats 26 / 27</b>  Unsealed pipe penetrations leading vertically through floor slab and non-compliant foam used to seal vertical openings

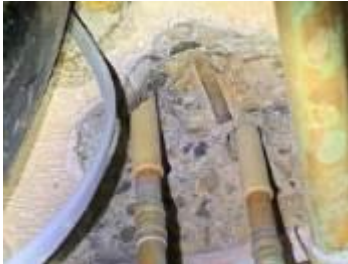
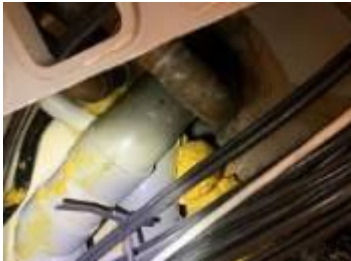
<p>PU foam provides inadequate fire resistance and should be replaced by suitable fire resisting materials.</p> <p><i>Recommendation - It is recommended that the PU foam in these areas is removed and subsequently fire-stopped and sealed providing a minimum of 90mins fire resistance.</i></p>

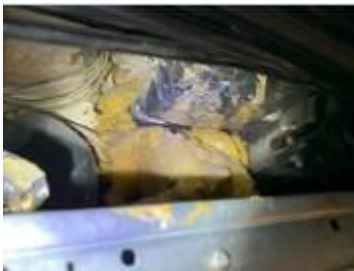
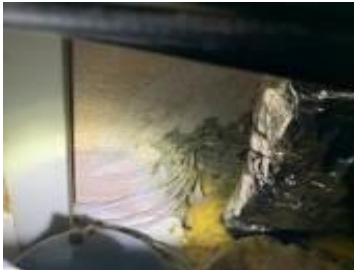
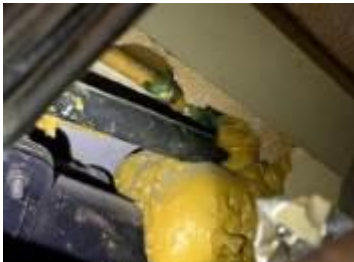
<p>Recommend intrusive inspection behind all of these units throughout the floors. The compartmentation is likely to be at the wall header behind the plasterboard partition.</p> <p><i>Recommendation –It is recommended that further intrusive investigations are undertaken to determine the sub-strata construction and ensure that a minimum of 90mins fire resistance is provided.</i></p>
12	<b>Communal corridor into flat 27</b>  Non-compliant foam used to seal vertical openings through floor slab and into flat 27

<p>PU foam provides inadequate fire resistance and should be replaced by suitable fire resisting materials.</p> <p><i>Recommendation - It is recommended that the PU foam in these areas is removed and subsequently fire-stopped and sealed providing a minimum of 90mins fire resistance.</i></p>

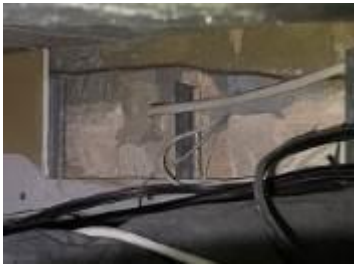
16	<b>Cross corridor (Fire door)</b>		n/a	<p>Excessive gaps between doors, unknown fire rating of beading used to seal glazing.</p> <p><i>Recommendation – it is recommended that either the doors are repaired/adjusted to ensure suitable gaps (below 4 – 5 mm) are provided and a fire rated beading provided or alternatively the door is replaced to provide a FD60S rated door set.</i></p>
17	<b>Opposite flats 29/30</b> Unsealed cable penetration

<p>Unsealed openings through blockwork wall into flats.</p> <p><i>Recommendation – It is recommended that these areas are fire-stopped and sealed providing a minimum of 90mins fire resistance.</i></p>
18	<b>Entrance between flats 29-30</b> Non-compliant foam used to seal openings into flat 29-30

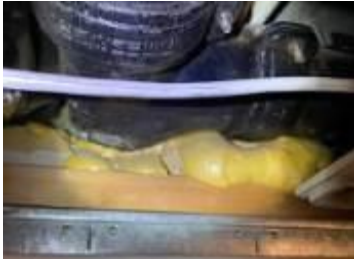
<p>PU foam provides inadequate fire resistance and should be replaced by suitable fire resisting materials.</p> <p><i>Recommendation - It is recommended that the PU foam in these areas is removed and subsequently fire-stopped and sealed providing a minimum of 90mins fire resistance.</i></p>

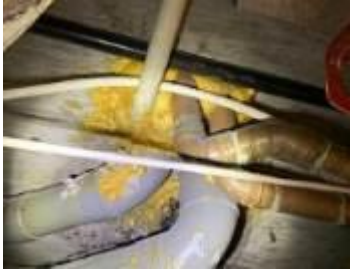
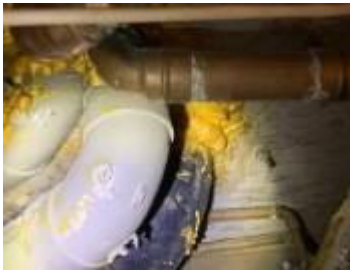
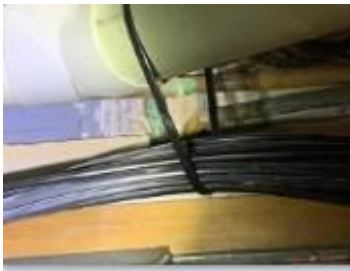
19	<p><b>Between display area and flat 31</b></p> <p>Non-compliant foam used to seal openings between display area and flat 31. Pipe penetrations appear to lead behind plasterboard partition but cannot identify if these have been fully sealed behind.</p>

<p>PU foam provides inadequate fire resistance and should be replaced by suitable fire resisting materials. Intrusive investigation required behind plasterboard to identify if has been adequately sealed.</p> <p><i>Recommendation - It is recommended that further investigations are made in this area and that the PU foam in these areas is removed and subsequently fire-stopped and sealed providing a minimum of 90mins fire resistance.</i></p>
20	<p><b>Between display area and flat 30</b></p> <p>Non-compliant foam used to seal openings between display area and flat 30. Pipe penetrations appear to lead behind plasterboard partition, but cannot identify if these have been fully sealed behind</p>

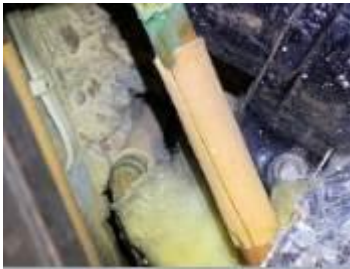
<p>PU foam provides inadequate fire resistance and should be replaced by suitable fire resisting materials. Intrusive investigation required behind plasterboard to identify if has been adequately sealed.</p> <p><i>Recommendation - It is recommended that further investigations are made in this area and that the PU foam in these areas is removed and subsequently</i></p>

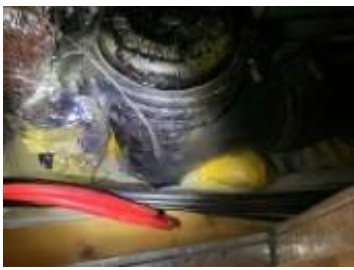
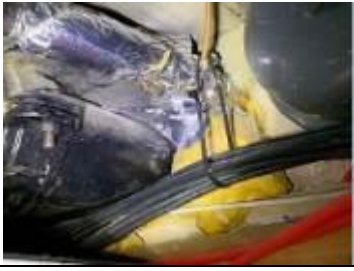
<p><i>fire-stopped and sealed providing a minimum of 90mins fire resistance.</i></p>
21	<p><b>Entrance between flats 32-31</b></p> <p>Non-compliant foam used to seal openings into flats 32-31</p>

<p>PU foam provides inadequate fire resistance and should be replaced by suitable fire resisting materials.</p> <p><i>Recommendation - It is recommended that the PU foam in these areas is removed and subsequently fire-stopped and sealed providing a minimum of 90mins fire resistance.</i></p>
22	<p><b>Meter cupboard by flat 32</b></p> <p>A sample of the meter cupboard</p>

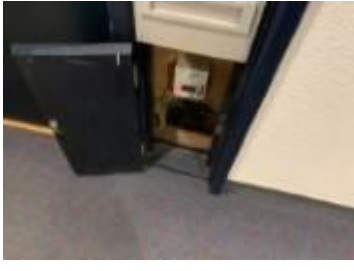
<p>Timber non-fire rated door and missing seal / damaged openings from meter cupboard into flat.</p> <p><i>Recommendation – It is recommended that the meter cupboard be replaced with a FD90S rated cabinet and the gaps between the cabinet and</i></p>

the flat are sealed to provide a minimum of 90minutes fire resistance.
23	<b>Vertical services by cross corridor door sets</b>  Non-compliant foam used to seal openings vertical openings through floor slab

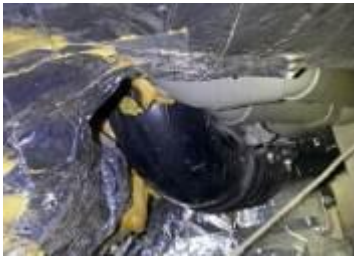
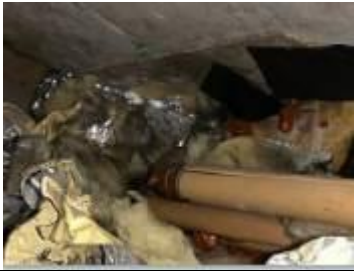
PU foam provides inadequate fire resistance and should be replaced by suitable fire resisting materials.  <i>Recommendation - It is recommended that the PU foam in these areas is removed and subsequently fire-stopped and sealed providing a minimum of 90mins fire resistance.</i>
24	<b>Cross corridor separation</b>  Header above door set providing inadequate seal.

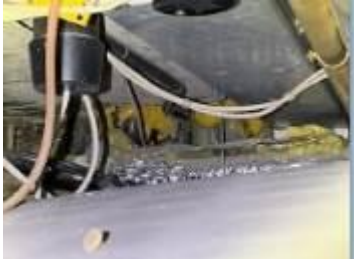
Plasterboard partition inadequately fitted and unsealed. Services leading through it do not have closers or intumescent seals.  <i>Recommendation - It is recommended that these areas are fire-stopped and sealed providing a minimum of 60mins fire resistance.</i>
25	<b>Vertical service openings by cross corridor separation</b>  Non-compliant foam used to seal openings vertical openings through floor slab

PU foam provides inadequate fire resistance and should be replaced by suitable fire resisting materials.  <i>Recommendation - It is recommended that the PU foam in these areas is removed and subsequently</i>

fire-stopped and sealed providing a minimum of 90mins fire resistance.
26	<b>Cross corridor (Fire door)</b>		n/a	<p>Excessive gap in middle of doors, unknown material used for beading to seal glazing.</p> <p><i>Recommendation – It is recommended that either the doors are repaired/adjusted to ensure suitable gaps (below 4 – 5 mm) are provided and a fire rated beading provided or alternatively the door is replaced to provide a FD60S rated door set.</i></p>
27	<b>Entrance between flats 33/34</b>  Combustible pipes unsealed through blockwork wall

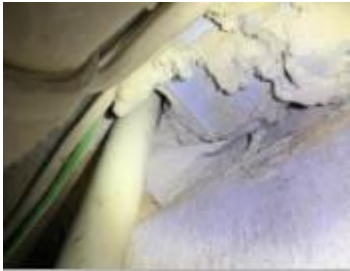
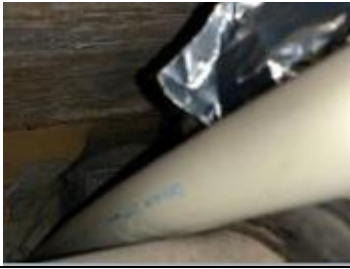
<p>Combustible pipes unsealed and missing intumescent mastic seals to allow closing during a fire situation.</p> <p><i>Recommendation - It is recommended that these areas are fire-stopped and sealed providing a minimum of 90mins fire resistance.</i></p>
28	<b>Corridor by flat 34</b>  Non-compliant foam used to seal openings vertical openings through floor slab

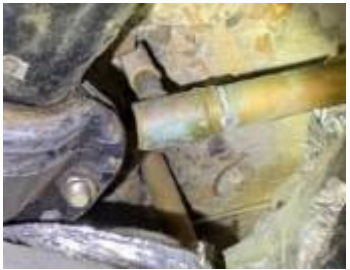
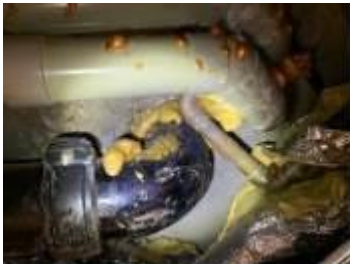
<p>PU foam provides inadequate fire resistance and should be replaced by suitable fire resisting materials.</p> <p><i>Recommendation - It is recommended that the PU foam in these areas is removed and subsequently fire-stopped and sealed providing a minimum of 90mins fire resistance.</i></p>

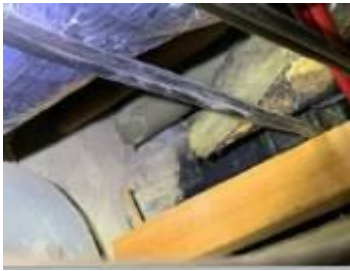
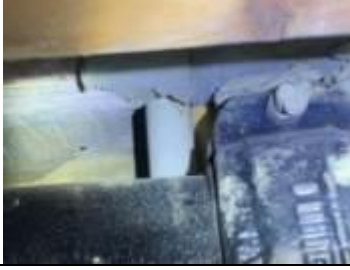
29	<b>Services between flats 36/35</b>  Combustible pipework sealed through walls without intumescent mastic

Intumescent seals are required around combustable pipes in order to seal them in a fire situation.  <i>Recommendation - It is recommended that these areas are fire-stopped and sealed providing a minimum of 90mins fire resistance.</i>
30	<b>Meter cupboard by flat 36</b>  A sample of the meter cupboard

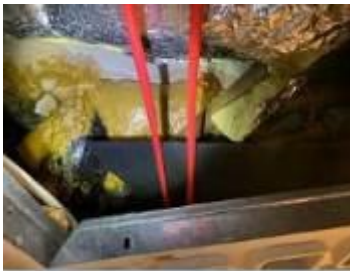
Timber non-fire rated door and missing seal / damaged openings from meter cupboard into flat.  <i>Recommendation - It is recommended that the meter cupboard be replaced with a FD90S rated cabinet and the gaps between the cabinet and the flat are sealed to provide a minimum of 90minutes fire resistance.</i>
31	<b>Services between flats 37/36</b>  Services leading into flats 37/36 sealing with non-compliant foam and combustable pipe without intumescent seal

PU foam provides inadequate fire resistance and should be replaced by suitable fire resisting materials.  <i>Recommendation - It is recommended that the PU foam in these areas is removed and subsequently fire-stopped and sealed providing a minimum of 90mins fire resistance.</i>

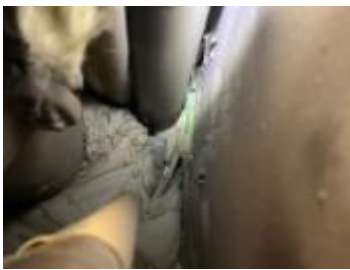
32	<b>By entrance to flat 37</b> Combustible pipework sealed through wall without intumescent mastic

Intumescent seals are required around combustible pipes in order to seal them in a fire situation.  <i>Recommendation - It is recommended that these areas are fire-stopped and sealed providing a minimum of 90mins fire resistance.</i>
33	<b>Above door to North stairs</b> Incorrectly installed damper

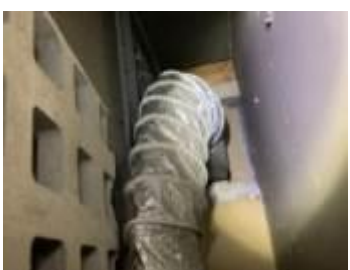
Damper installed away from wall without seal and unknown fixings.  <i>Recommendation – it is recommended that the damper is fixed and secured with an appropriate seal provided providing a minimum period of 90mins fire resistance.</i>
34	<b>Old Hosereel cupboard</b> Services unsealed between floor levels

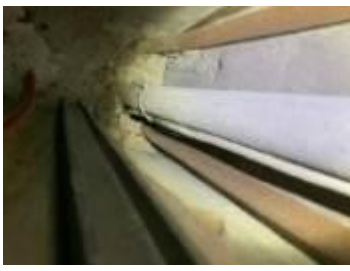
As it's a low-risk riser cupboard without any electrical risks, separation is only required between floors. This is inadequate as the slab has unsealed openings around pipe penetrations.  <i>Recommendation – due to the lack of fire resistance it is recommended that these areas are sealed and secured to provide a minimum of 90mins fire</i>

resistance.
35	<b>North stairs (Fire Door)</b>		n/a	<p>Door does not close flush in frame, hinges badly fitted, different sections of intumescent strip / smoke seals used, doors warped.</p> <p><i>Recommendation – Due to the nature and extent of the issues raised it is recommended that the doors are replaced with an FD60S rated door set.</i></p>

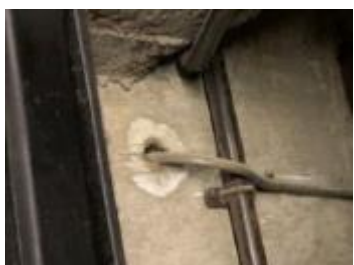
<b>LIFT SHAFTS – NOT IDENTIFIED ON THE FIGURES ABOVE</b>					
Survey Report ID#	Survey Description	Report and Recommendation	Status	Photograph	Comment
I	<b>Internal lift shaft (left side only)</b>

Unsealed cable penetration leading through concrete shaft.

*In respect of items 1-16 identified within Table 9, it is recommended that all of these areas are fire-stopped and sealed with a suitable material providing a minimum of 90mins fire resistance.*

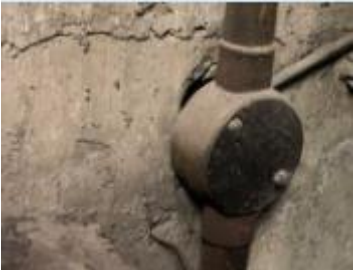
2	Internal lift shaft (left side only)

Unsealed conduit penetration leading through concrete shaft.
3	Internal lift shaft (left side only)

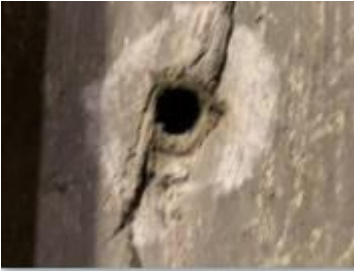
Unsealed opening leading through concrete shaft.
4	Internal lift shaft (left side only)

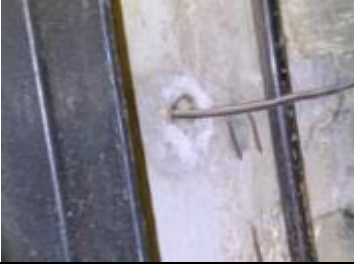
Unsealed cable penetration leading through concrete shaft.
5	Internal lift shaft (left side only)

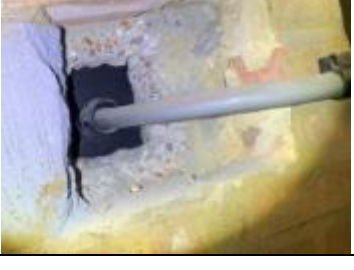
Unsealed cable penetration leading through concrete shaft.
6	Internal lift shaft (left side only)

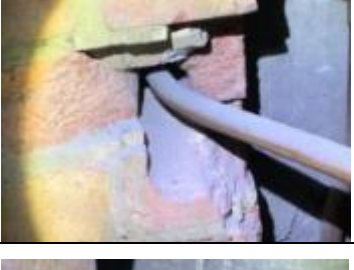
Unsealed cable penetration leading through masonry wall.
7	Internal lift shaft (left side only)

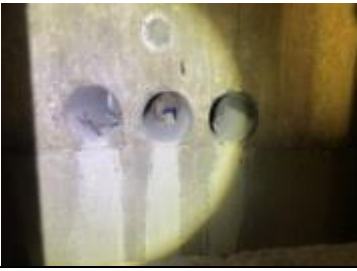
8	Internal lift shaft (left side only)

Unsealed openings leading through concrete shaft into flats. Exposed side of wall lining visible.
9	Internal lift shaft (left side only)

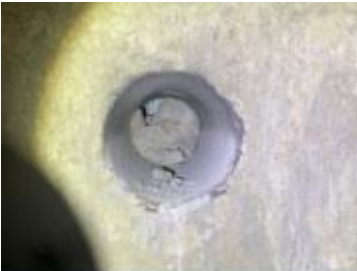
Unsealed openings leading through concrete shaft into flats. Exposed side of wall lining visible.
10	Internal lift shaft (left side only)

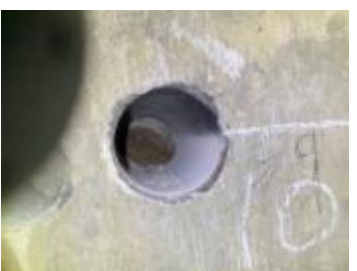
Unsealed openings leading through concrete shaft into flats. Exposed side of wall lining visible.
11	Internal lift shaft (left side only)

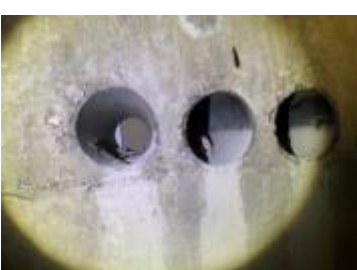
Unsealed openings leading through concrete shaft into flats. Exposed side of wall lining visible.
12	Internal lift shaft (left side only)

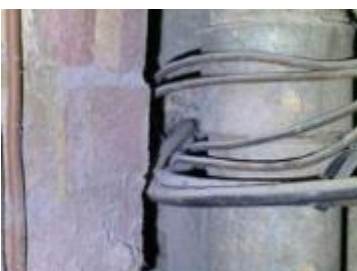
Unsealed cable penetration leading through masonry wall.
13	Internal lift shaft (left side only)

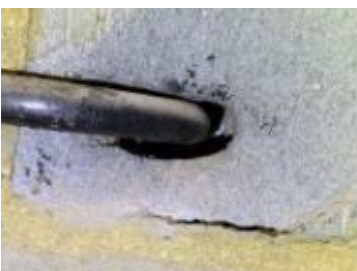
Unsealed pipe penetration leading through blockwork wall.

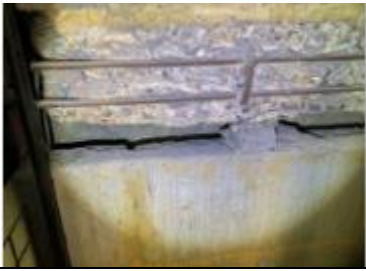
14	Internal lift shaft (left side only)

Expose steelwork and opening leading through concrete wall.
15	Internal lift shaft (left side only)

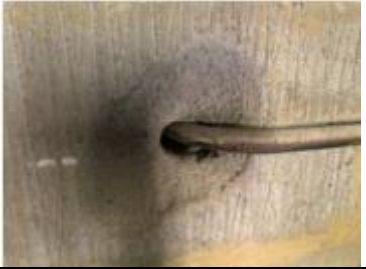
Unsealed conduit penetration leading through masonry wall.
16	Internal lift shaft (left side only)

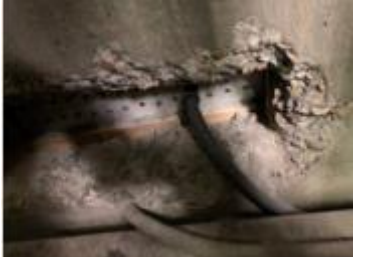
Unsealed opening leading through masonry wall.
