—The British Museum

King Edward Building Basement Ventilation Tunnels Waterproofing Refurbishment Design & Access Statement R01

Revision	Date	Comments
0	23.03.2022	Draft Issue for Comment
01	25.03.2022	Issue for LBC Application

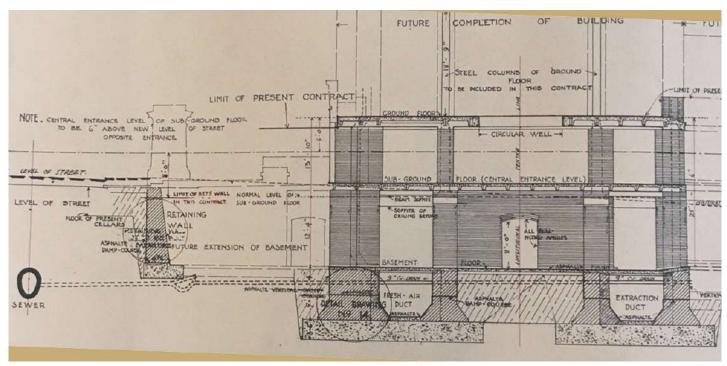
Copy of original section drawing showing the construction of the basement tunnels

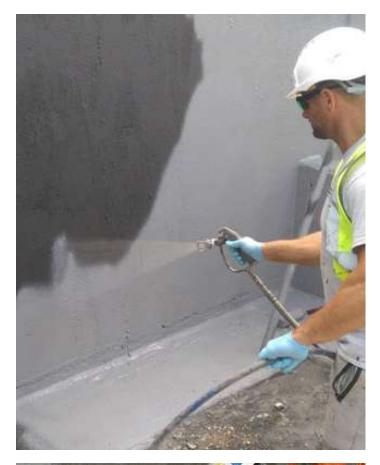
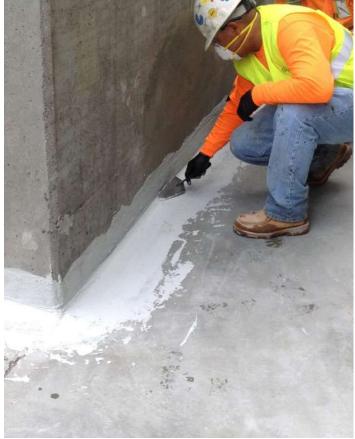
Examples of type A barrier waterproofing applied to wall-floor junction and sprayed on

Within the circular stair wells that access the basement tunnels the existing render finishes on the bottom 1m of the stairs are also defective with cracks showing and water ingress. The walls and floor will be repaired, and a new Type A Tanking system will be applied to both walls and floor taking over lowest 10 steps.

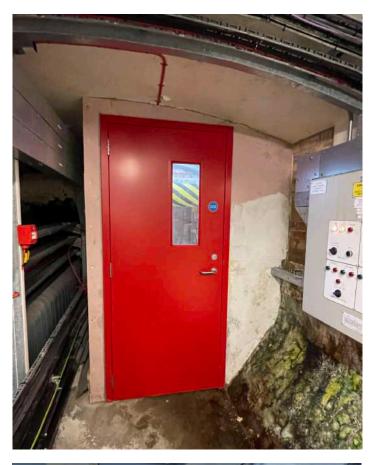
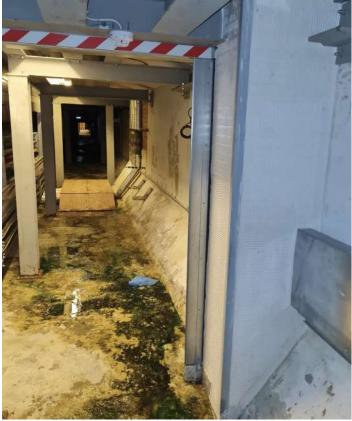
Two sections of existing, non-original partitions including fire doors, along with two fire curtains - all installed for fire compartmentation - will be removed during the works to allow for the retanking of the tunnels. The existing doors and fire curtains in these constructions will be retained and reinstated, within new, fire-rated partitions, to maintain the existing fire compartmentation of the building.

Fire door within partition (top) and fire curtain (bottom) $\$

On completion, these compartments will be replaced with similar fire rated partitions lined in durable fermacell board. Fire doors will be reinstated or replaced with a like-for-like alternative. Refer to Nex drawings for full details.
