Our Ref: SV220310-746: Mr& Mrs Holmes, Garden Flat, 37 Redington Road, NW3 7QY

T1 Oak – Background history, pruning guidance and current pruning recommendations.

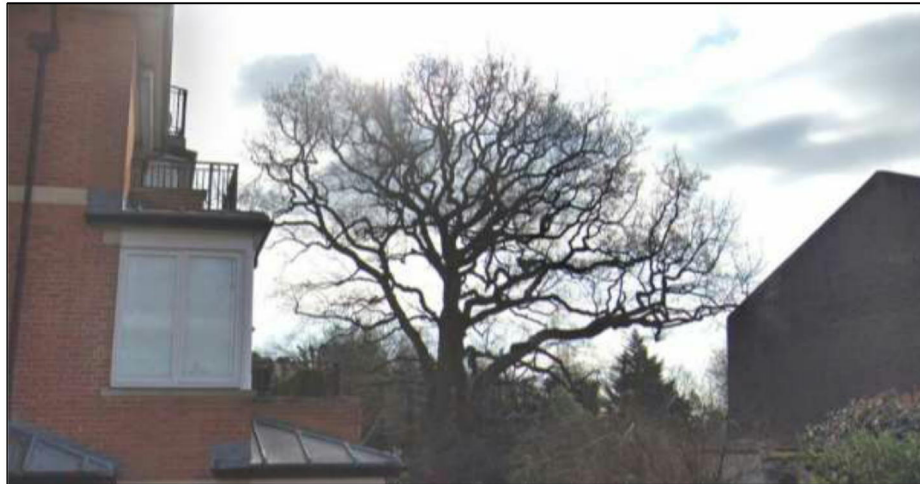
View from Oakhill Avenue, NW3 of Oak T1 in pre-reduction condition
[Google Earth Image dated Feb. 2018]

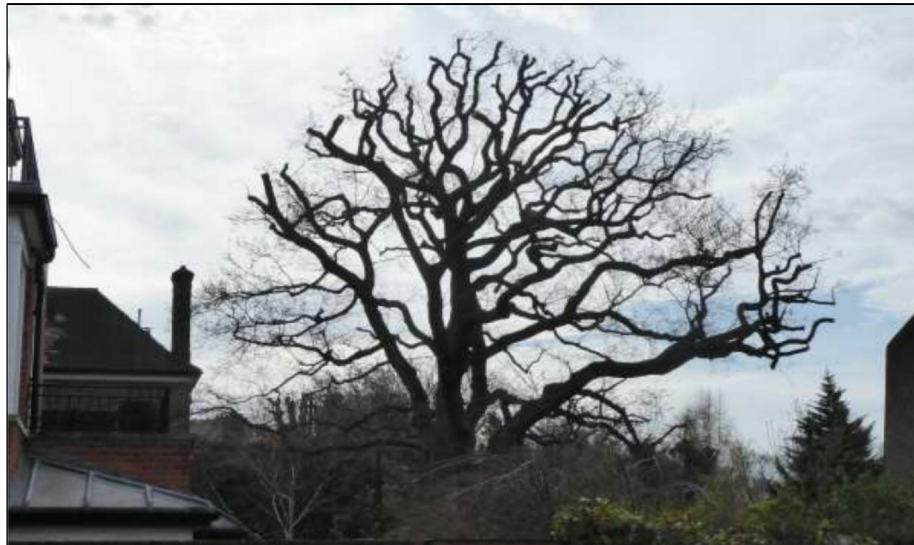
View from Oakhill Avenue, NW3 of Oak T1 in post-reduction condition
[Image dated 17 April 2018]

A review of the trees health and condition following the reduction works was carried out on the 06/10/2018, which showed that the tree appeared to have responded well to the extent of reduction works carried out. Whilst particular dense in some areas, the tree exhibited obvious extension growth from both the past cut points and as reactive new epicormic growth throughout the inner crown.
