25th April 2022

## **Health & Safety issues associated with access to 82 Fitzjohn's Avenue, Hampstead, London, NW3 6NP**

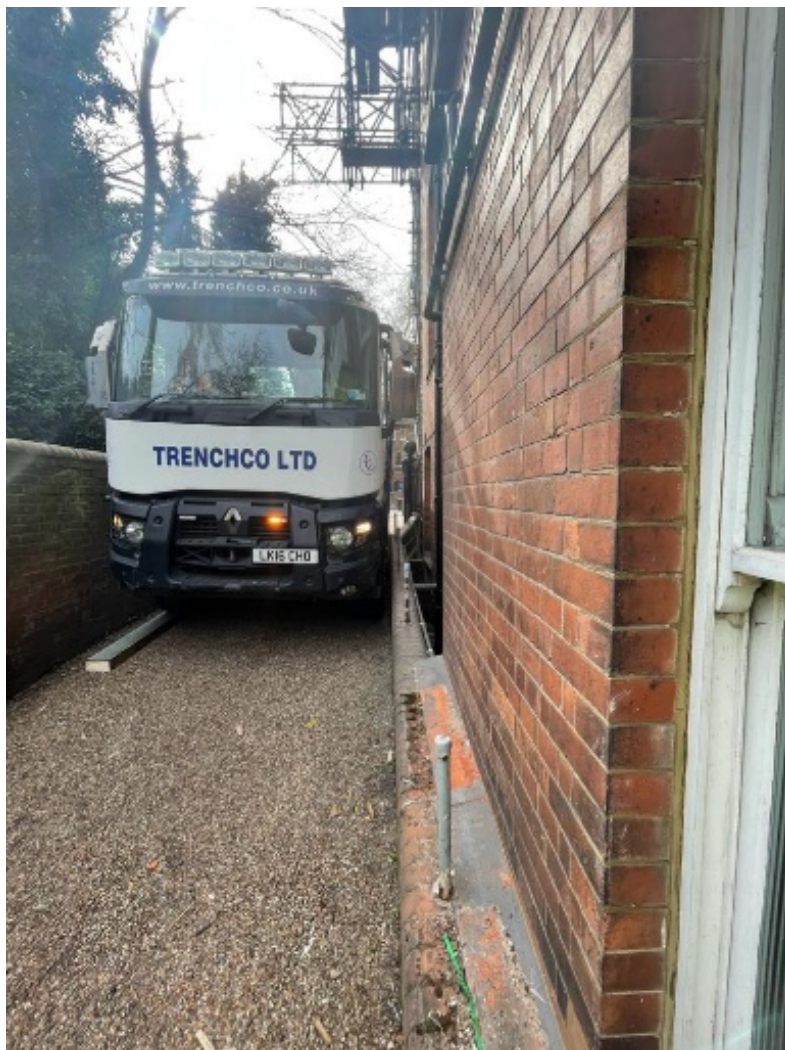
For efficient programming of the Phase 1 work Trenchco Ltd propose the use of a HIAB 'grab' lorry for the removal of waste and spoil: these vehicles are 2.49m wide giving 5cm clearance to either side of the driveway. Additionally, there is insufficient space on the site to turn vehicles meaning the it is necessary for the vehicles to be reversed into the site (under the supervision of a banksman).

**The below images show the limited clearance available for construction vehicles accessing the site**

**Given the very small tolerance between the boundary wall and construction vehicles, there is a real risk of damage to the wall include its collapse. This could cause serious injury or death to any member of the public walking along Shepherds Walk. We consider the risk of retaining the wall too great. We highly recommend that the wall is taken down in a controlled manner (salvaging bricks for its later reinstatement) and that a safe temporary hoarding is erected.**

Removing the wall under controlled conditions will ensure the maximum number of bricks including the brick specials can be salvaged.
