The Frontage Building -

Feasibility appraisal for re-use/demolition

20/05/2022

GOSHCCC-BDP-ZZ-ZZ-RP-A-2000-0048

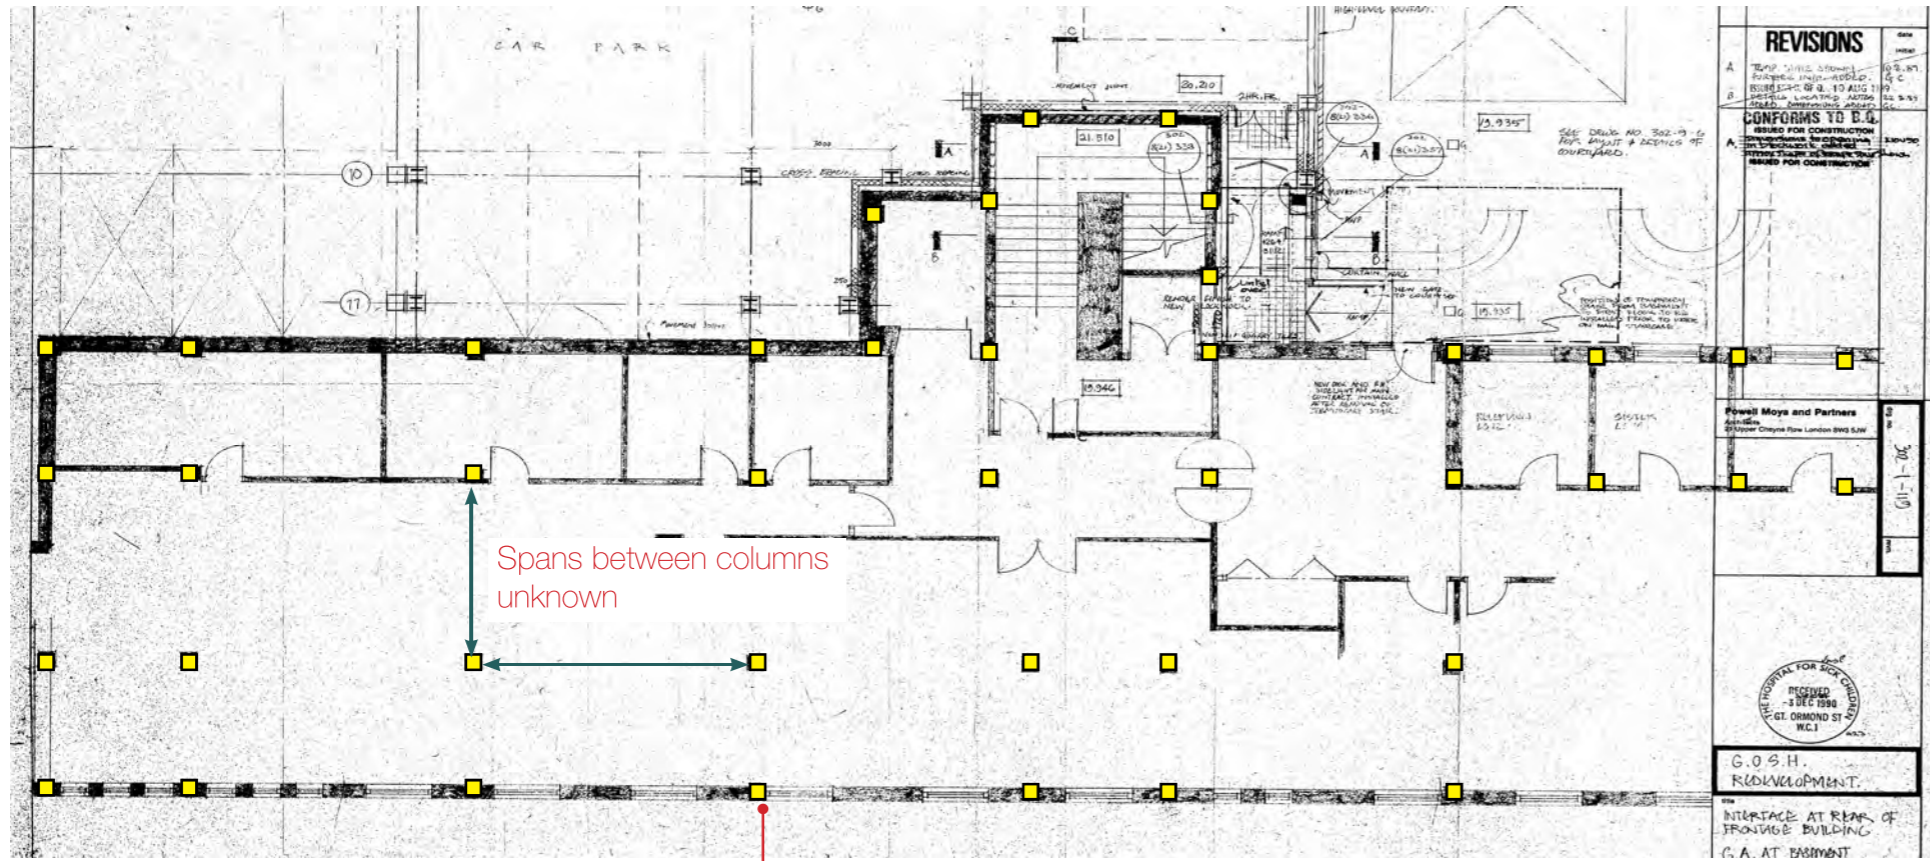
Basement Plan - Frontage

- Existing structure assumed to be a concrete frame in both parts of the building. Ribbed slab assumed in older part of building but slab construction in Frontage East unknown.
- Assumed there is no capacity in existing slabs for imaging equipment with much heavier loading. Also that existing slab structure would likely not fulfil strict vibration criteria for theatre spaces and ward rooms.
