Title:
200944 - Crown Estate Paving Commission (MASTER)

Project:
Cumberland Terrace

5 T266 LIME TREE CUMBERLAND TERRACE

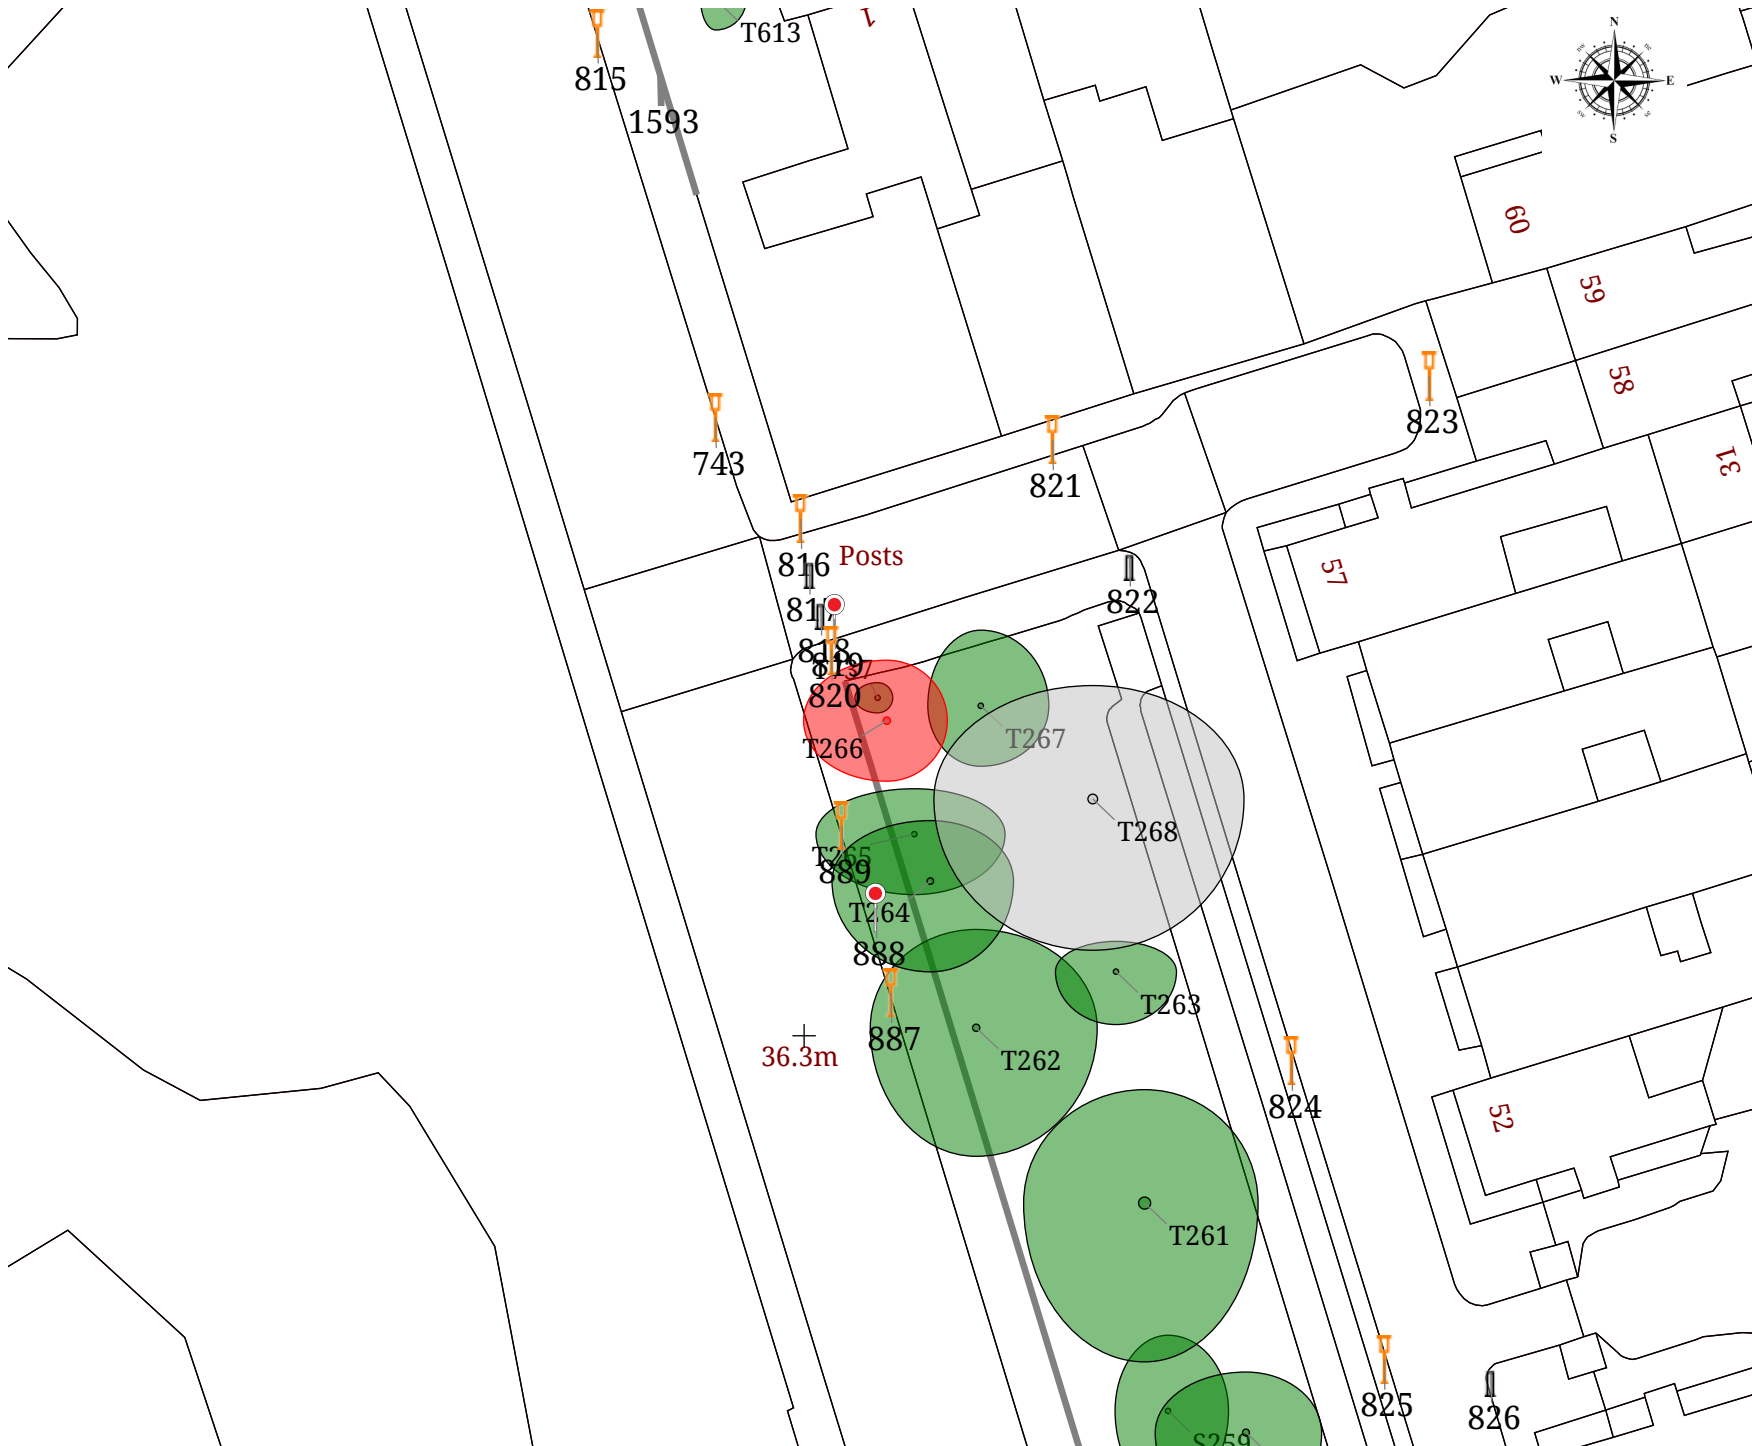
Drawing No:
200944

Tree No (old tag)	Vegetation type	Species	No. of stems	Height (m)	Crown spread	DBH (cm)	Life stage	Vitality	Physiological Condition	Structural Condition	Safe Life Expectancy	Access	CAVAT value (£)/ Crown area (m2)
T266 (106)	Tree	1 Tilia x vulgaris Common Lime	1	13.0	8.5	49	Mature	High	Good	Poor	5-10 yrs	Fair	£8983.66 / 56.74m2
Site Features	Targets		Conditions			Notes							Survey date/ Surveyor
	Footpath within crown spread. Car parking within falling distance of tree. Road within falling distance of tree. Wall or fence within crown spread.		Base / stems obscured - Vegetation. Buttresses / buttress roots - Major adaptive growth / strong development. Crown reduction - Historic. Deadwood - Minor. Decay / structural defect - Base. Epicormic growth - Base / bole / principal stems. Fungal fruiting body - structural decay suspected. Fork - Weak with included bark. Pruning wounds - Decayed. Sheltered crown.			Unable to inspect closely - Dense epicormic growth on base/stem. Decay fungi - Ganoderma sp. brackets and Kretzschmaria deusta fruiting bodies at base/loer stem. Sounding mallet test - suspected partially decayed around brackets.							2022-05-18. /James Chambers.

Recommendation	- Fell - Retain high stump of approximately 2m to manage risk of harm or damage through stem failure onto footpath or road due to extensive basal decay. Retain high stump for wildlife and ecosystem service benefits.						Purpose of works		- Necessary		Safety Action Date	n/a	
Risk assessed	Tree failure on to footpath						Risk of harm range		1/10 000 - 1/1 000 000		Risk category	1
