## Site Investigation Report

Auger were commissioned by Crawford & Co to undertake a site investigation and CCTV inspection of the underground drainage within the area of concern at the property.

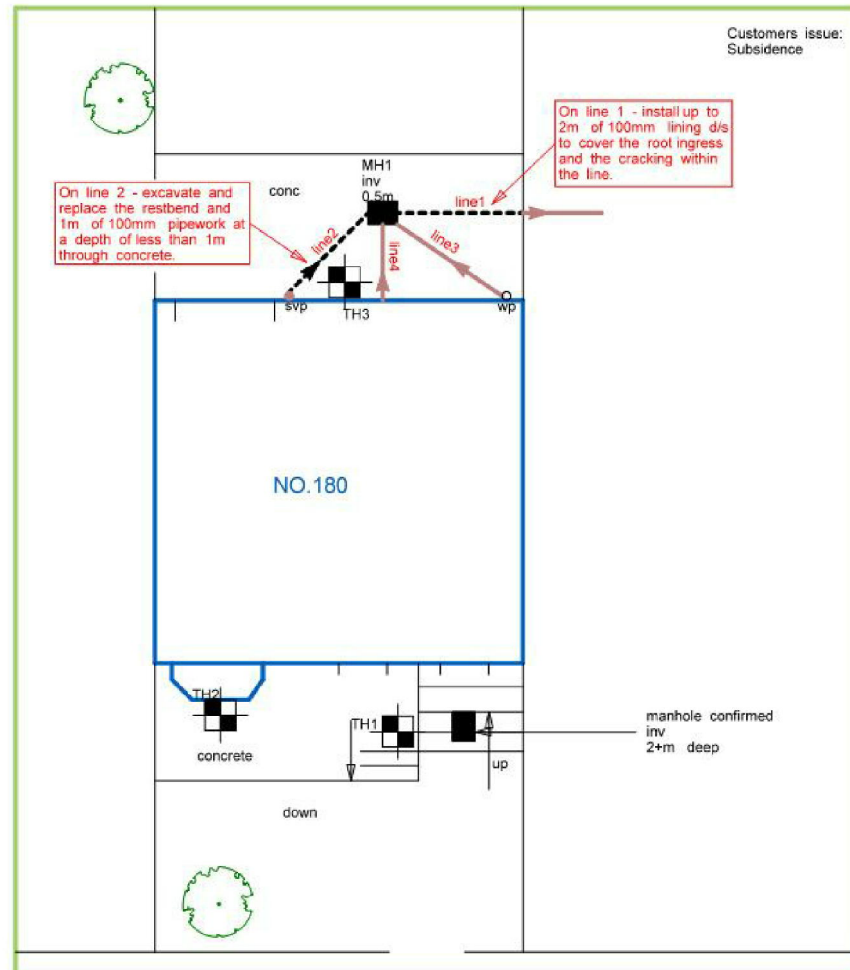
## Proposed Layout

Our CCTV survey revealed cracking and root ingress for the first 2m of pipework.

Our CCTV survey revealed cracking directly u/s of mh1.

On line 2, excavate and replace SVP and 1m of 100 mm pipework at a depth no greater than 1m through concrete.

On line 1, install 2m of 100 mm liner directly downstream of MH1.
