**ARBORICULTURAL IMPACT ASSESSMENT REPORT FOR:**

52-54 Avenue Road  
London  
NW8 6HS

**Ref:** DML/52AVR/AIA/01d

**Date:** 6<sup>th</sup> May 2022

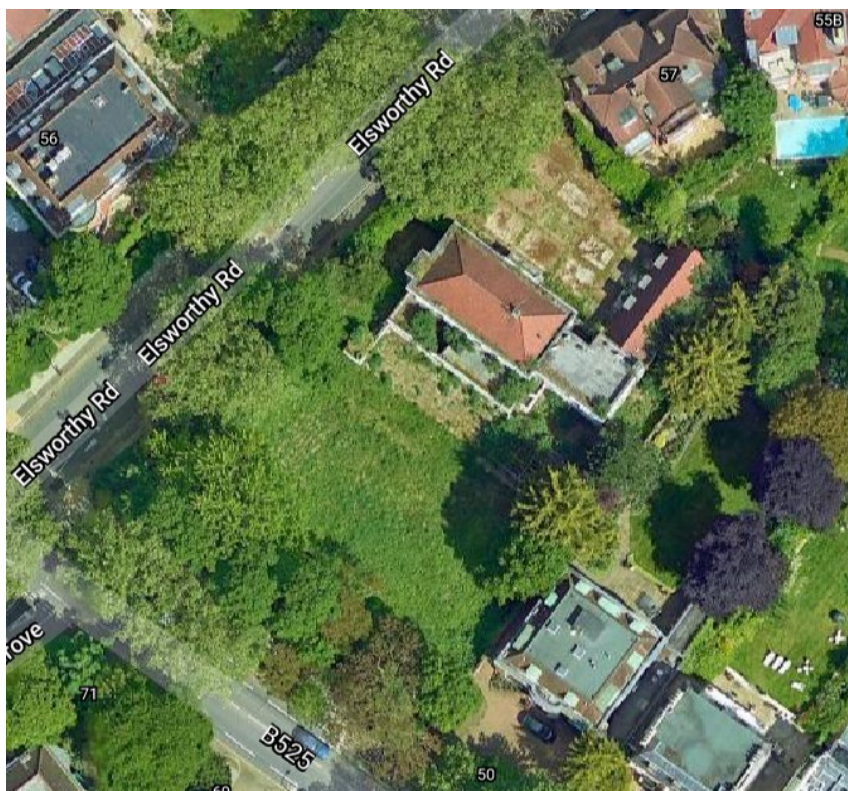
Photograph 1: Aerial view of application site (Source: Google Maps)

- 3.1.1 This site occupies a corner position on Avenue Road, at its junction with Elsworthy Road. The site comprises two plots with a double frontage on Avenue Road and separate access off Elsworthy Road. The site previously contained 2 villas to the south-west of the existing building and a garage (see Plan Extracts 1 & 2 over leaf). The rubble from the two original 1840s villas that were demolished was spread across the top layer of the site.

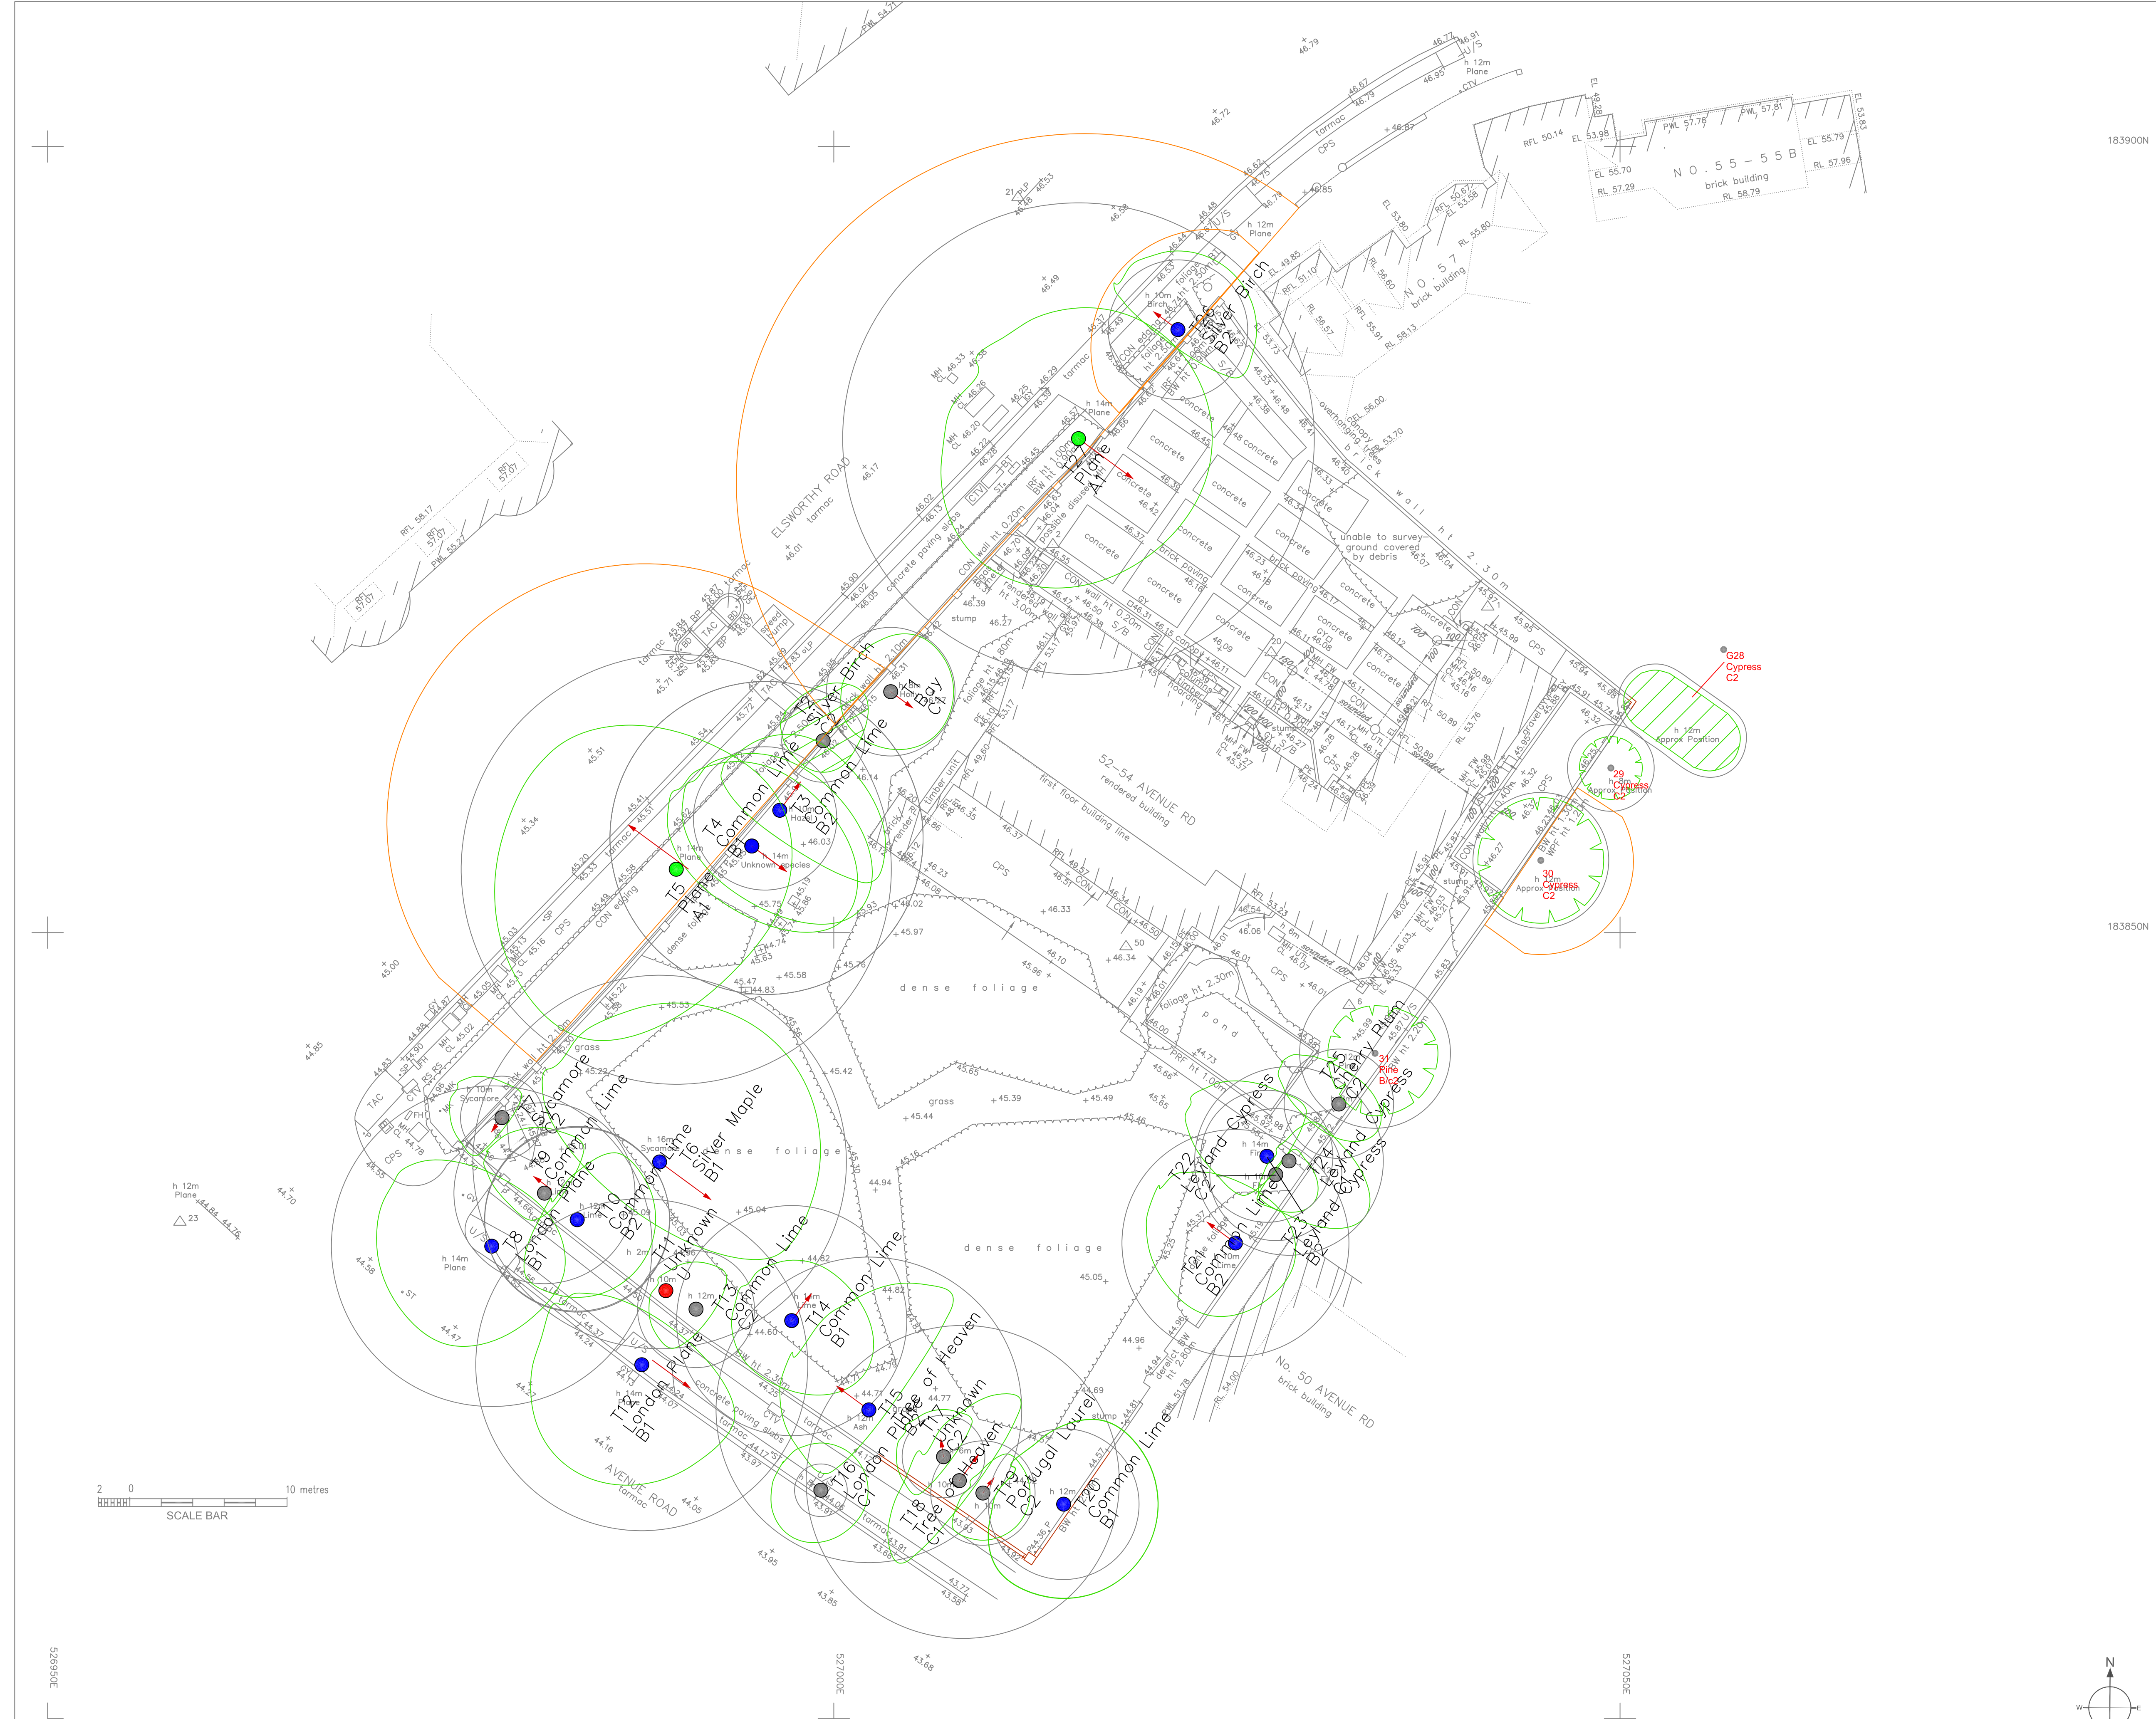
**PLAN 1**

**TREE CONSTRAINTS PLAN**

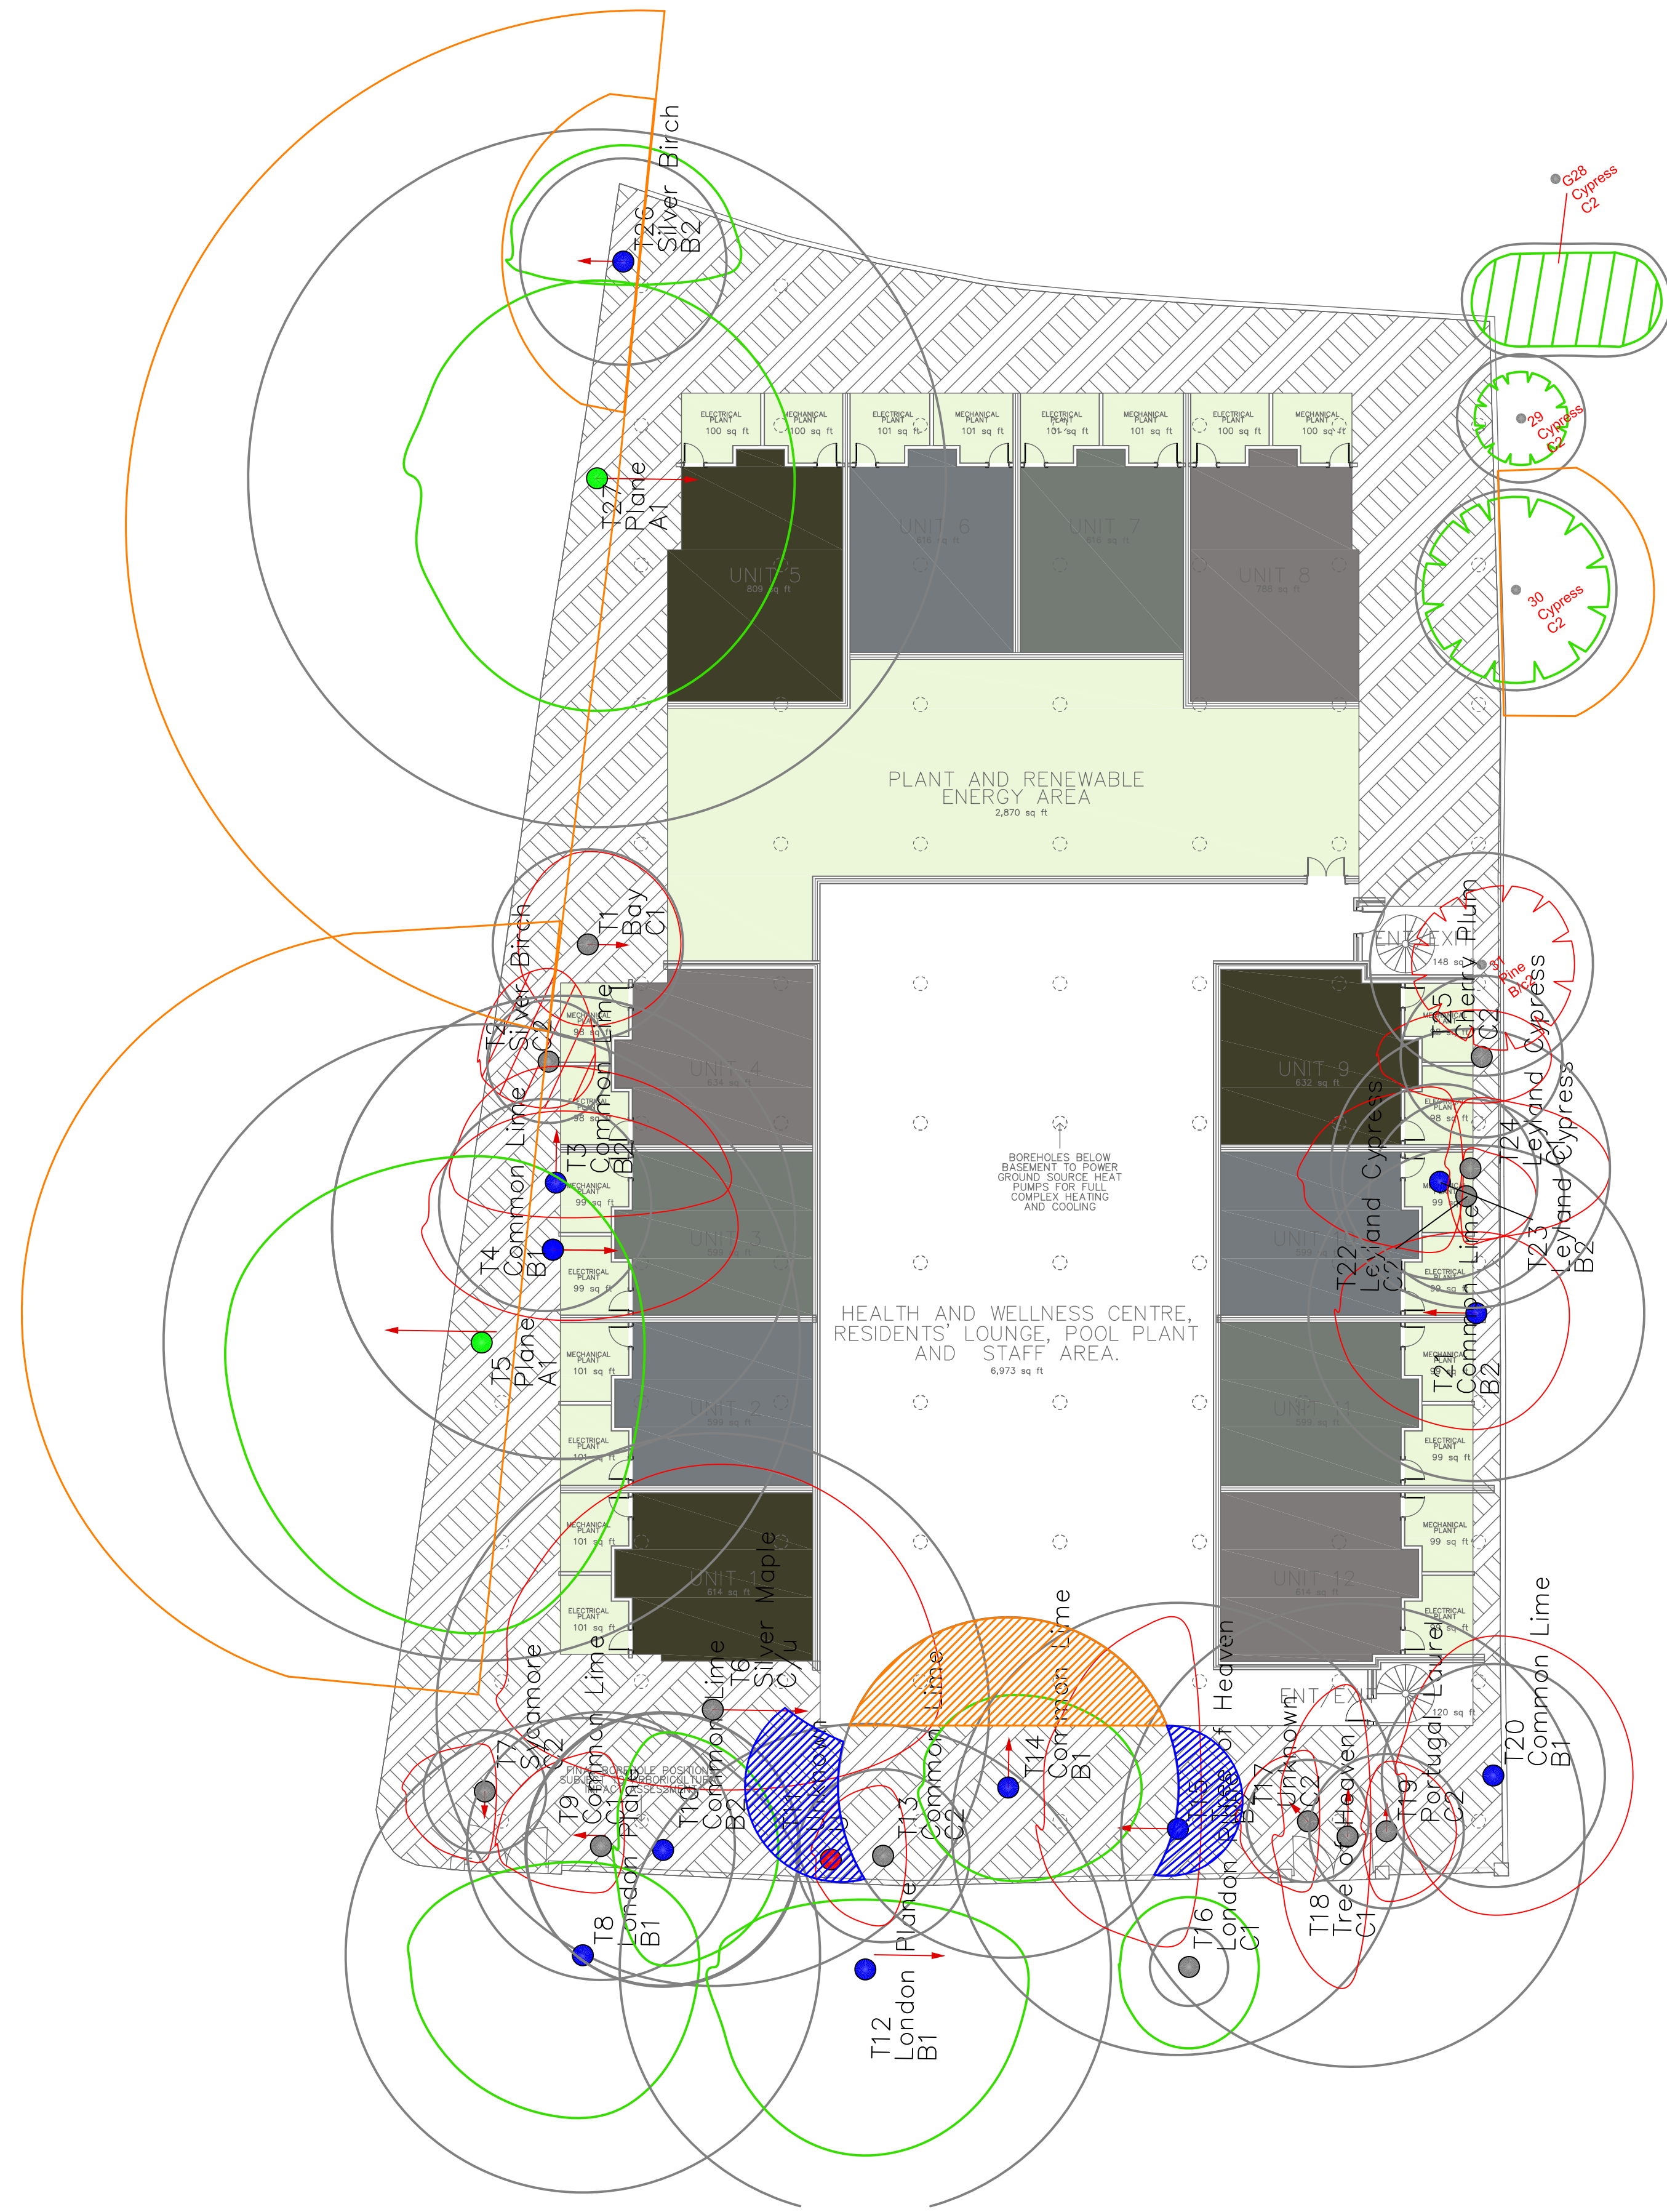
Proposed Basement Plan

**PLAN 2****ARBORICULTURAL IMPACT ASSESSMENT PLAN (S)**

- i. Basement
- ii. Lower Ground Floor
- iii. Ground Floor

6.3.4 The path of foundations through RPAs will be manually excavated to 750mm depth under arboricultural supervision; any roots encountered within the trenches / pits will be cleanly pruned back to an appropriate junction with a sharp pruning saw or secateurs back to a junction. Roots larger than 25mm diameter may only be cut in consultation with an arboriculturalist.

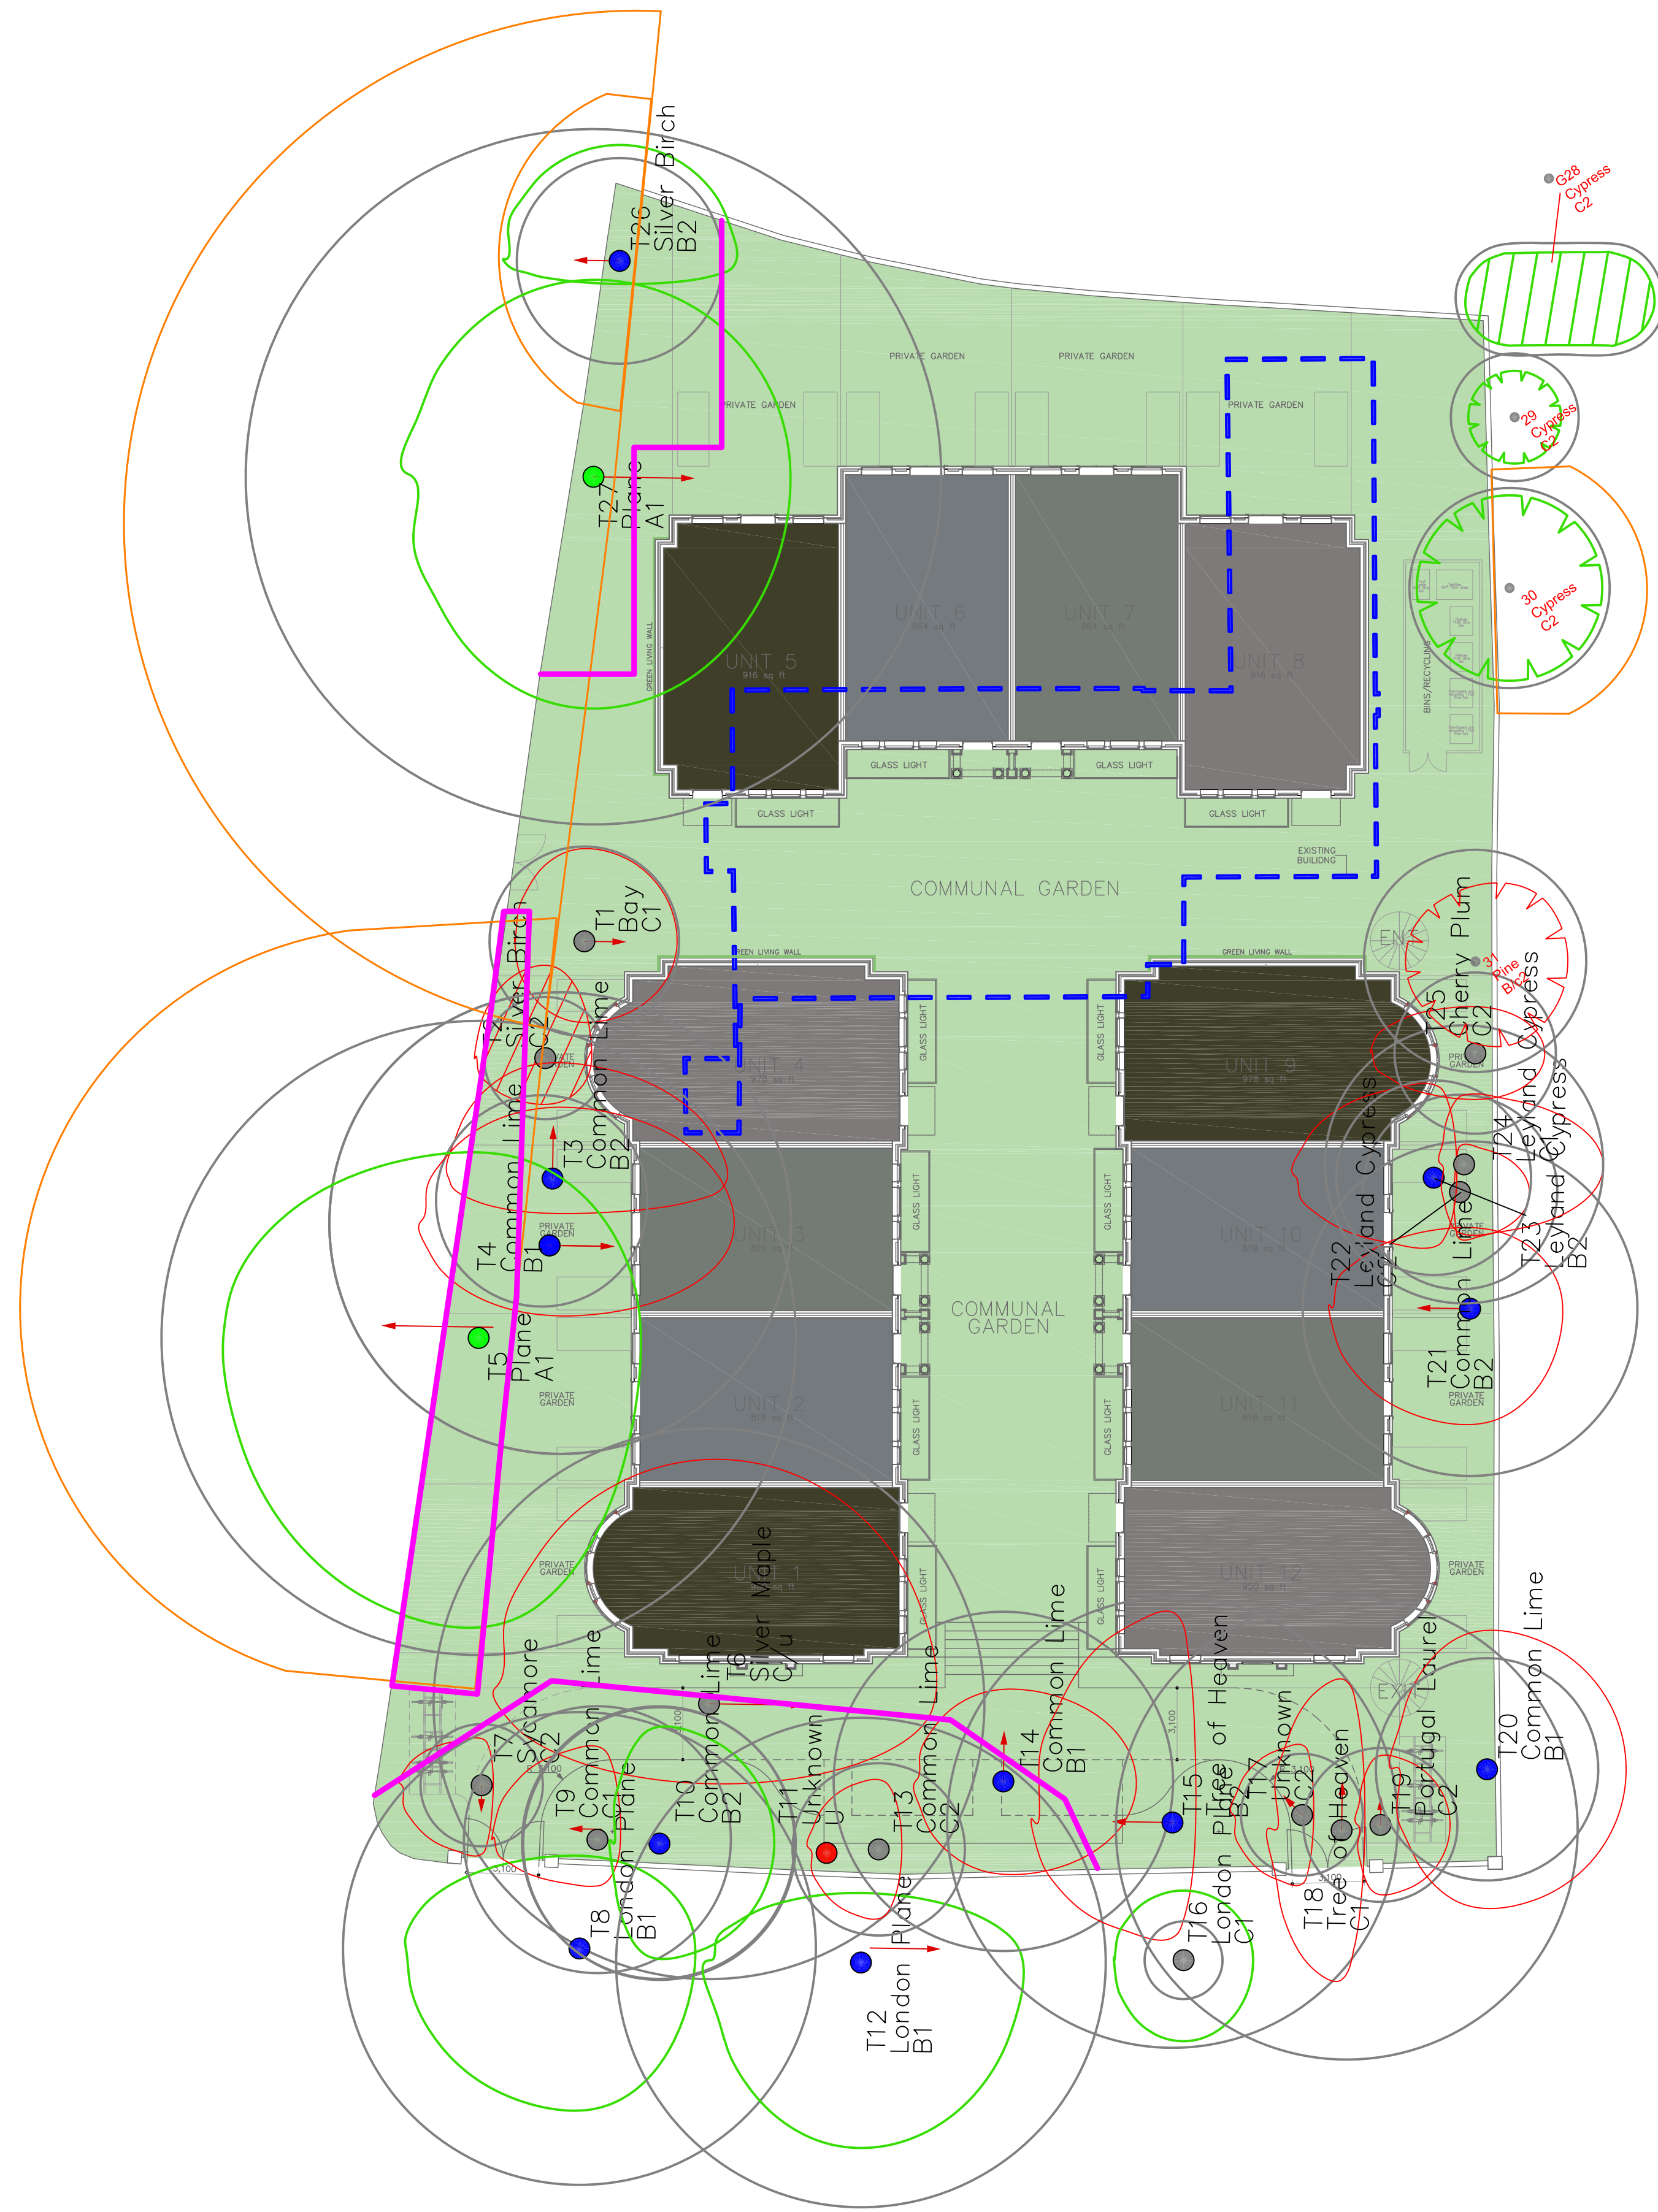
Proposed Ground Floor Plan

**OUTLINE TREE PROTECTION PLAN**

- 8.2.1 Any trees which are in close proximity to the proposed development should be protected with a Tree Protection Barrier (TPB). Protective barrier fencing should be installed immediately following the completion of the tree works, remaining in situ for the entire duration of the development unless otherwise agreed in writing by the Council. It should be appropriate for the intensity and proximity of the development, usually comprising steel, mesh panels 2.4m in height ('Heras') and should be mounted on a scaffolding frame (shown in Fig 2 of BS5837:2012). The position of the TPB can be shown on plan as part of the discharge of conditions, once the layout is agreed with the planning authority. The TPB should be erected prior to commencement of works, remain in its original form on-site for the duration of works and be removed only upon full completion of works.
