# 1-10 Cambridge Gate

## Condition Report

**Condition survey of  
Gate piers, 1-10  
Cambridge Gate,  
Regents Park.**

Report prepared for:  
**Crown Estate Paving  
Commission**

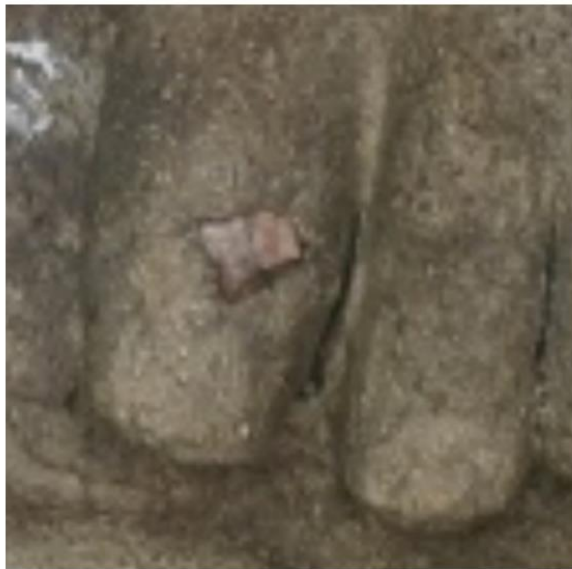
*Figure 11*  
M3S.2 Big toe, L foot. Very large looking like quartz with a coloured vein running through. This statue in particular has larger grogg particles.

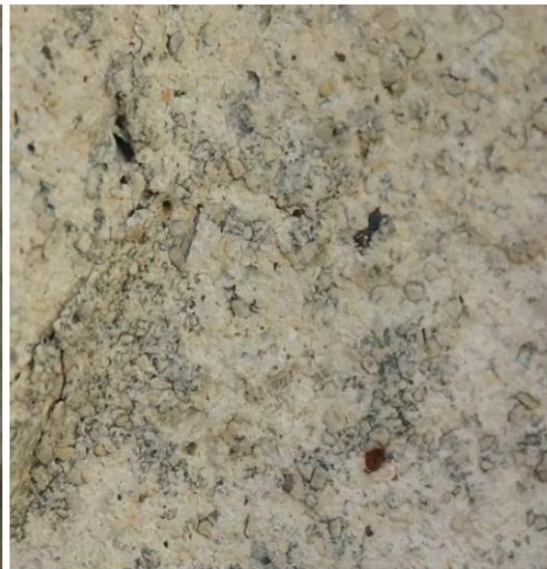
*Figure 12*  
M3S.2. Drapery: Large particles of different colours and sizes. Note the dark red particles. Other areas show a sandier looking matrix.

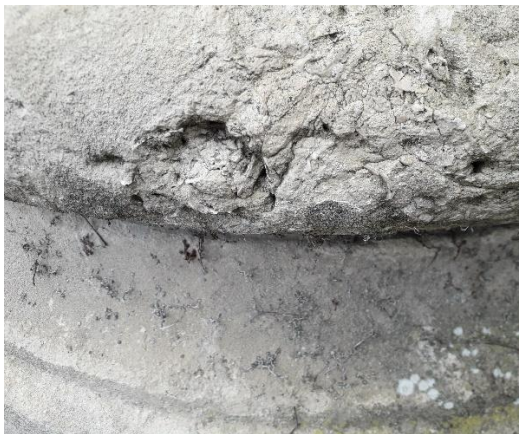
*Figure 27*  
*Erosion of material around shell fossils*

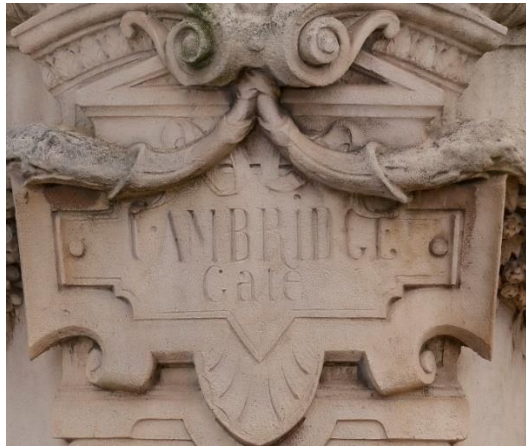
The carving on the shaft of MP3 is the most whole and with some crisp carving of swags and drops, showing how MP2 would have been. This could be useful if areas are to be recurved or modelled/ carved. The raised letters of the top moulding of M3 are softened in profile, but still just about reads as three dimensional, aided by the sign-writing. (Figure 36). For full details of condition of MP2 see annotated drawings. Only significant or typical comparative details are outlined here.

*Figure 36*  
MP3 Crisp detail

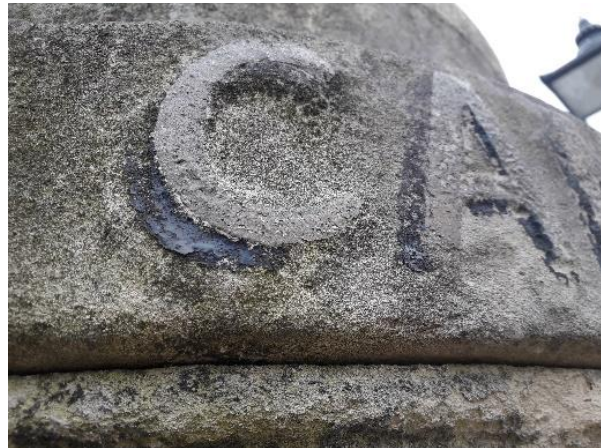
*Figure 37*  
MP3 Raised letters discernable

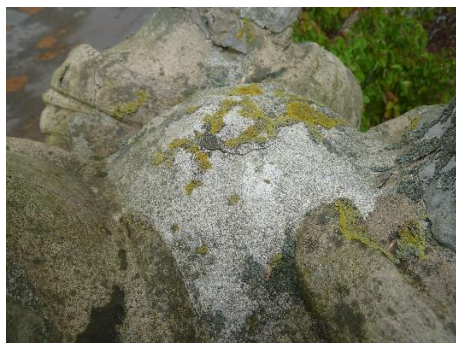
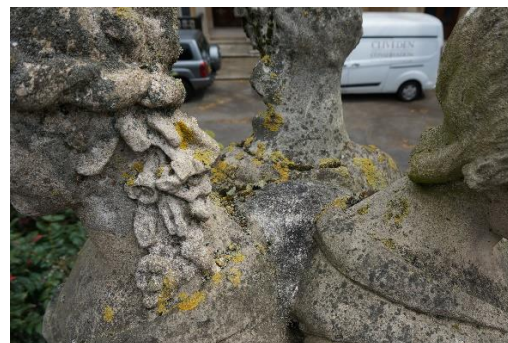
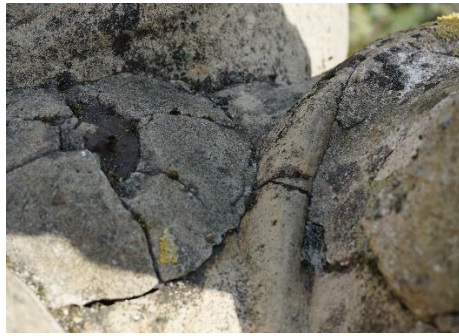
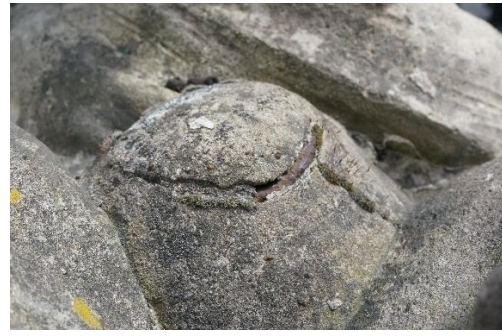
*View of the top centre of each set of statues between the heads. Showing the only sign of metal armature beyond one repaired hand. M3 and M4 show minor signs of expansion where the cement capping is cracked*

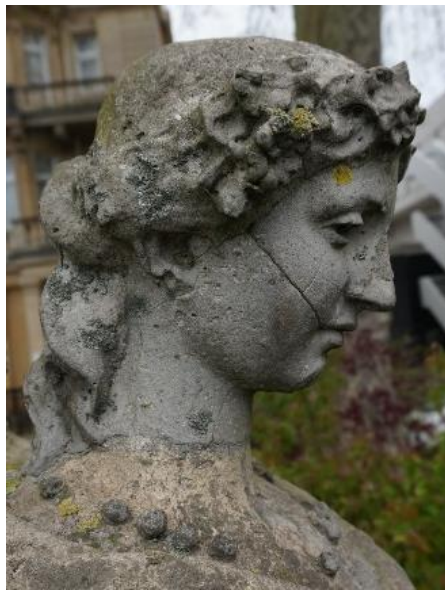
*Figure 56*  
*MS1.1*  
*Soft grey*  
*cement*

Cast taken from remaining statue? If so from which? This head is important as it may have been replicated before the original became eroded and be the closest in original shape to any of the existing.

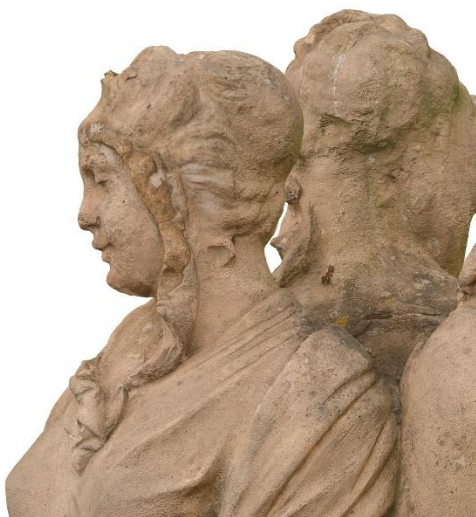
*Figure 61*  
MS4

No replacement heads, all originals well attached

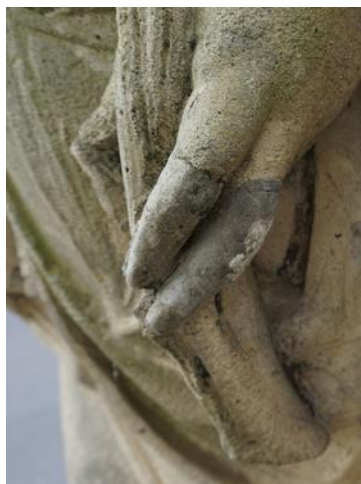
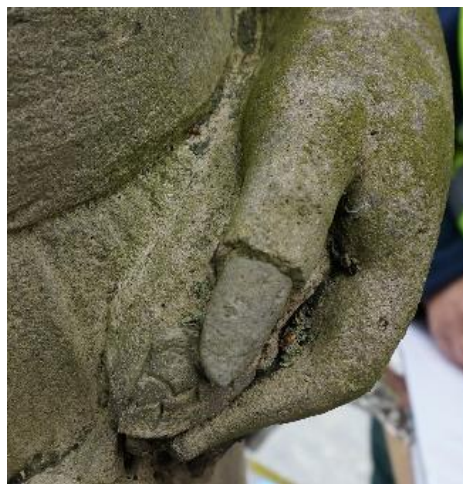
Many of the fingers are cracked and have been lost but largely replaced. The full extent of these losses is mapped on the annotated drawings and are too many to illustrate here beyond typical or notable examples. The extent of repairs and the variety of colours and textures that they create has made the figures read as fragmented, making them less aesthetically pleasing overall.

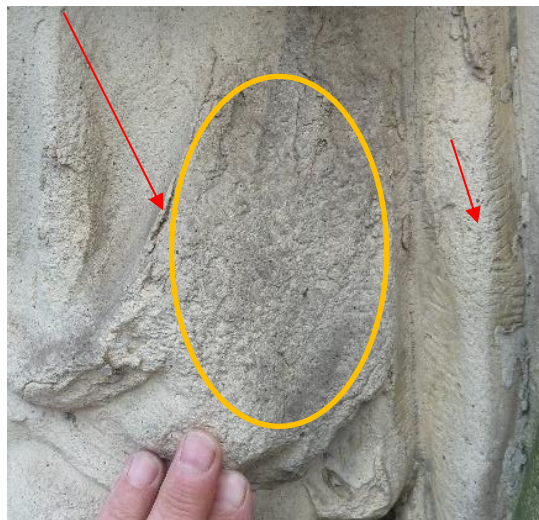
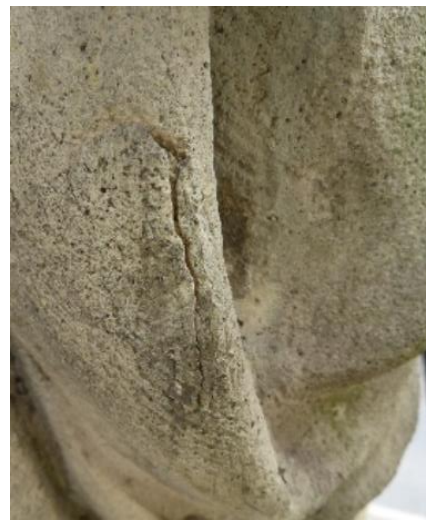
Some areas are delaminating. This is shown as orange hatching on the 3d images. Here, larger areas of terracotta are spalling from the main body where small cracks have allowed water in. These cracks may be started and then exacerbated by the growth of biological material and the presence or debris of insects and the expansion of water during freeze, thaw cycles which push the surface off. This can cause large areas of loss to happen at once. This can be seen in the head of M1.3 above and examples below.

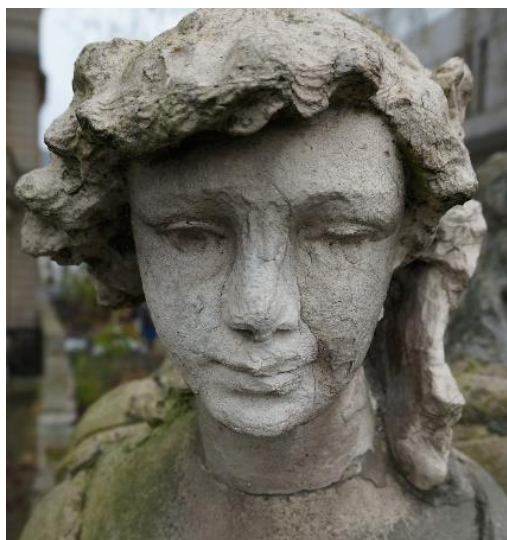
Figure 71

MS1.1 General pitting of the fire-skin is very common over the surface of all figures. The fire-skin in places is very rough and difficult to distinguish from where it is partially lost

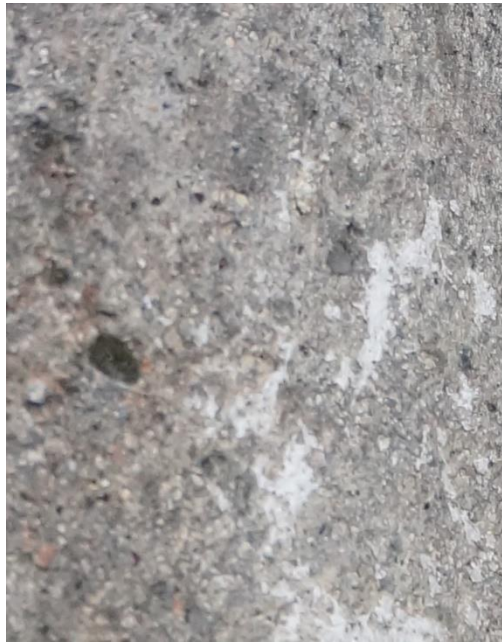
*Figure 73 (left)*

*Holes left in the surface where aggregate has been washed from the surface of the terracotta leaving various sized holes*

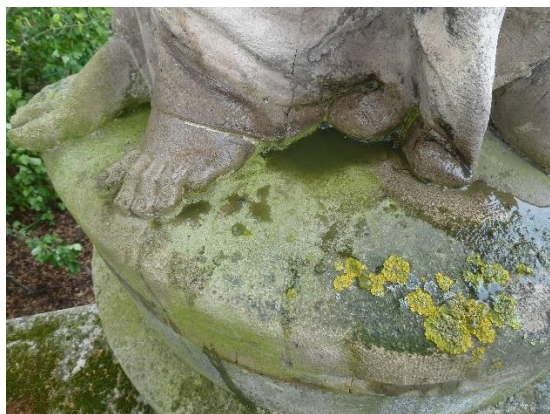
*Figure 74*  
*MS1 Algae greening and lichen growth under the trees*

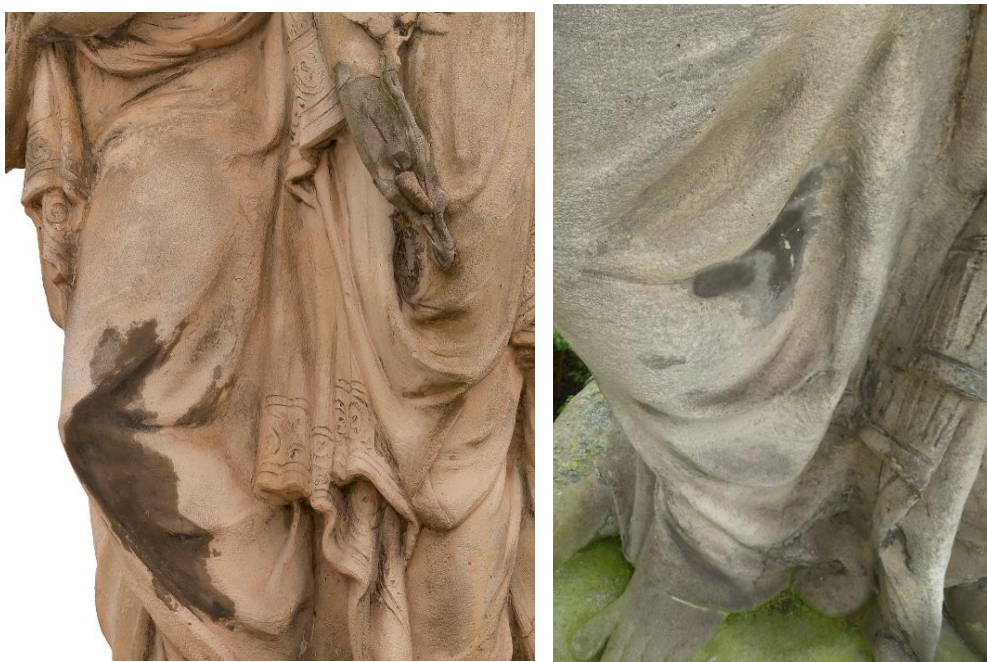
*Figure 81 & 82*

*Sulphation associated with fills. MS3.3 (left) subject to cleaning trials. This has proved difficult to remove in trials. The fills themselves don't seem to be causing any harm to the object and may have a surface similar in permeability which allows them to be compatible.*

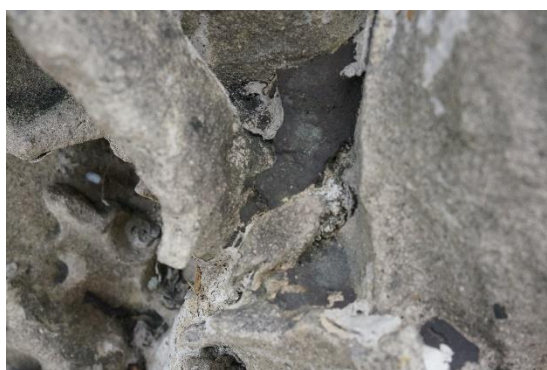
*Figure 85*  
*Sulphation associated with paint in sheltered areas*

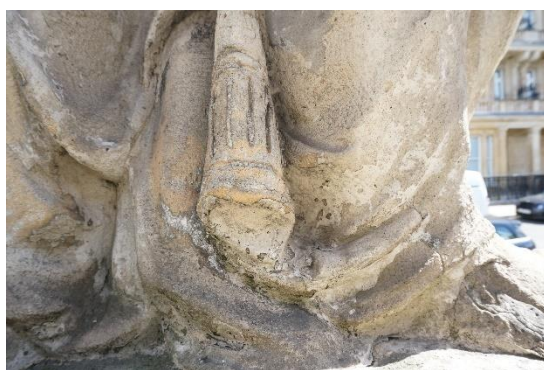
*Figure 86*  
*Paint clogging the detail*

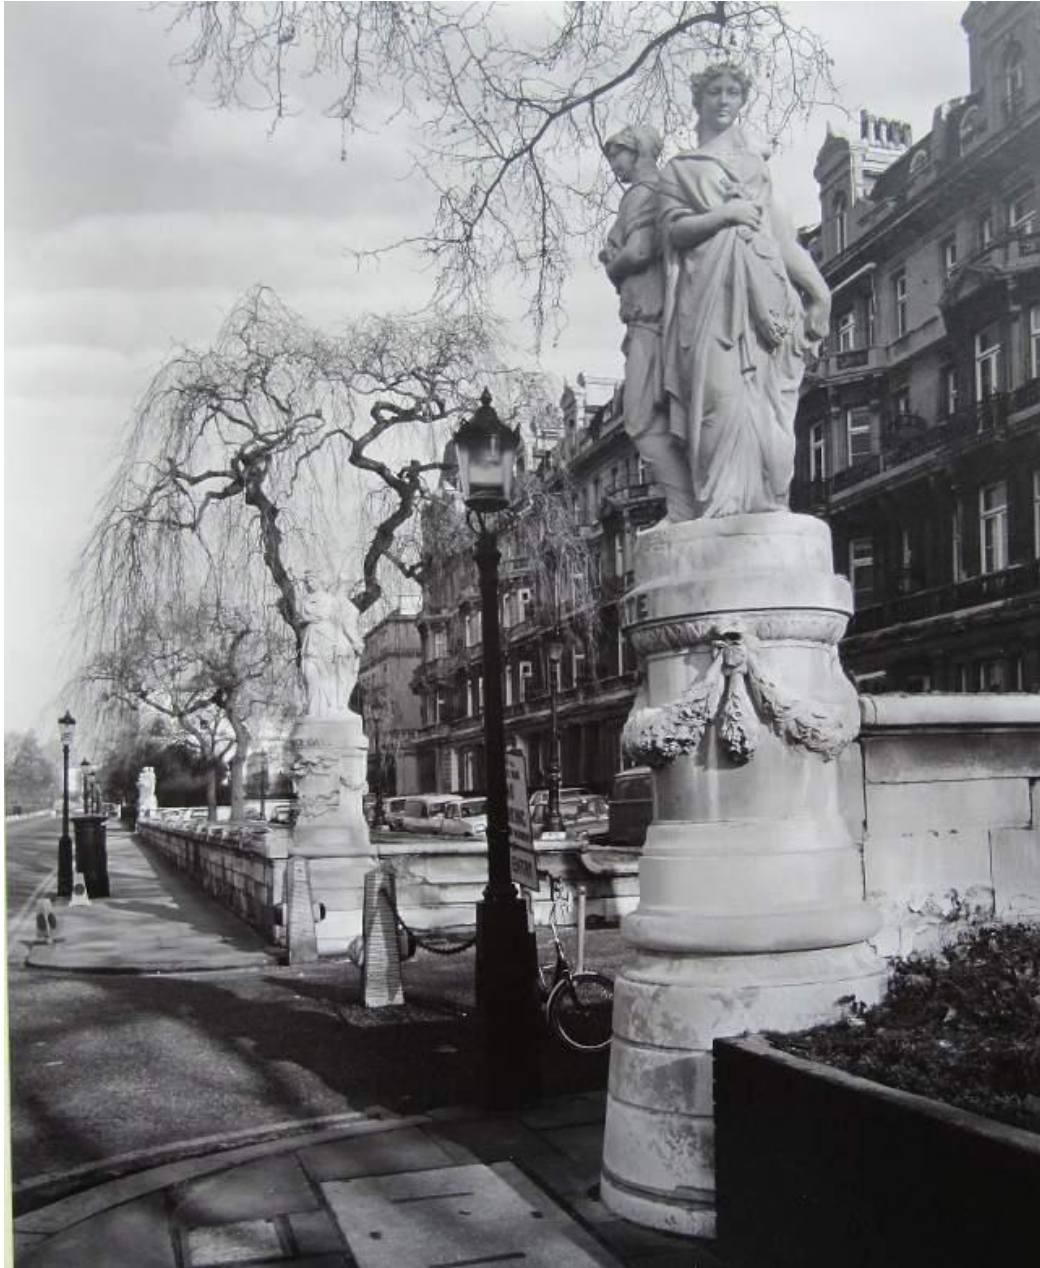
Figure 87 <sup>19</sup>

*This photograph appears to show the statue painted. Note the missing railings and the displacement of the plinth from the wall. The photograph is not dated but cars, a bike, plastic traffic cone and the lack of railings suggest that it was taken within the last 50 years.*

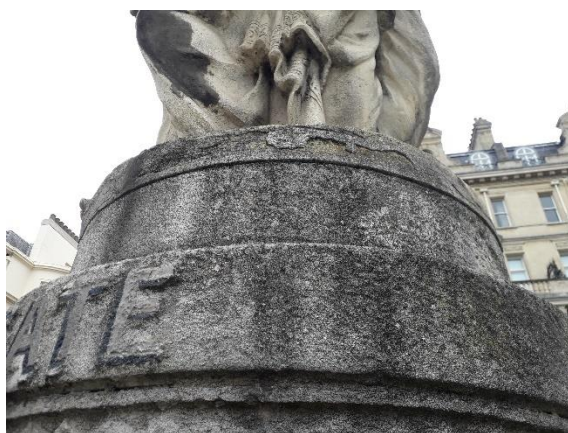
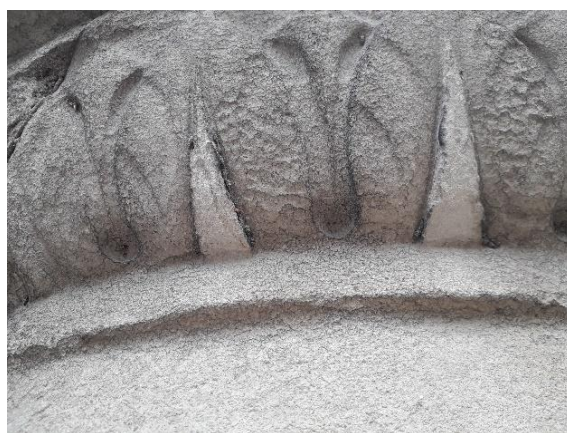
*Figure 90 & 91*

*Atmospheric pollution and biological growth and insect debris*

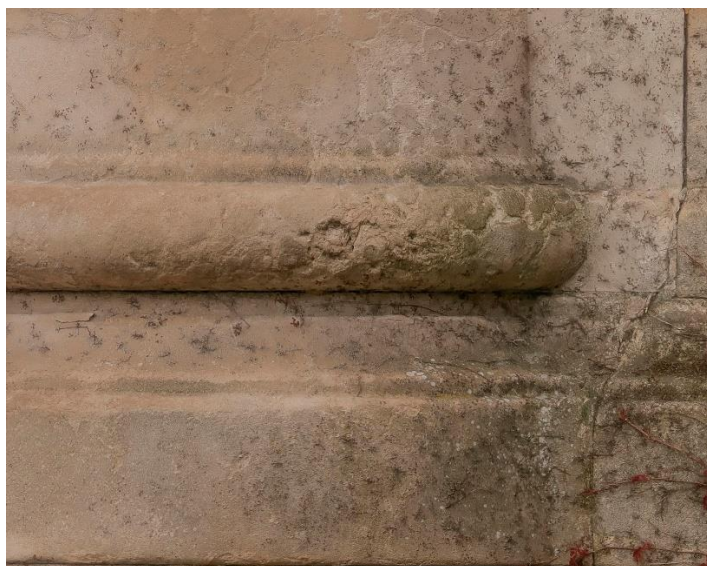
Except where the rain has washed it away, the bases are largely covered with green algae. Moss can be found in cracks and joints and lichen on the upper moulding. This is likely to hasten the decay of the surface. MP4 shows significant damage from the roots of a creeper which have left a series of marks etched into the stone. Some dead roots are still firmly attached after the rest of the creeper has been removed.

*Figure 92*

*The creeper has left small round dots over much of the surface of the plinth on the south side. It may even be responsible for the giraffe skin type of pattern where the plant has plucked away the surface when being removed.*

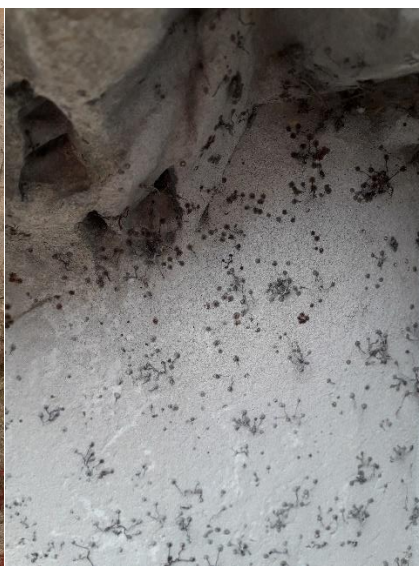
*Figure 93*

*Creeper sucker pads/roots adhering to the stone*
