BS5837 Arboricultural Impact Assessment & Method Statement

Flat 6, 9-11 Belsize Grove, Belsize Park, London, NW3 4UU

Client: Mr J Delaney

Job Reference: 03792R

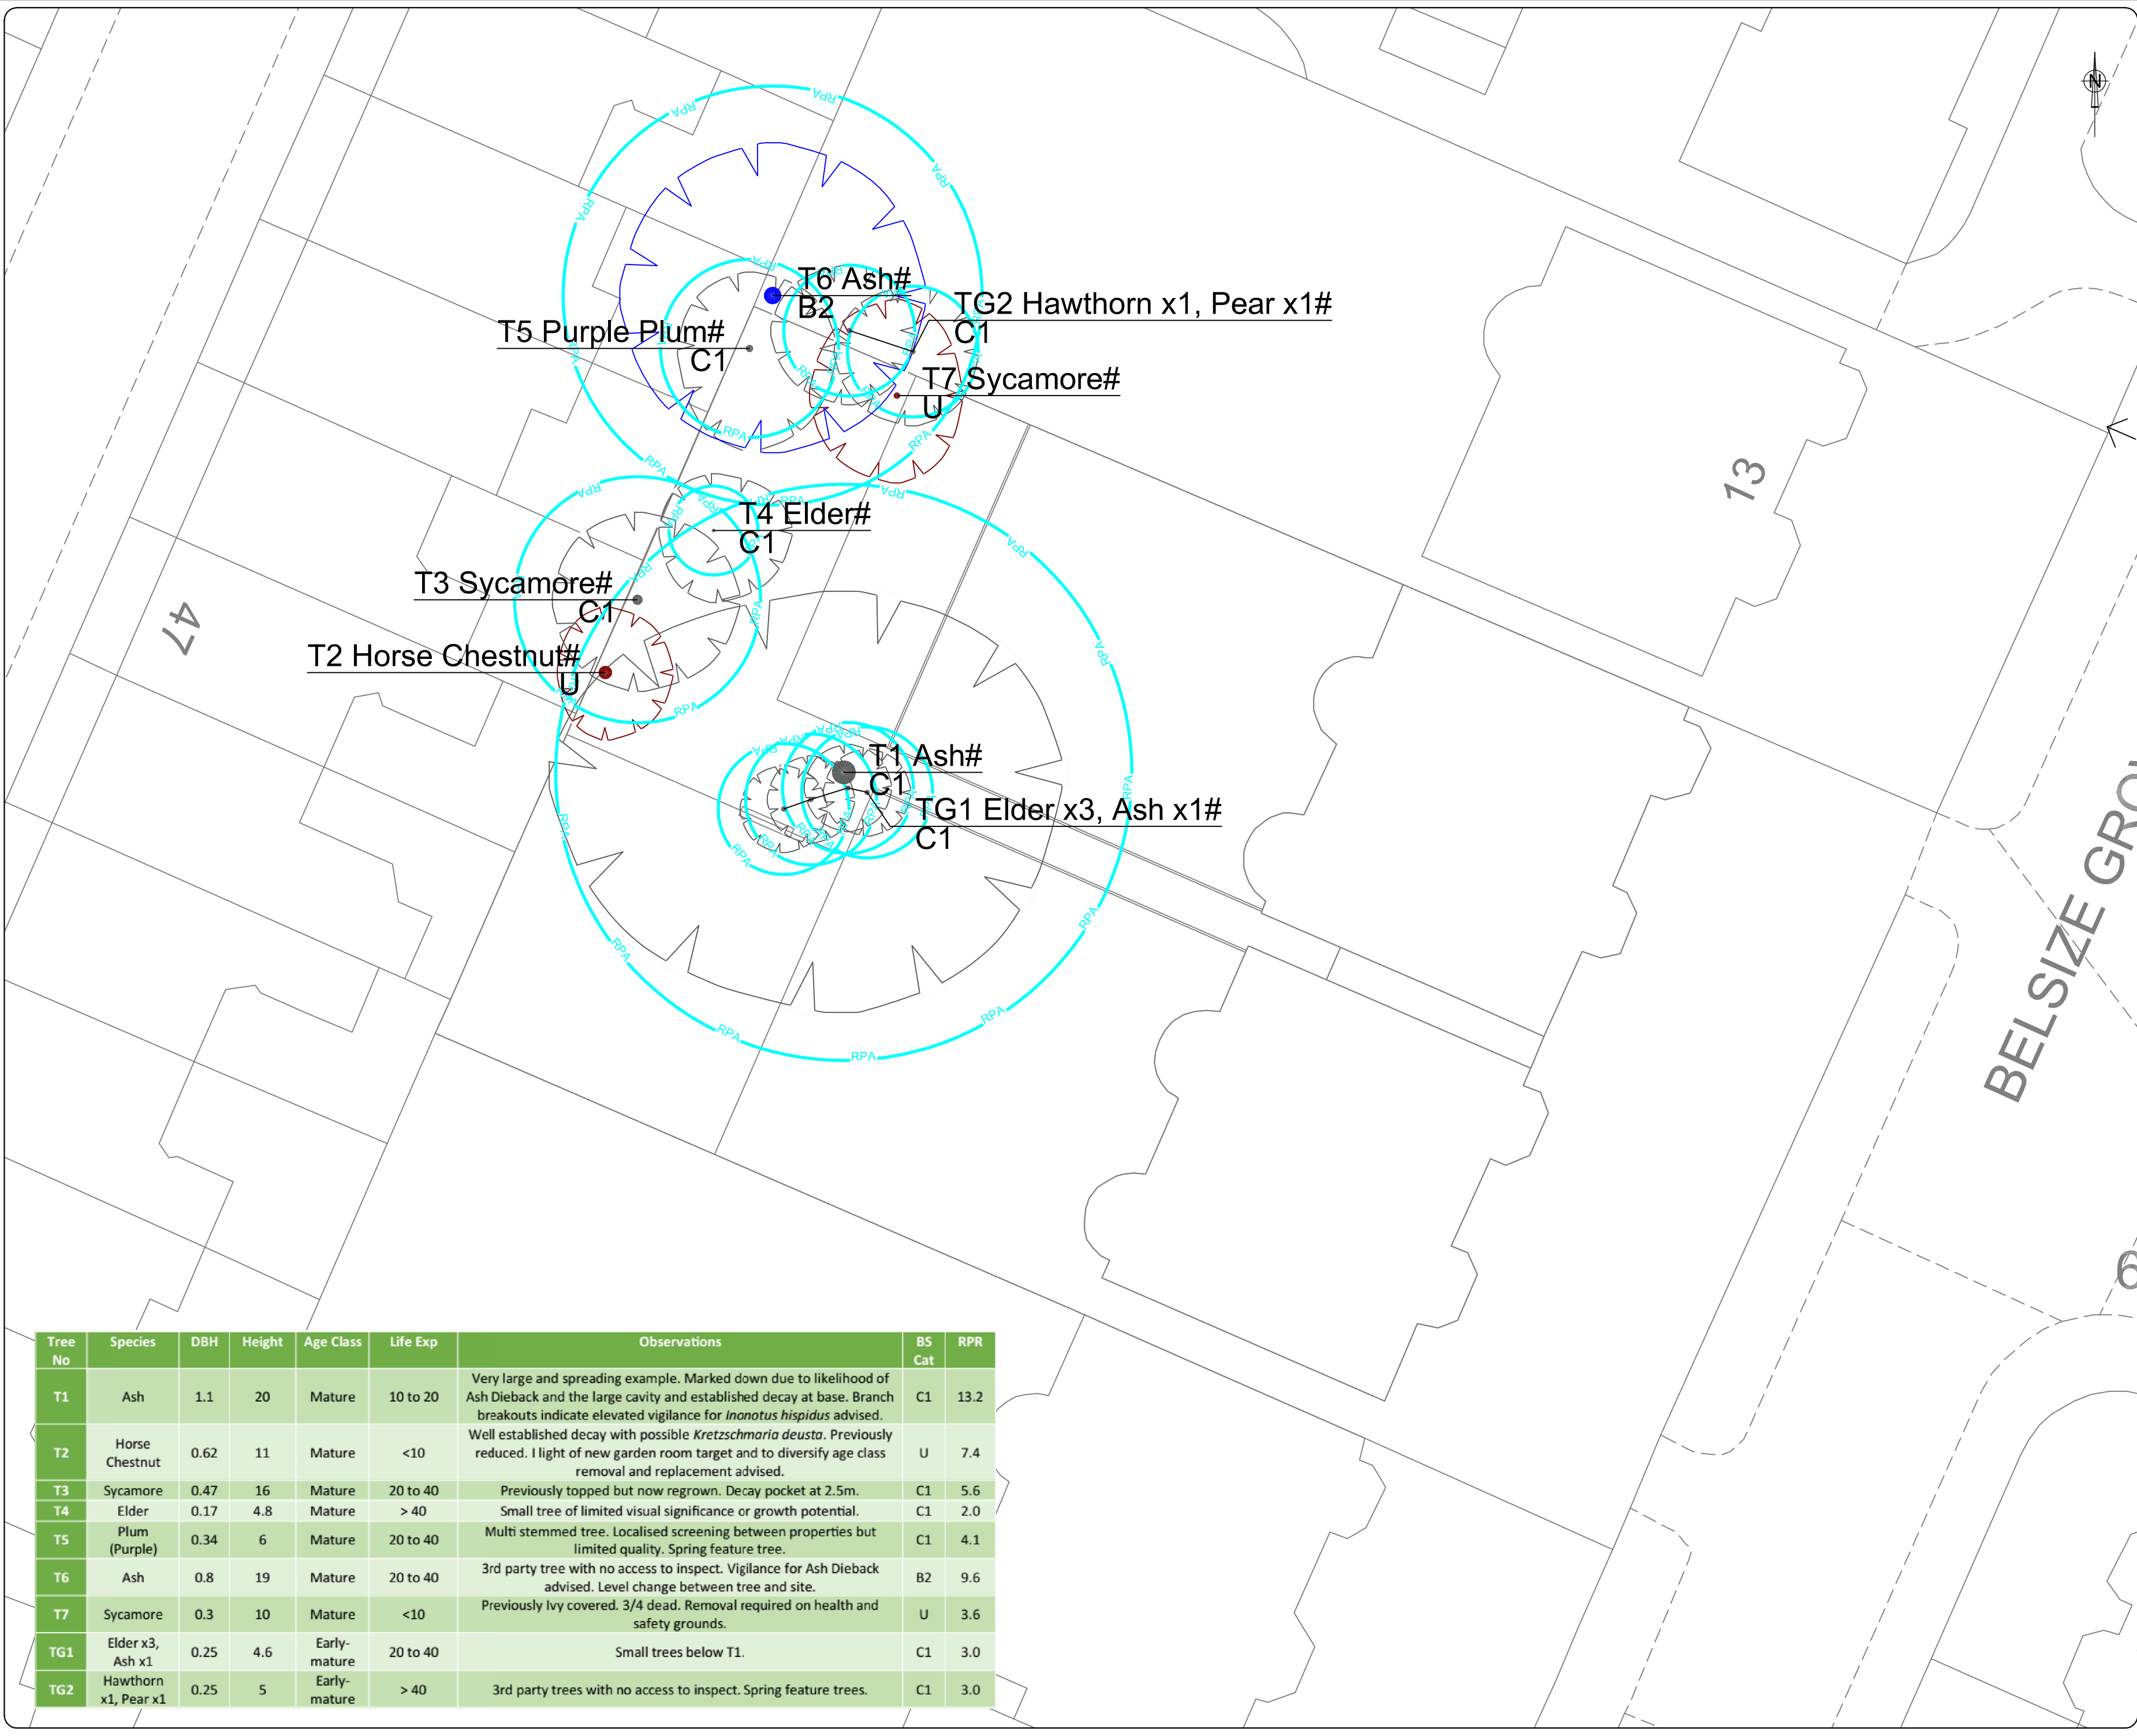
Appendix 5 - Tree Constraints Plan

Tree No	Species	DBH	Height	Age Class	Life Exp	Observations	BS Cat	RPR
T1	Ash	1.1	20	Mature	10 to 20	Very large and spreading example. Marked down due to likelihood of Ash Dieback and the large cavity and established decay at base. Branch breakouts indicate elevated vigilance for <i>Inonotus hispidus</i> advised.	C1	13.2
T2	Horse Chestnut	0.62	11	Mature	<10	Well established decay with possible <i>Kretzschmaria deusta</i> . Previously reduced. I light of new garden room target and to diversify age class removal and replacement advised.	U	7.4
T3	Sycamore	0.47	16	Mature	20 to 40	Previously topped but now regrown. Decay pocket at 2.5m.	C1	5.6
T4	Elder	0.17	4.8	Mature	> 40	Small tree of limited visual significance or growth potential.	C1	2.0
T5	Plum (Purple)	0.34	6	Mature	20 to 40	Multi stemmed tree. Localised screening between properties but limited quality. Spring feature tree.	C1	4.1
T6	Ash	0.8	19	Mature	20 to 40	3rd party tree with no access to inspect. Vigilance for Ash Dieback advised. Level change between tree and site.	B2	9.6

T7	Sycamore	0.3	10	Mature	<10	Previously Ivy covered. 3/4 dead. Removal required on health and safety grounds.	U	3.6
TG1	Elder x3, Ash x1	0.25	4.6	Early-mature	20 to 40	Small trees below T1.	C1	3.0
TG2	Hawthorn x1, Pear x1	0.25	5	Early-mature	> 40	3rd party trees with no access to inspect. Spring feature trees.	C1	3.0
