# GEOTECHNICAL

160 Camden Road, London, NW1 9HJ

## Drainage Investigation Report

**Risk Address:** 160 Camden Road, London, NW1 9HJ

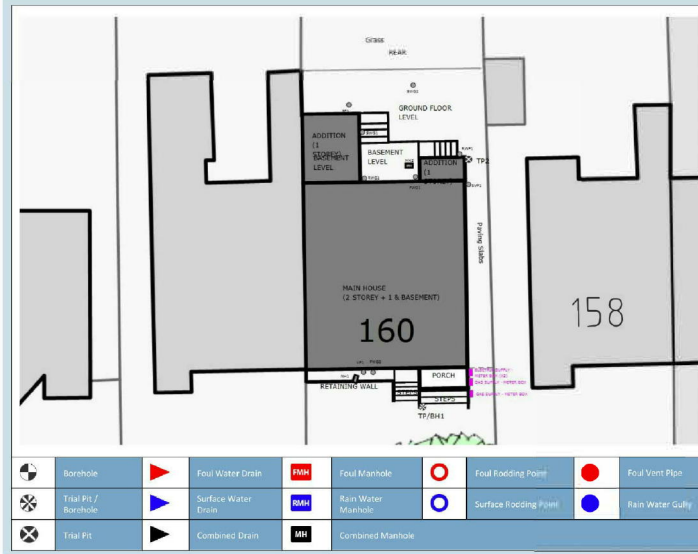
### Site Plan

The rainwater downpipe (RWP1) was encountered not connected to the sub-surface drainage system and discharging to ground surface.

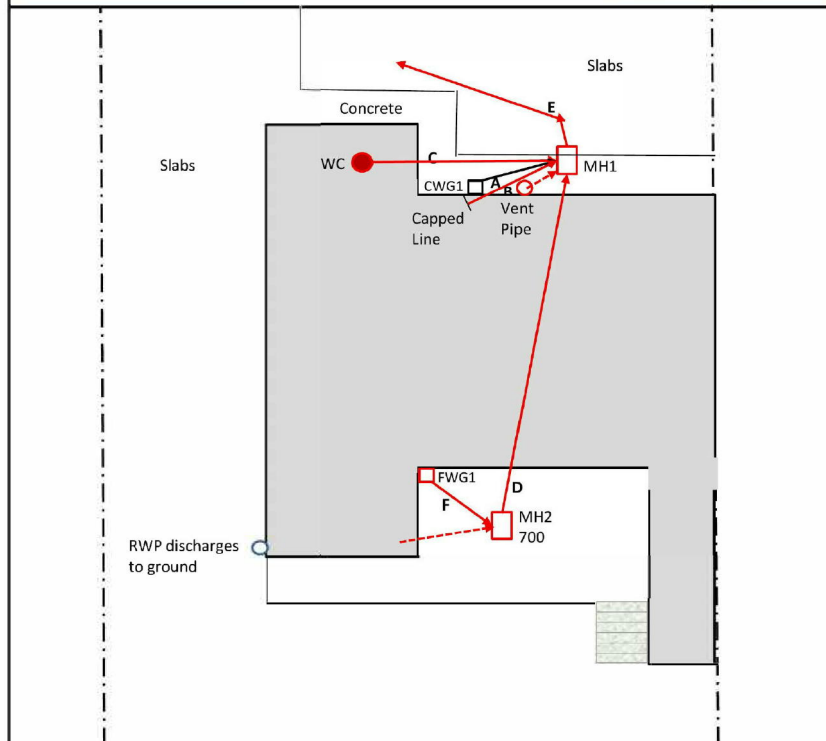
SubsNetUK		CCTV Survey		SubsNetUK	
RUN A	Start From :	MH1	Finish at :	CWG1	Pipe Ø: 100mm
	Invert Level (m):	1.1	Invert Level (m):	N/A	Material: Plastic
COMBINED	Condition grade:	A	Direction:	Upstream	Shared: NO
Distance	Code	Remarks

0.00	SN	Start Node from MH1			
0.00	WL	Water Level 0%			
0.60	FN	Finish Node at CWG1			
Hydraulic Pressure Test		From	To	Result	Comments
		MH1	CWG1	PASS	
RUN B	Start From :	MH1	Finish at :	Capped Line	Pipe Ø: 100mm
	Invert Level (m):	1.1	Invert Level (m):	N/A	Material: Clay
FOUL	Condition grade:	C	Direction:	Upstream	Shared: NO
Distance	Code	Remarks

0.00	SN	Start Node from MH1			
0.00	WL	Water Level 0%			
0.30	JDL	Joint Displaced (Large)			
0.50	LU	Line of drain deviates up 90°			
0.90	FN	Finish Node at Capped Line			
RUN C	Start From :	MH1	Finish at :	WC	Pipe Ø: 100mm
	Invert Level (m):	1.1	Invert Level (m):	N/A	Material: Clay
FOUL	Condition grade:	B	Direction:	Upstream	Shared: NO
Distance	Code	Remarks

4.80	LU	Line of drain deviates up 90°			
5.20	FN	Finish Node at WC			
RUN D	Start From :	MH1	Finish at :	MH2	Pipe Ø: 100mm
	Invert Level (m):	1.1	Invert Level (m):	0.7	Material: Clay
FOUL	Condition grade:	B	Direction:	Upstream	Shared: NO
Distance	Code	Remarks

0.00	SN	Start Node from MH1			
0.00	WL	Water Level 0%			
0.00	DEE	Attached Deposits (encrustation) 10%			
9.90	FN	Finish Node at MH2			
Hydraulic Pressure Test		From	To	Result	Comments
		MH1	MH2	FAIL	
Address: 160 Camden Road, London, NW1 9HJ
