Swiss Cottage Library

Fin inspection London Borough of Camden

22 April 2022

5206133-ATK-XX-XX-RP-SE-000001

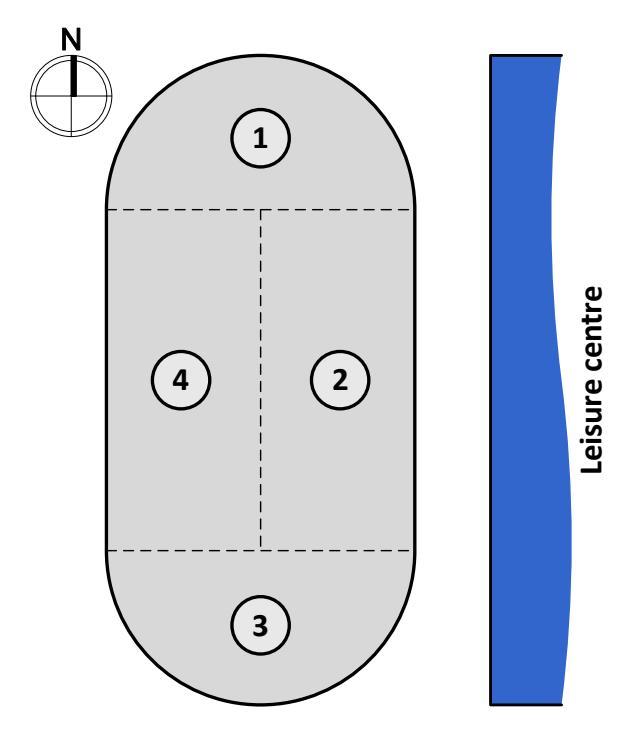
Figure 2.1 – Key plan with zone references

At both first and second floor levels it was noticeable that in Zones 1 and 2, cracking was infrequent and where it did occur on a given fin, the spacing was large, e.g. greater than 1m. By contrast, in the other zones the cracking was seen on most fins and at close centres, e.g. 250mm; spot checks of crack widths were in the order of 0.3mm in all zones.
