12 & 13 PRIMROSE HILL STUDIOS
CONDITION SURVEY AND BUILDING CONSERVATION PROPOSALS
MAY 2022
REV A - JULY 2022

12 & 13 PRIMROSE HILL STUDIOS
CONDITION SURVEY AND BUILDING CONSERVATION PROPOSALS
CONTENTS

Purcell were commissioned by Rory and Barbara Campbell-Lange in May 2022 to carry out a non-intrusive condition survey of two properties at 12 & 13 Primrose Hill Studios, to inform and set out proposals for conservation of the building as part of a Planning and Listed Building Consent application for renewed studio and residential use.

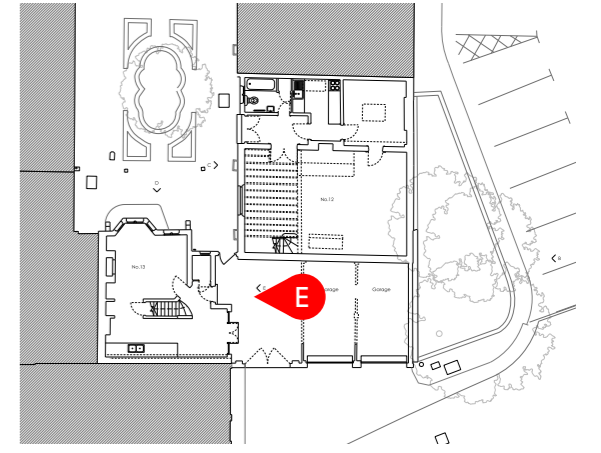
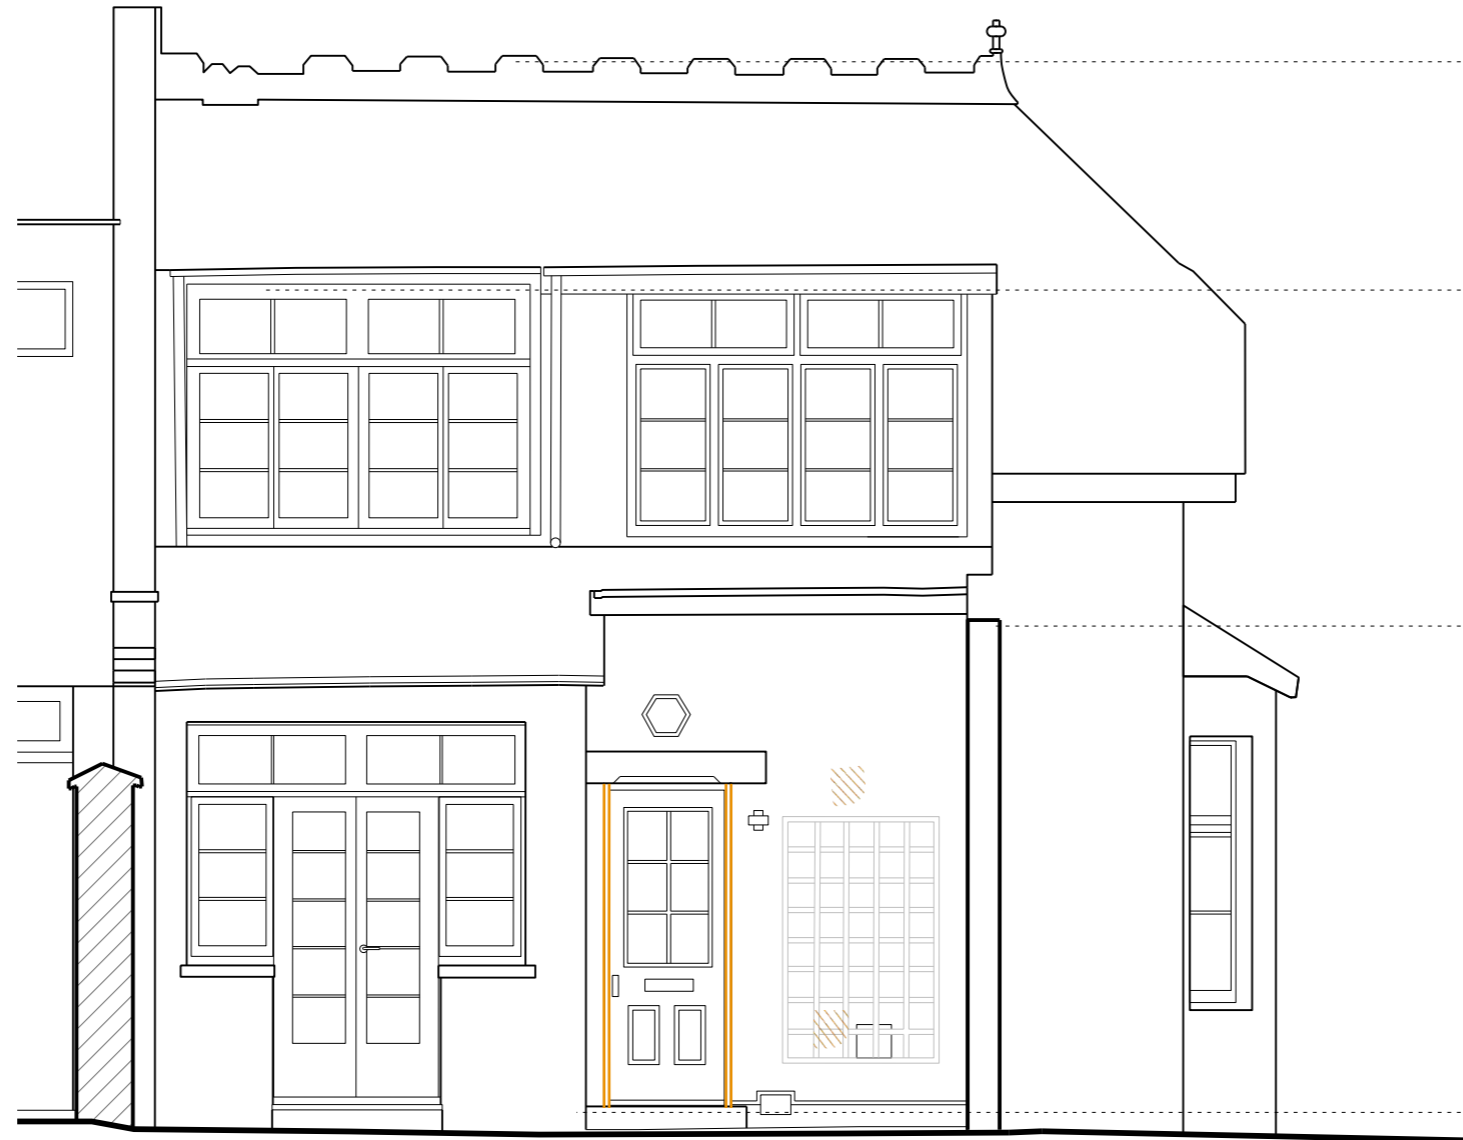
3.4 ELEVATION E

NOTE: This elevation will be rebuilt.

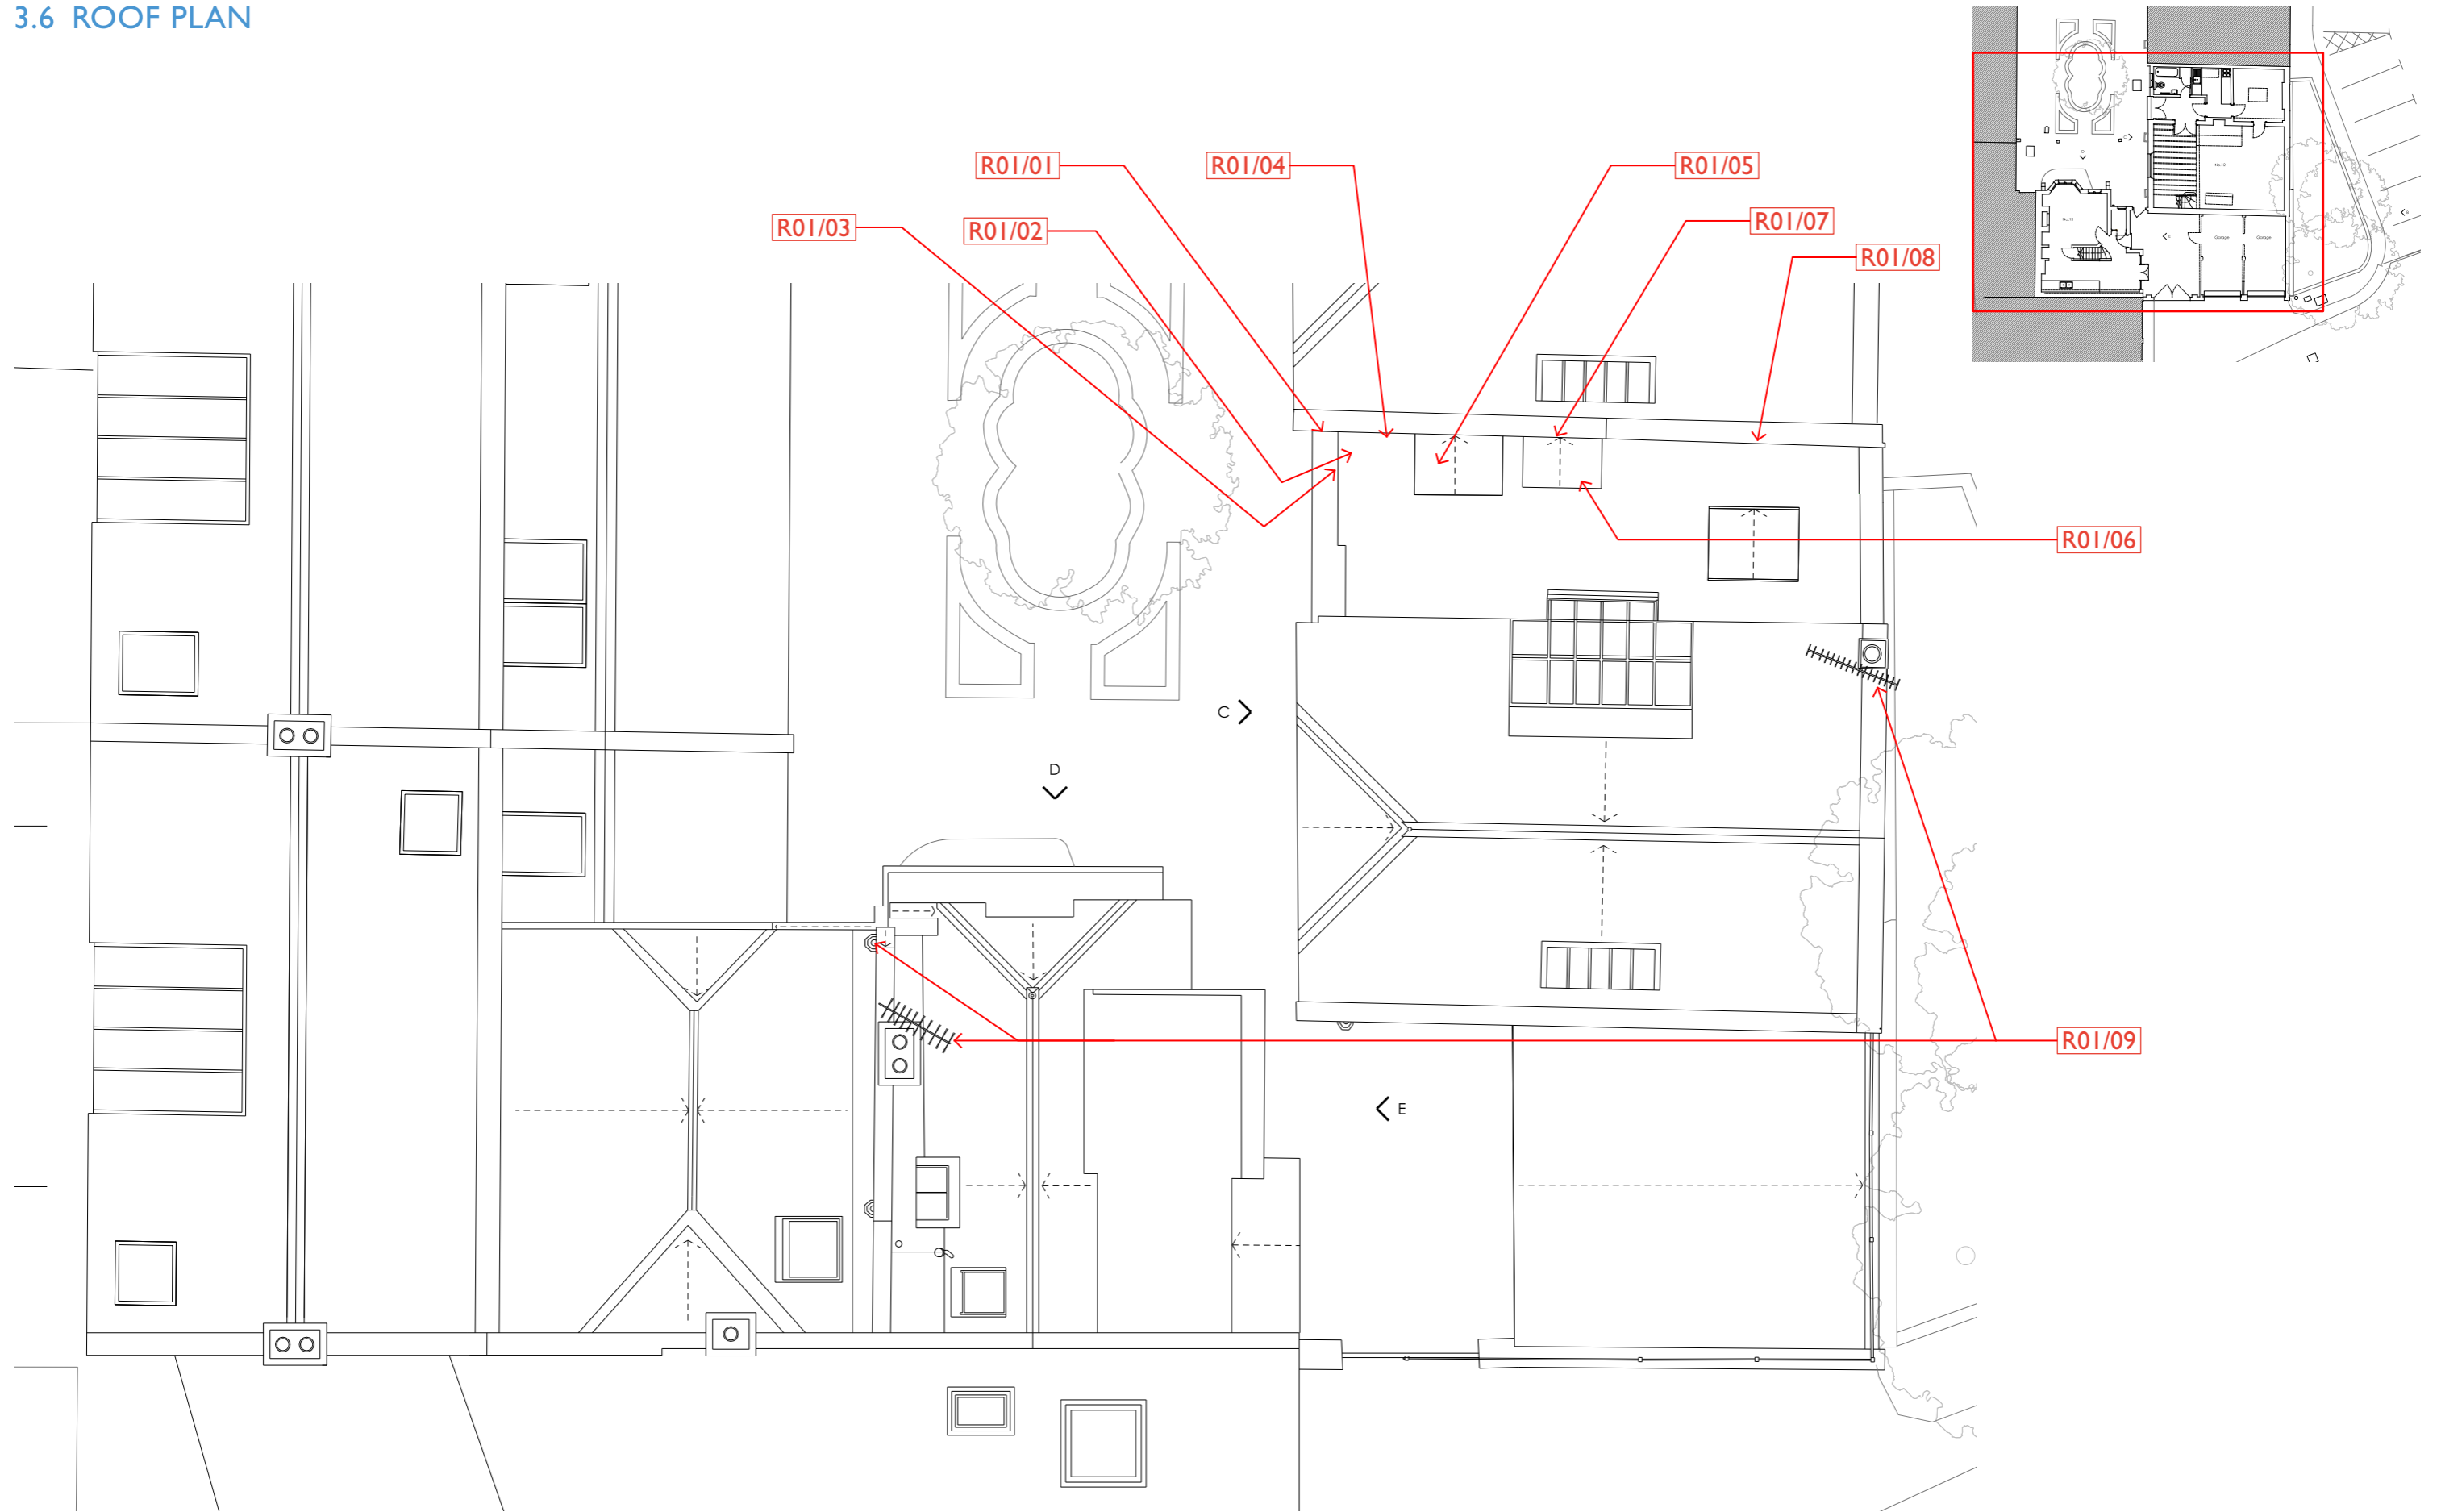
3.6 ROOF PLAN

Pitched roof. The pitched slate roof has weathered and there is evidence of previous repairs and leaks internally. It is proposed to re-roof with a new/ salvaged slate with a new breather membrane and insulation. Existing sound slates are to be reused and the new ones are to match existing, which will be either Welsh Penrhyn (Heather blue/purple) or Cwt-y-Bugail (Dark Blue Grey slate) in size, texture, colour and thickness. We recommend to retain decorative ridge tiles and replace the damaged ones.

- **Flat roof.** The flat roof over the entrance bay has a modern single ply membrane, and is stepped at circa 2 metre increments which indicates that originally it might have had a lead finish. The eastern rooflight is modern with PPC aluminium frame. The central rooflight has been modified and is in a poor condition. Our recommendation is to replace or remove deteriorated and modern fabric to meet proposals of the new scheme.
