**20 WELL ROAD  
WINDOWS -  
DESIGN AND ACCESS STATEMENT**

07th September 2022

**BAYNESANDMITCHELLARCHITECTS**

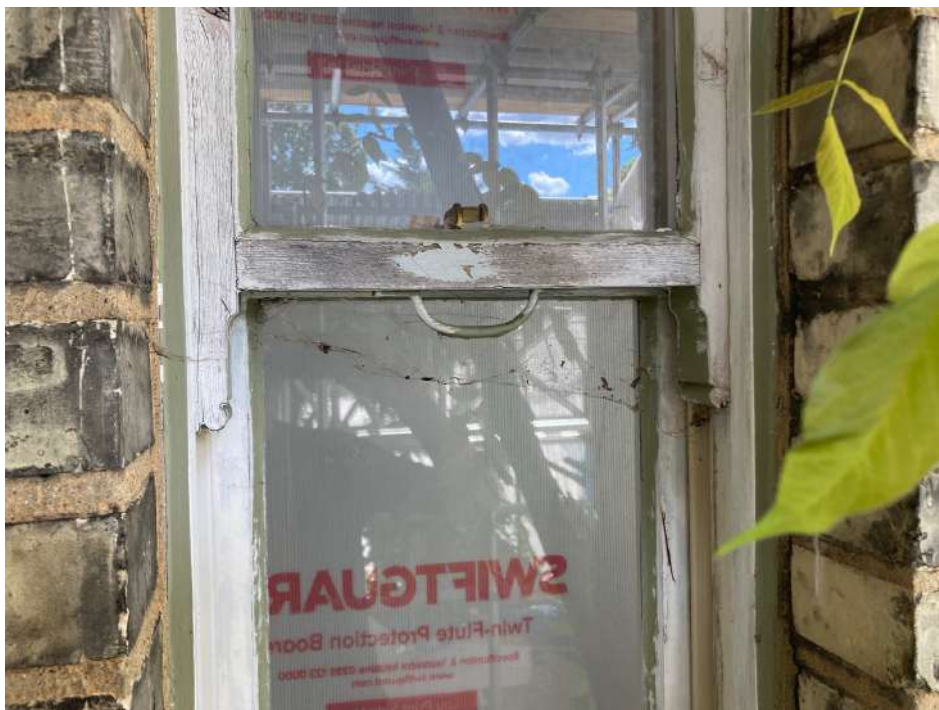
PROFILES AND SIGHT LINES OF EXISTING WINDOWS WILL BE METICULOUSLY RESPECTED

- 3.4 New windows will reduce considerably the energy loss caused by leaks. This application seeks approval to install double glazed units within the replacement windows. All mouldings and sight lines of the existing windows will be meticulously respected.

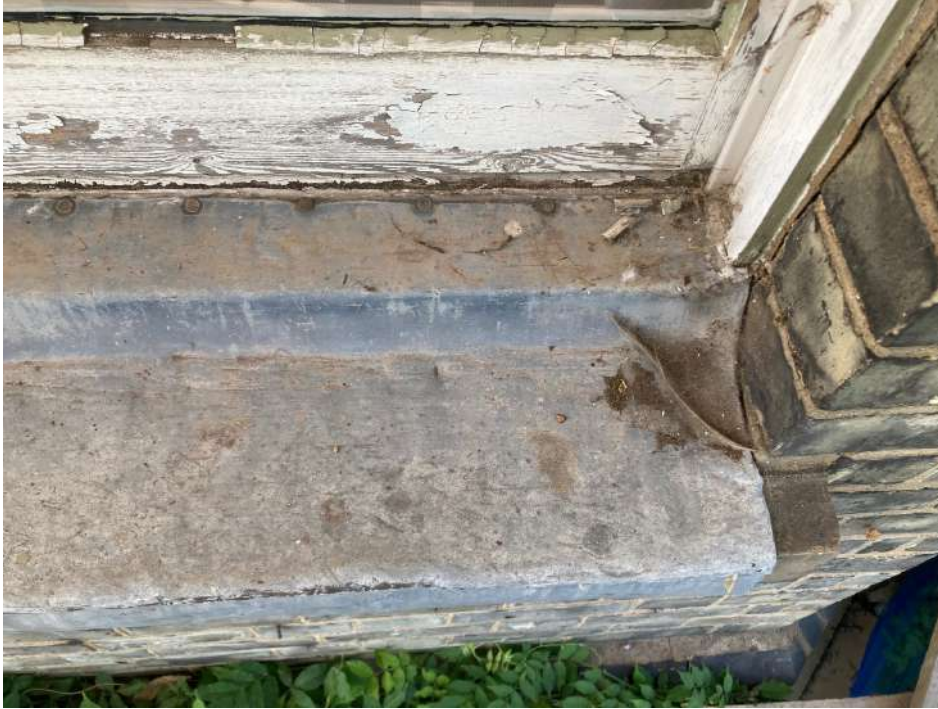
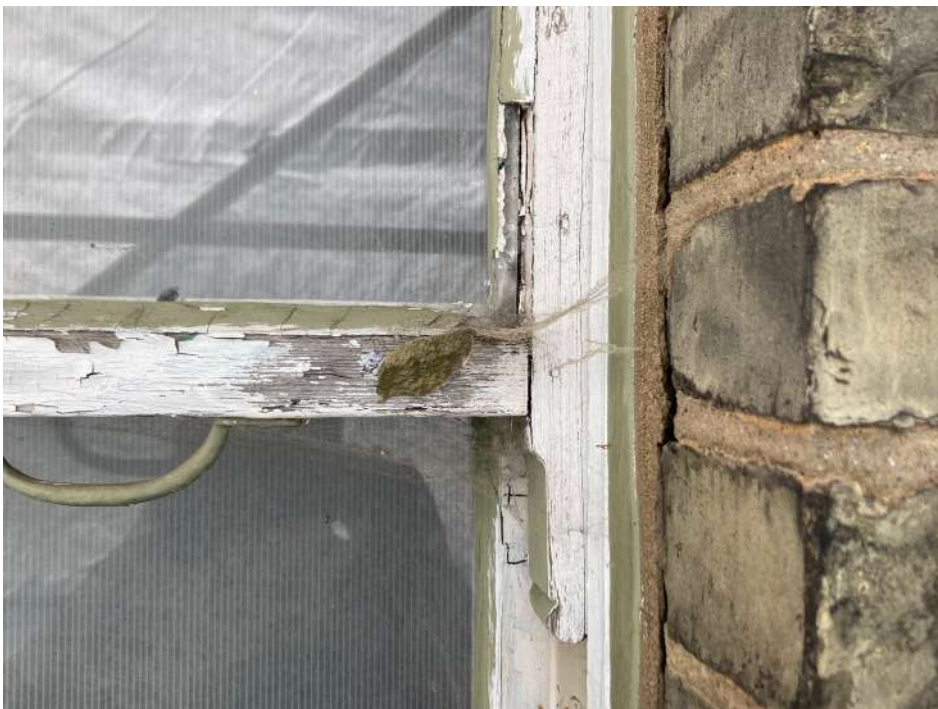
- 3.3 All windows are in a serious state of decay and are in need of replacement. Many of the rotten sills have been lined with lead sheet in an attempt to slow down the deterioration (see pictures).

WINDOWS ARE IN A SERIOUS STATE OF DECAY

- 5.2 The current windows have reached the end of their life cycle and are no longer fit for purpose. They have already had a number of remedial works carried out and a full replacement is now necessary.

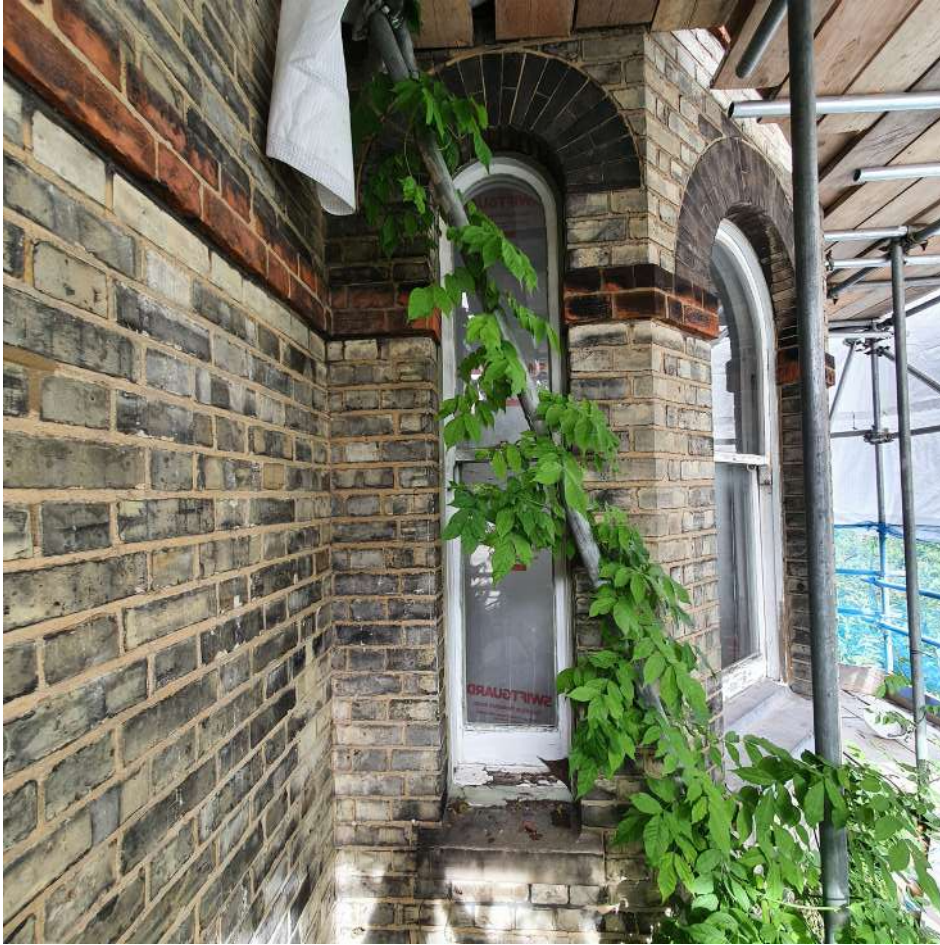
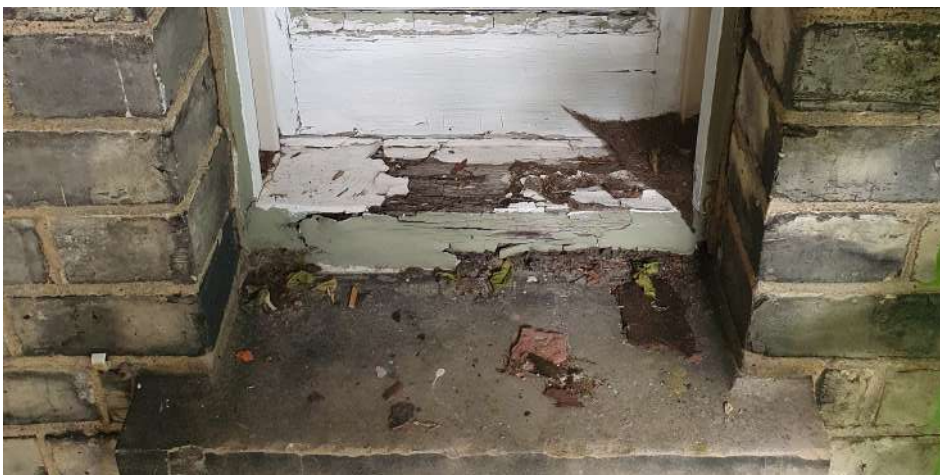
MANY OF THE ROTTEN SILLS HAVE BEEN LINED WITH LEAD SHEET IN ORDER TO SAVE THEM FROM FURTHER DECAY

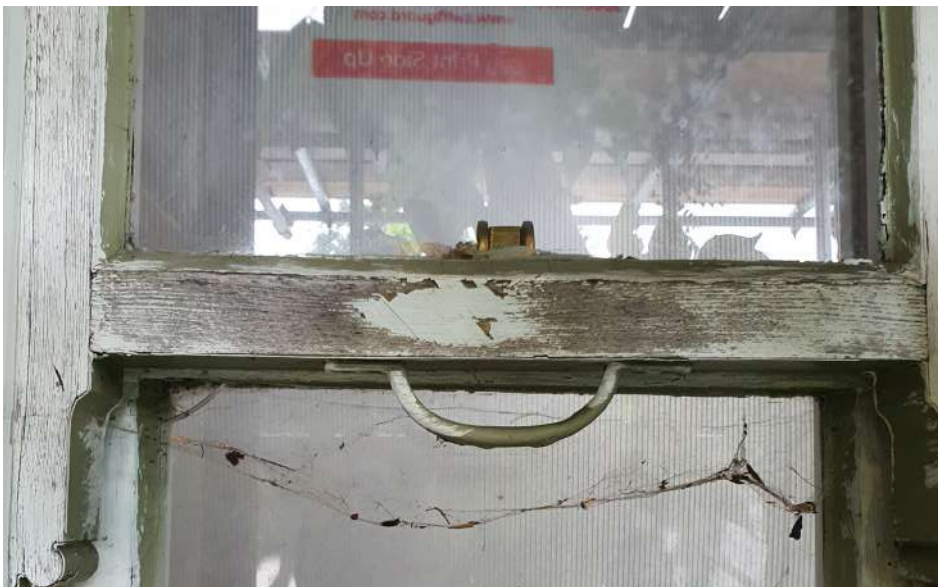
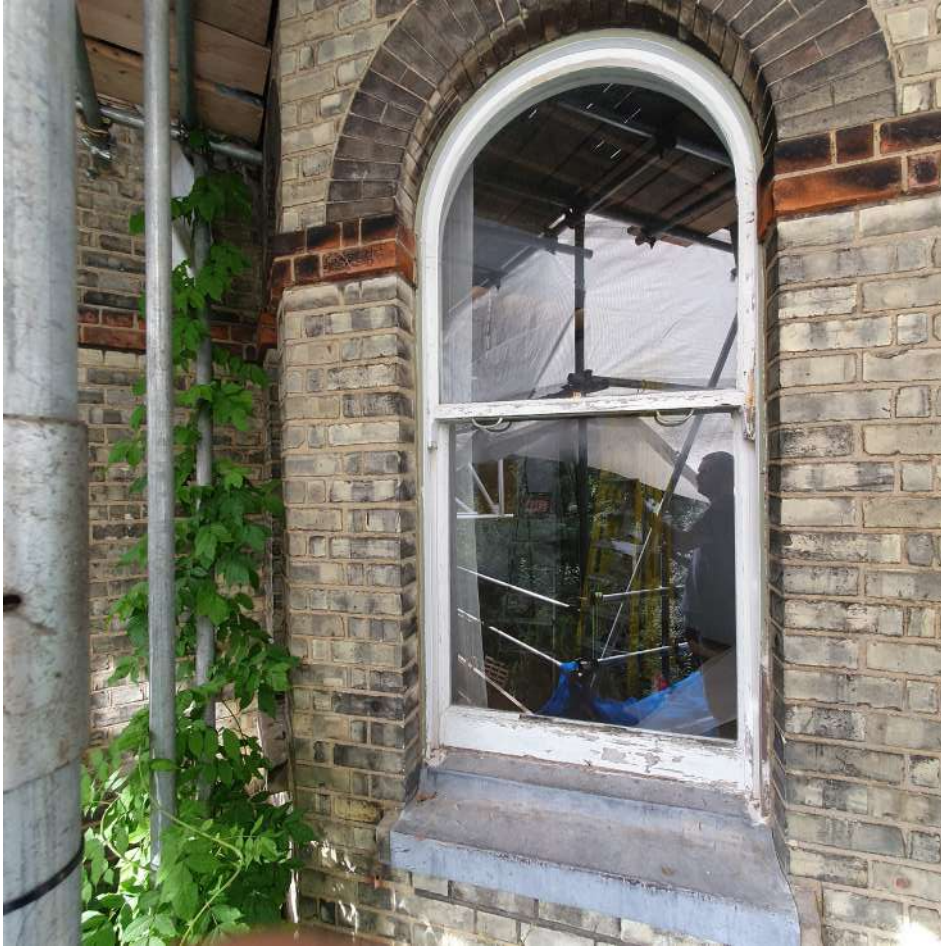
STONE SILLS BENEATH WINDOWS APPEAR TO BE IN GOOD CONDITION AND WILL BE REPAIRED AS NECESSARY AND RETAINED.

- 3.6 There will be no changes made to the structural openings. Stone sills beneath windows appear to be in good condition and would be repaired as necessary and retained.
