BS 5837 Arboricultural Report

**15 Holly Lodge Gardens
London
N6 6AA**

Arboricultural Report to BS 5837: 2012 for: Paul Archer Design Ltd

Crown Ref: 10889

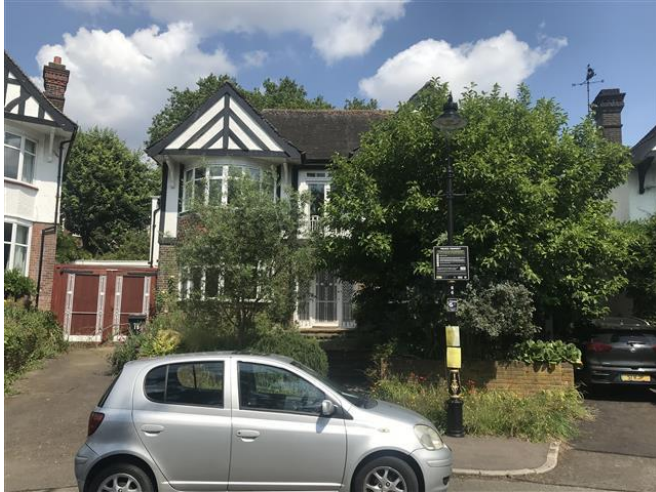
Photo 1.

- 2.1.1. Number 15 Holly Lodge Gardens is a detached, two-storey residential property with gardens to the front and rear.
- 2.1.2. The front garden (see Photographs 1 and 2) contains a semi-mature Olive tree (T1), an early-mature Magnolia (T2) and a semi-mature Spindle (T3). All vegetation is located on a raised garden.

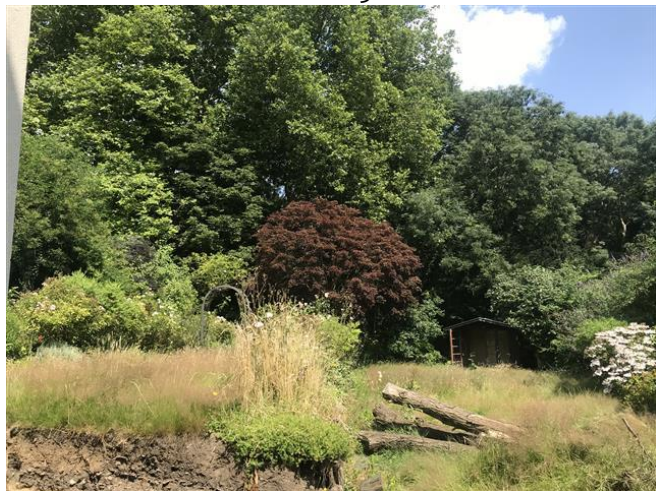
Photo 3.

- 2.1.3. The larger rear garden (see Photographs 3 to 8) contains a semi-mature Yew (T5), a semi-mature Viburnum (T6), an early-mature Japanese Maple (T7) and a group of semi-mature Plum trees (G12). These trees are mostly located towards the rear of the garden.
