TREE SURVEY, ARBORICULTURAL IMPACT ASSESSMENT AND TREE PROTECTION PLAN

A report to accompany a planning application for the demolition of an existing garage, relocation of site access and development of a two-storey extension and basement level at 4 Frognal Rise, London, NW3 6RD

Report by Dr Martin Dobson

5 June 2015

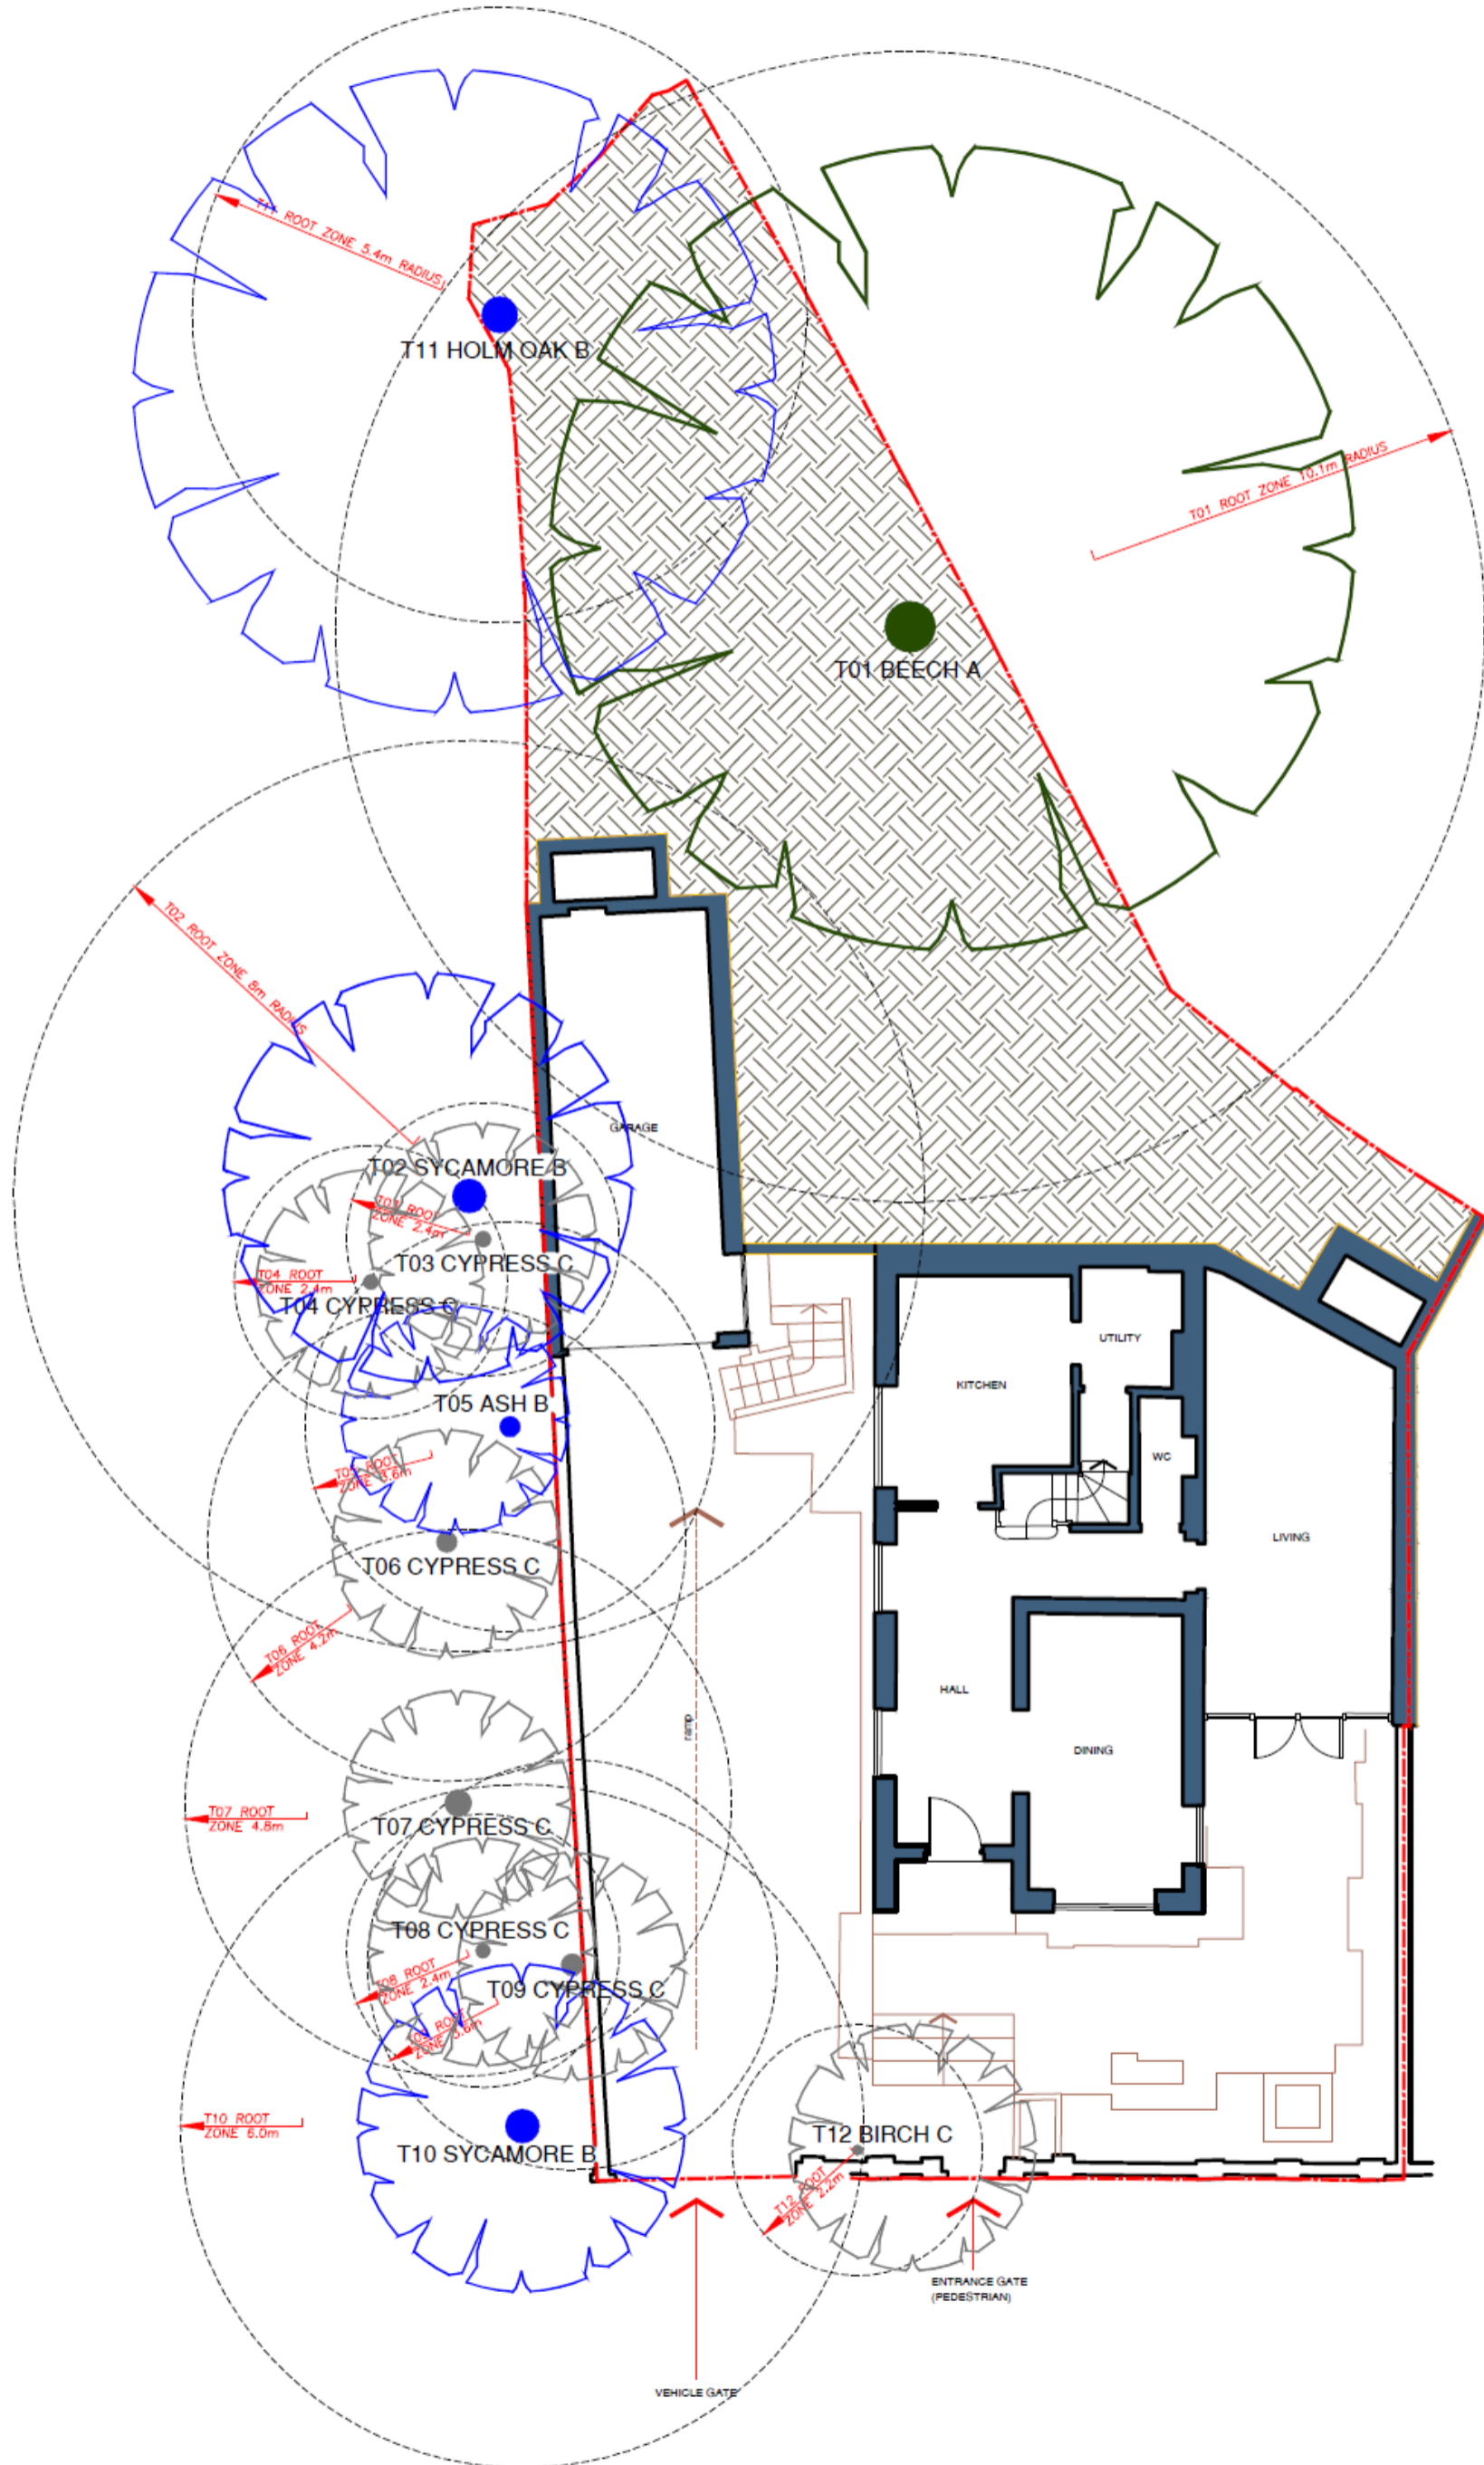
APPENDIX MD2

Tree constraints plan (ground floor) showing existing plot layout with tree numbers, BS5837: 2012 colour codes (A – Green, B – Blue, C – Grey, U - Red) and root protection areas (dashed circles)

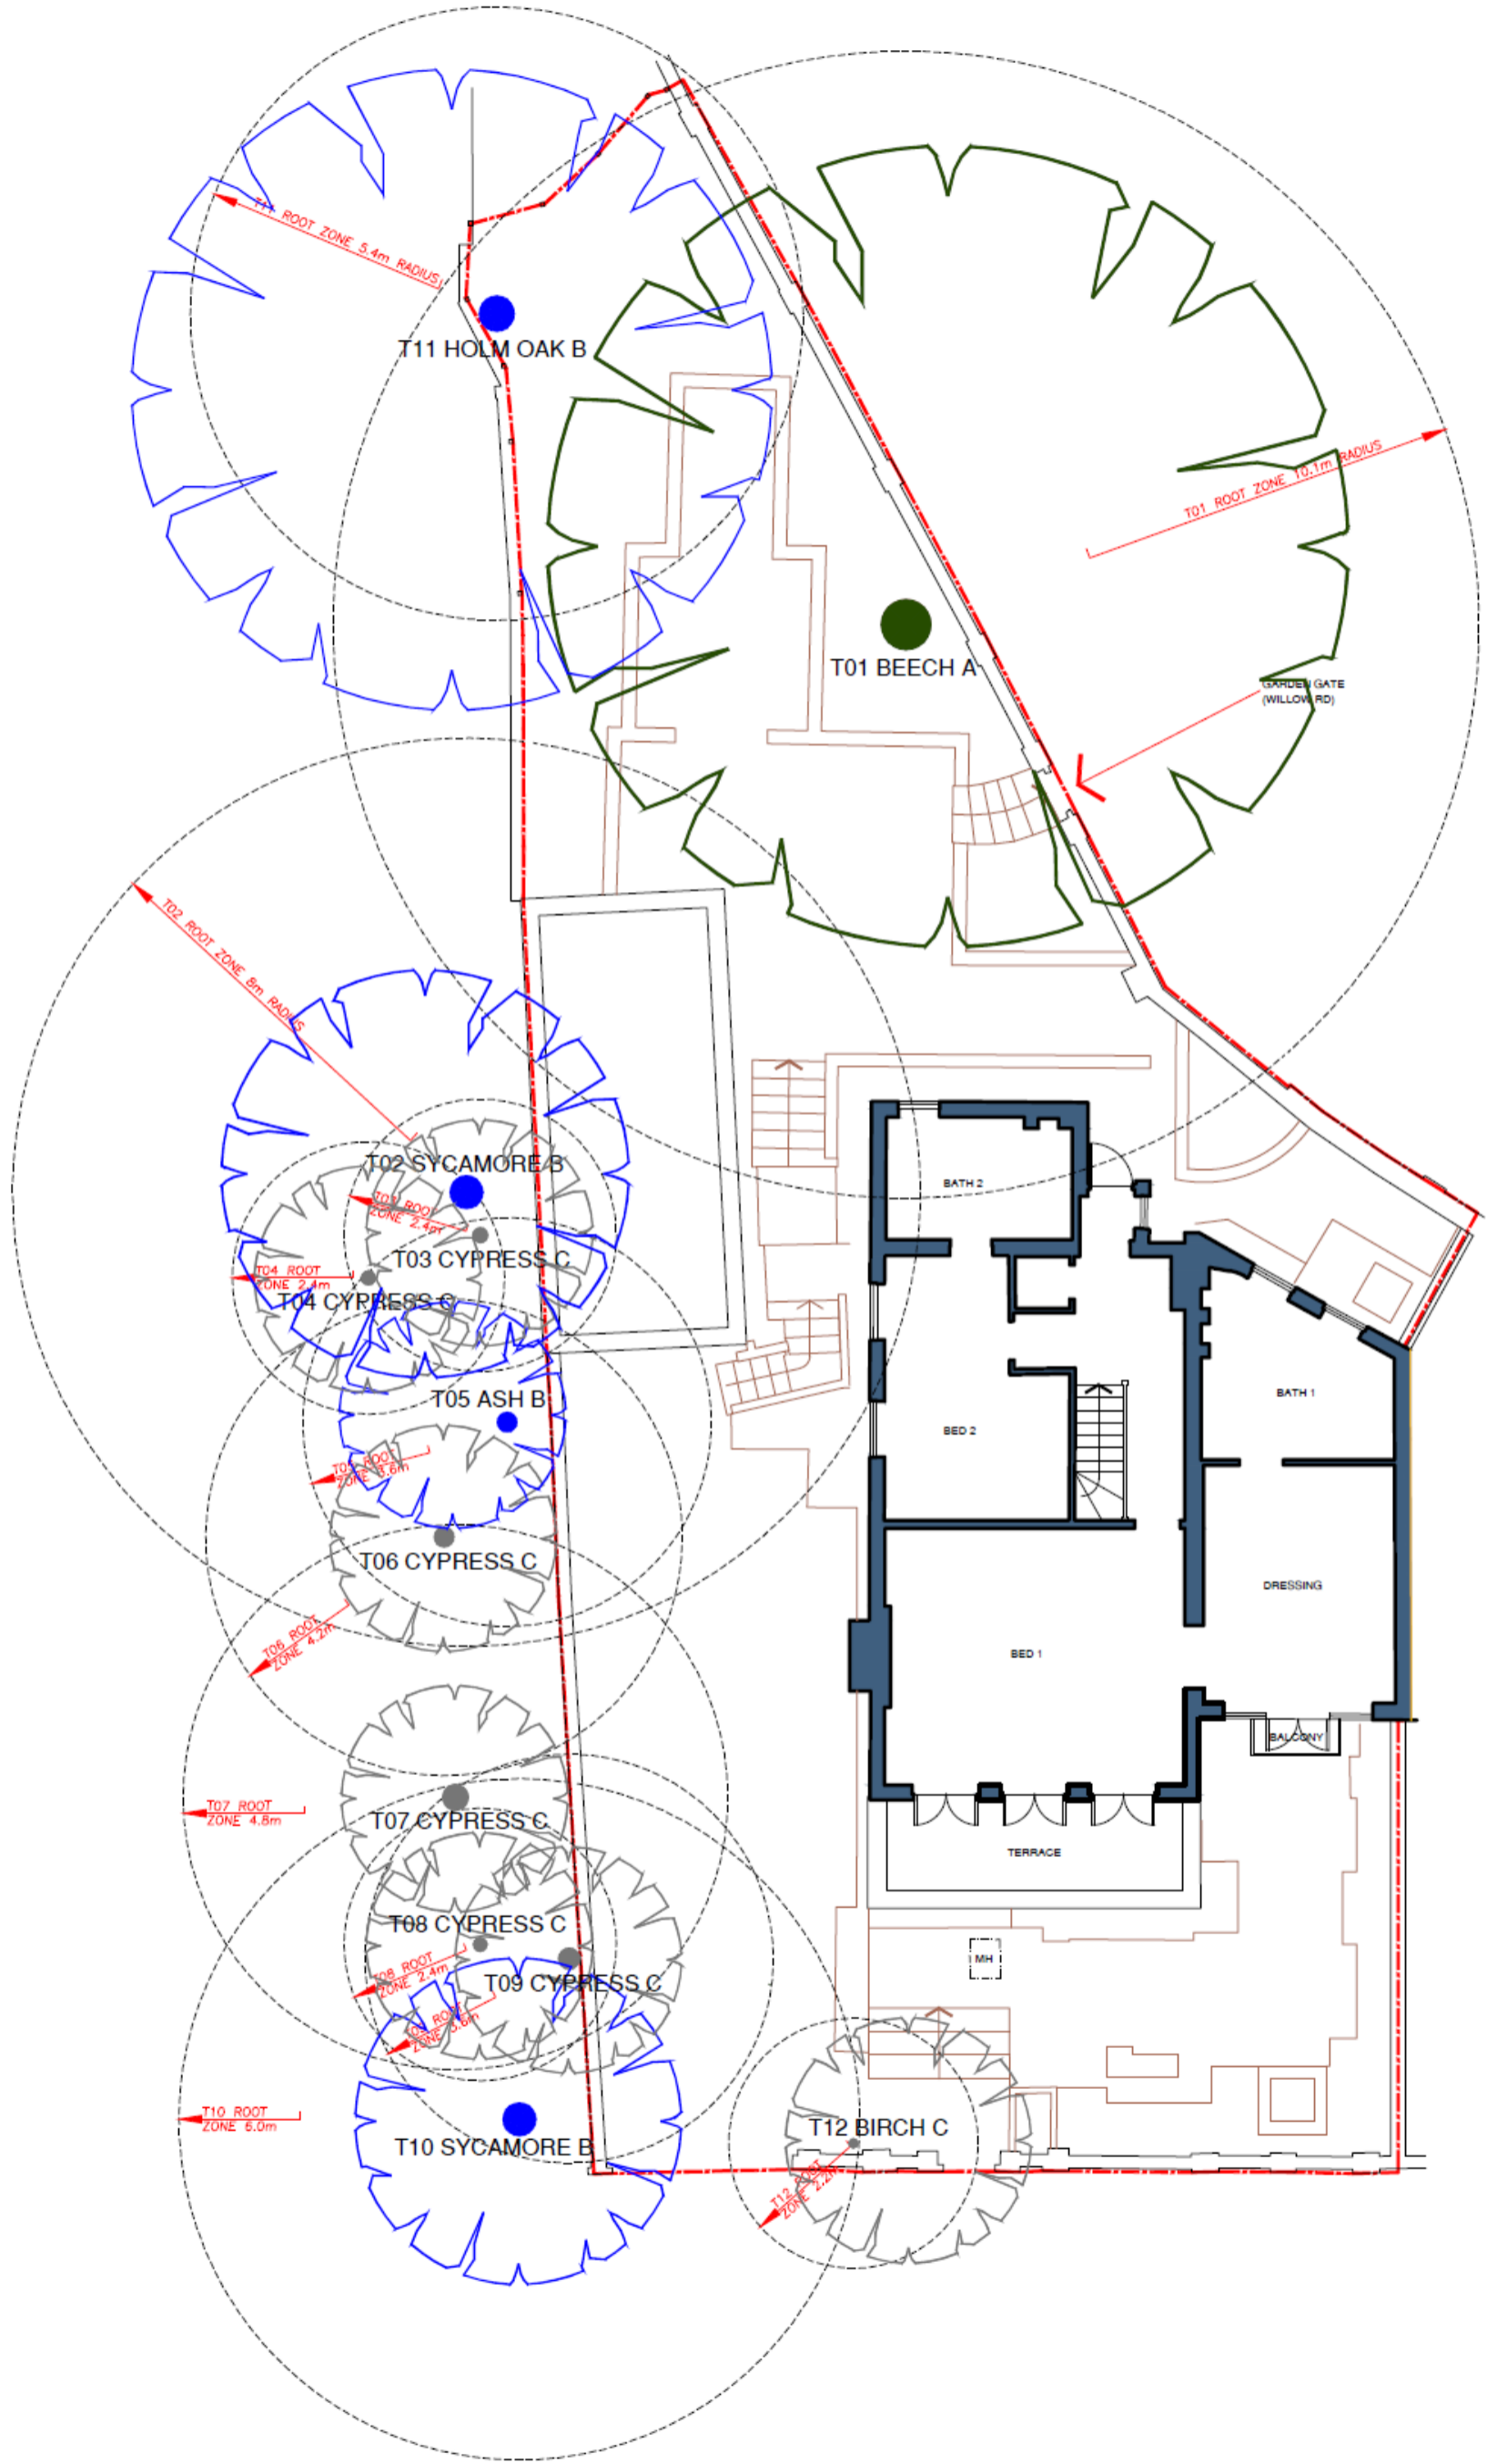
APPENDIX MD3

Tree constraints plan (first floor) showing existing plot layout with tree numbers, BS5837: 2012 colour codes (A – Green, B – Blue, C – Grey, U - Red) and root protection areas (dashed circles)

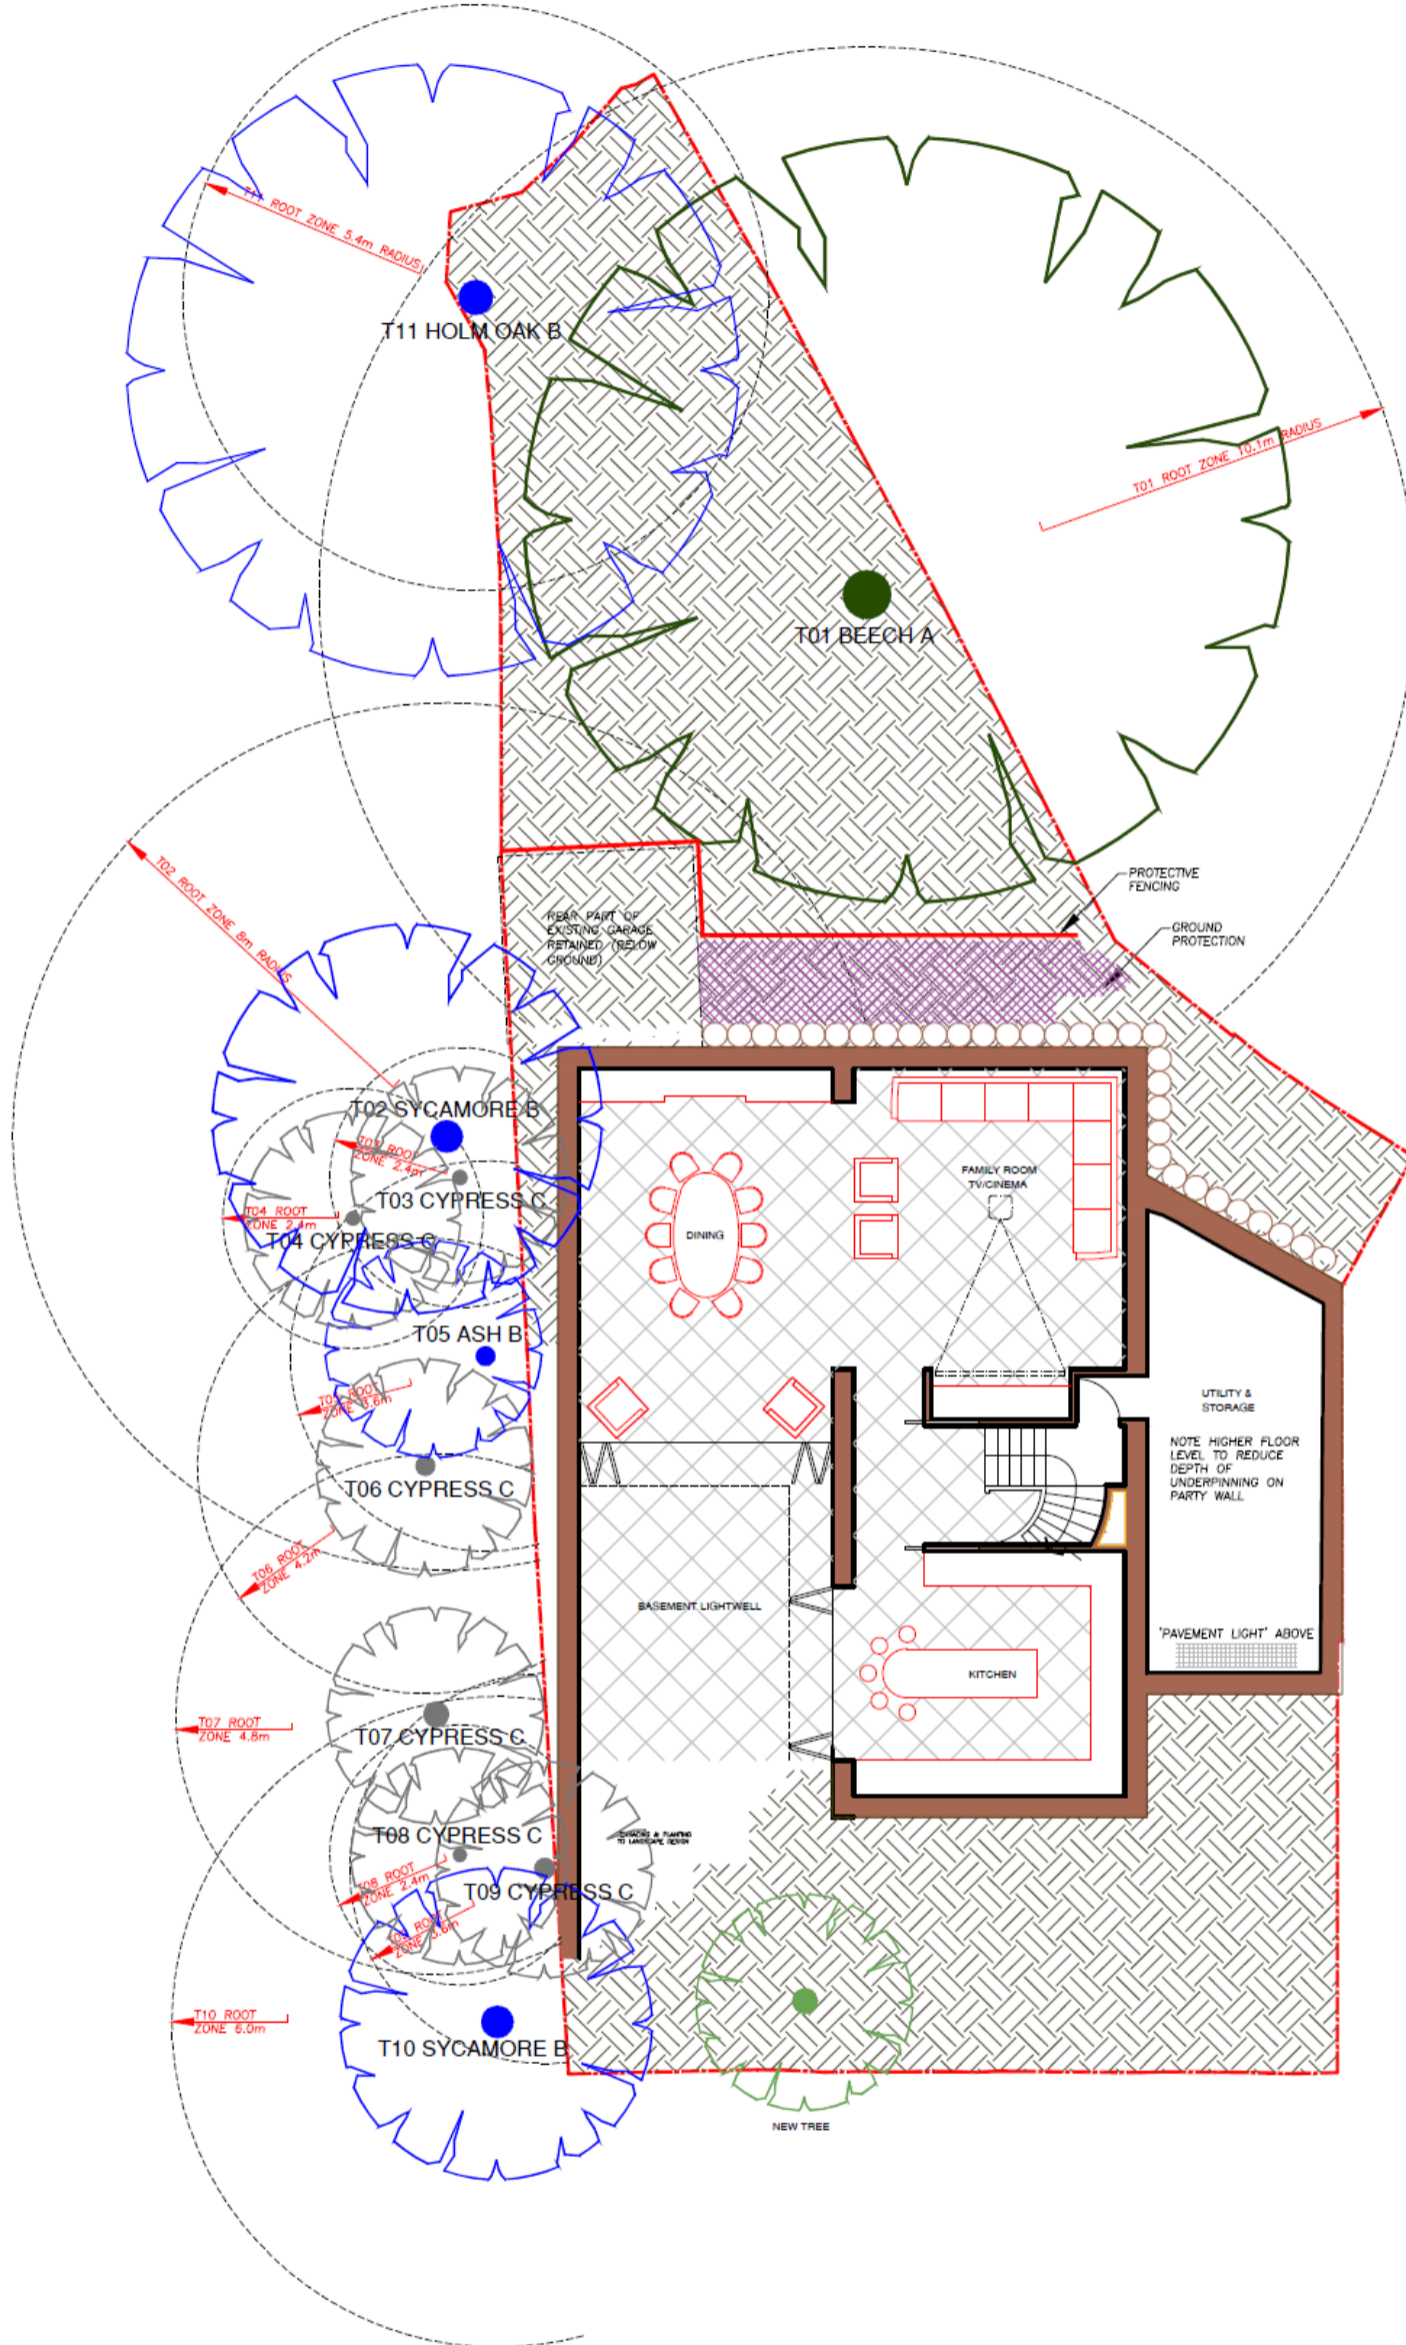
APPENDIX MD5

Tree protection plan (basement floor) showing retained trees, tree numbers and root protection areas (dashed circles). The location of protective fencing is shown as red lines, ground protection as blue hatching and above-ground no-dig driveway as purple hatching.

- 5.3 Tree protection will comprise of 2 m tall fencing installed in the positions shown at **MD5 – MD7** before materials are delivered to site or construction commences. The fencing will consist of a scaffold framework, well braced to resist impacts, with vertical tubes spaced at a maximum interval of 3 m (Figures 9 – 11). Onto this, weld mesh panels or 2 m high shuttering board will be securely fixed with wire or scaffold clamps. Weld mesh panels alone on unsecured rubber or concrete feet will not be used as these are not resistant to impact and are too easily removed by site operatives. An alternative system of bracing which does not require a scaffold framework is shown in Figure 10. Fencing will define a construction exclusion zone (CEZ).

- 5.5 In order to allow access for construction workers and piling rig around the perimeter of the development it is proposed that part of the RPA will be protected by ground protection. The area hatched purple on the tree protection plan (MD5 – MD7) will be covered by heavy duty plywood boards (Figure 13) laid over the existing paving slabs. Once laid the plywood sheeting will be secured in place by wooden battens screwed into adjacent sheets. The existing paving will provide a platform from which the piling rig and site workers can operate without causing compaction of the underlying soil.

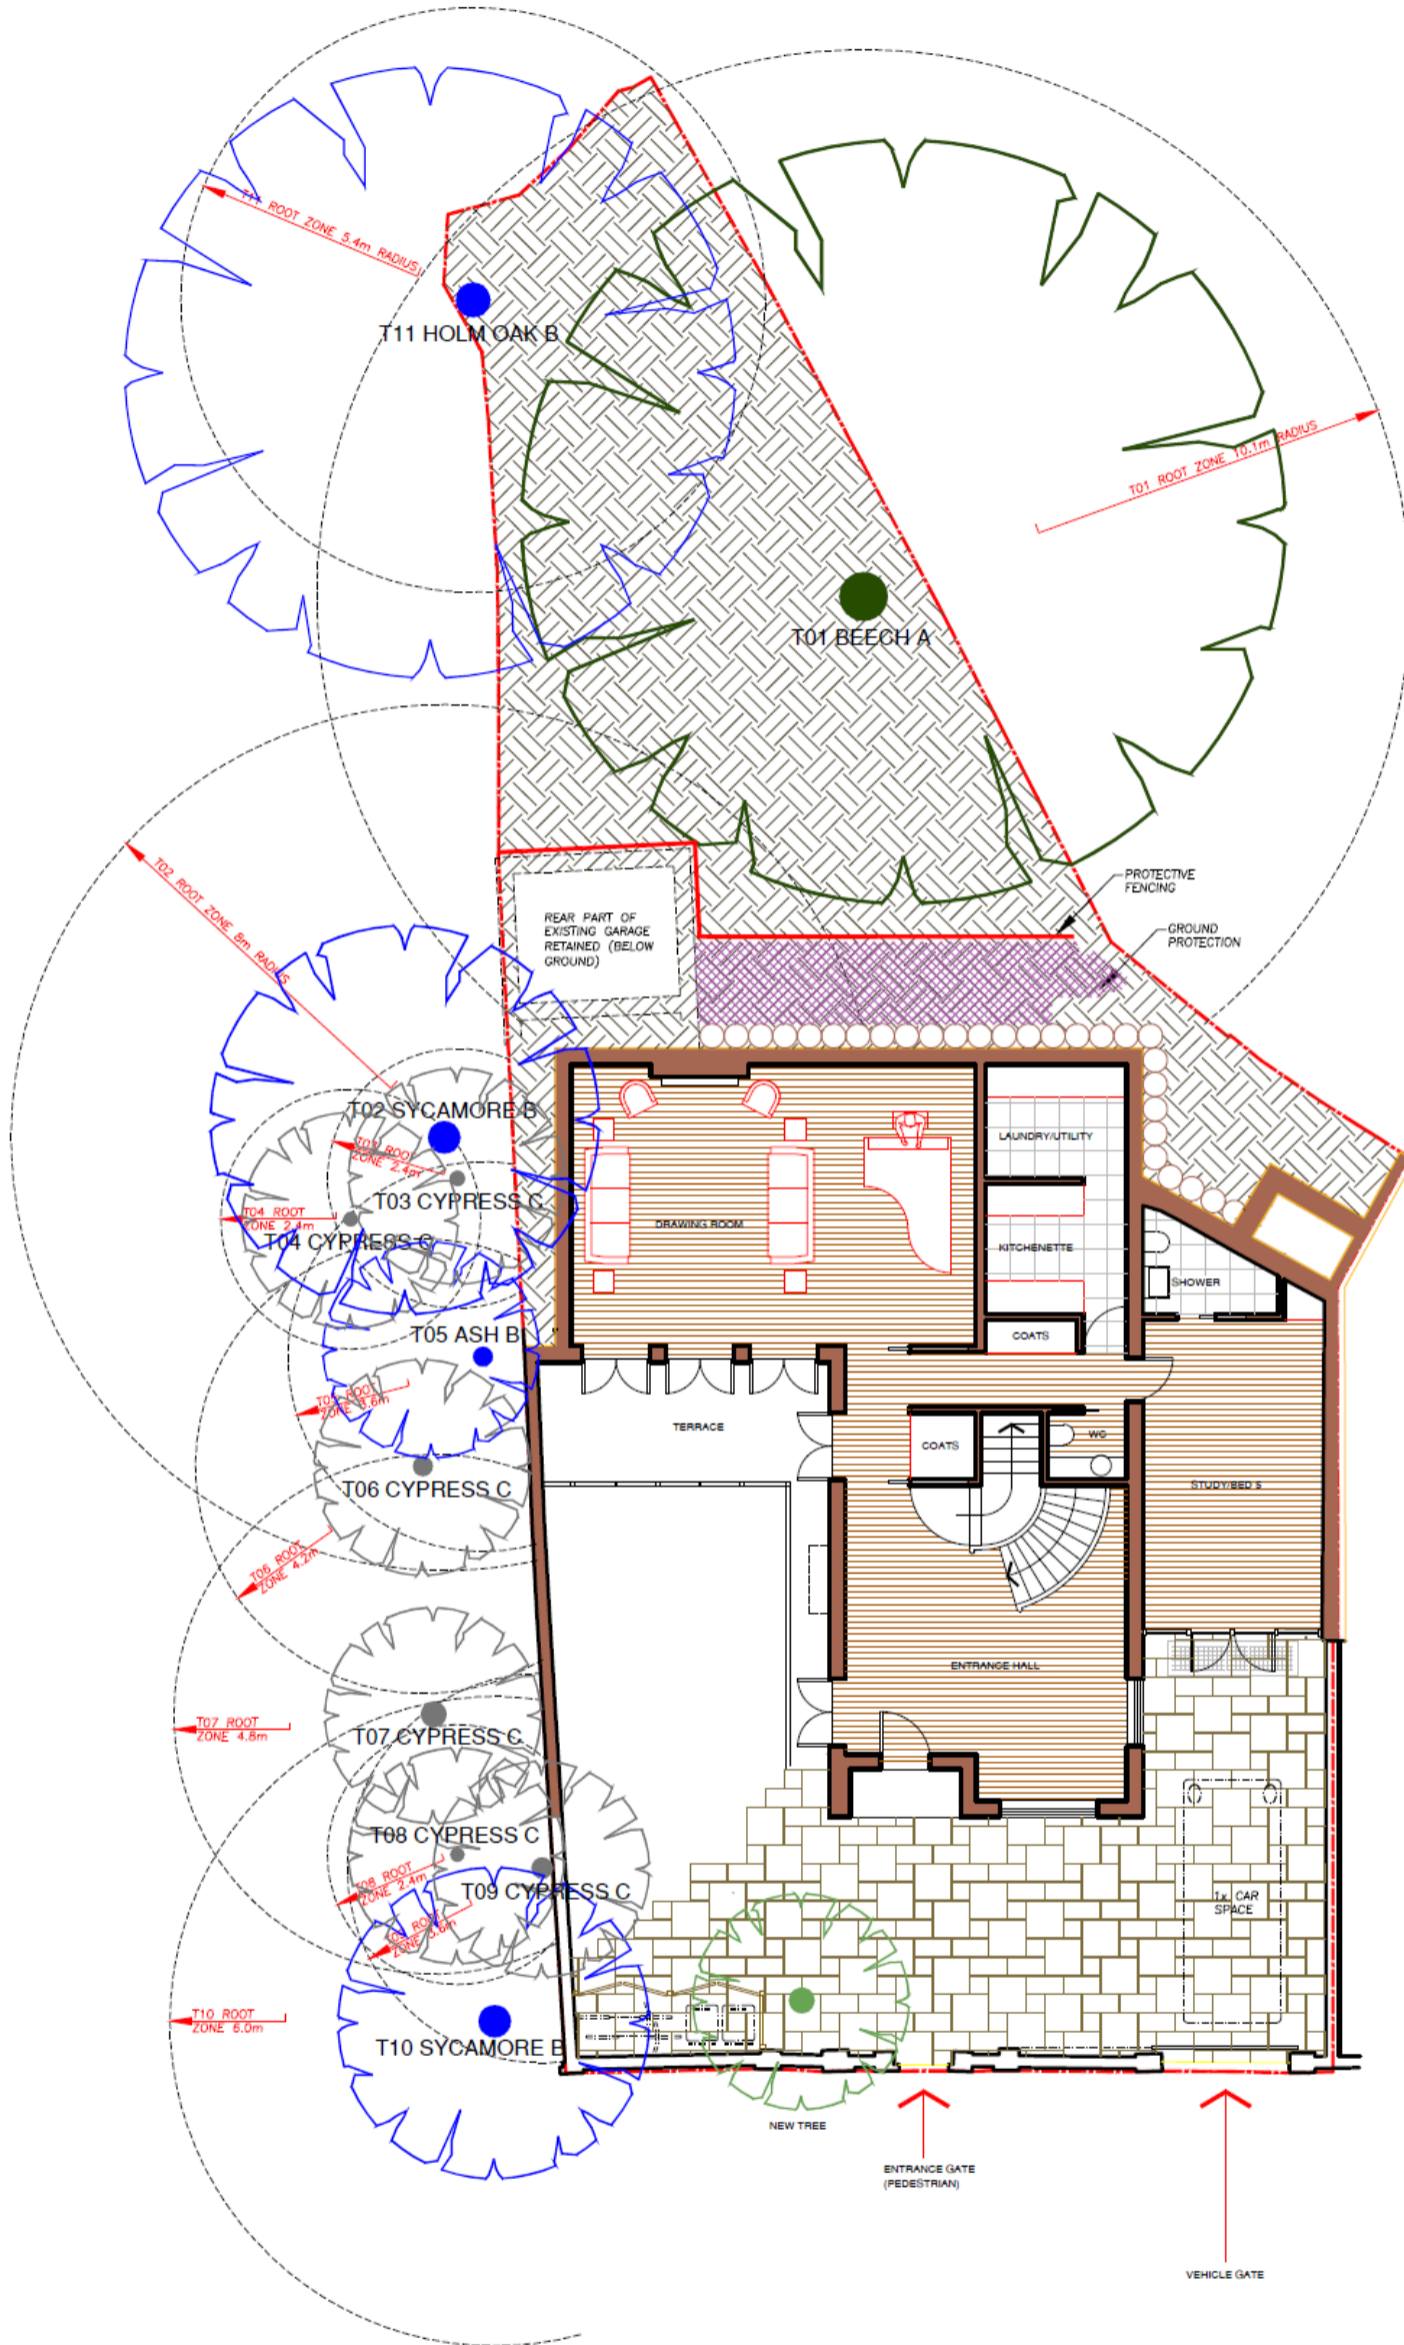
APPENDIX MD6

Tree protection plan (ground floor) showing retained trees, tree numbers and root protection areas (dashed circles). The location of protective fencing is shown as red lines, ground protection as blue hatching and above-ground no-dig driveway as purple hatching.

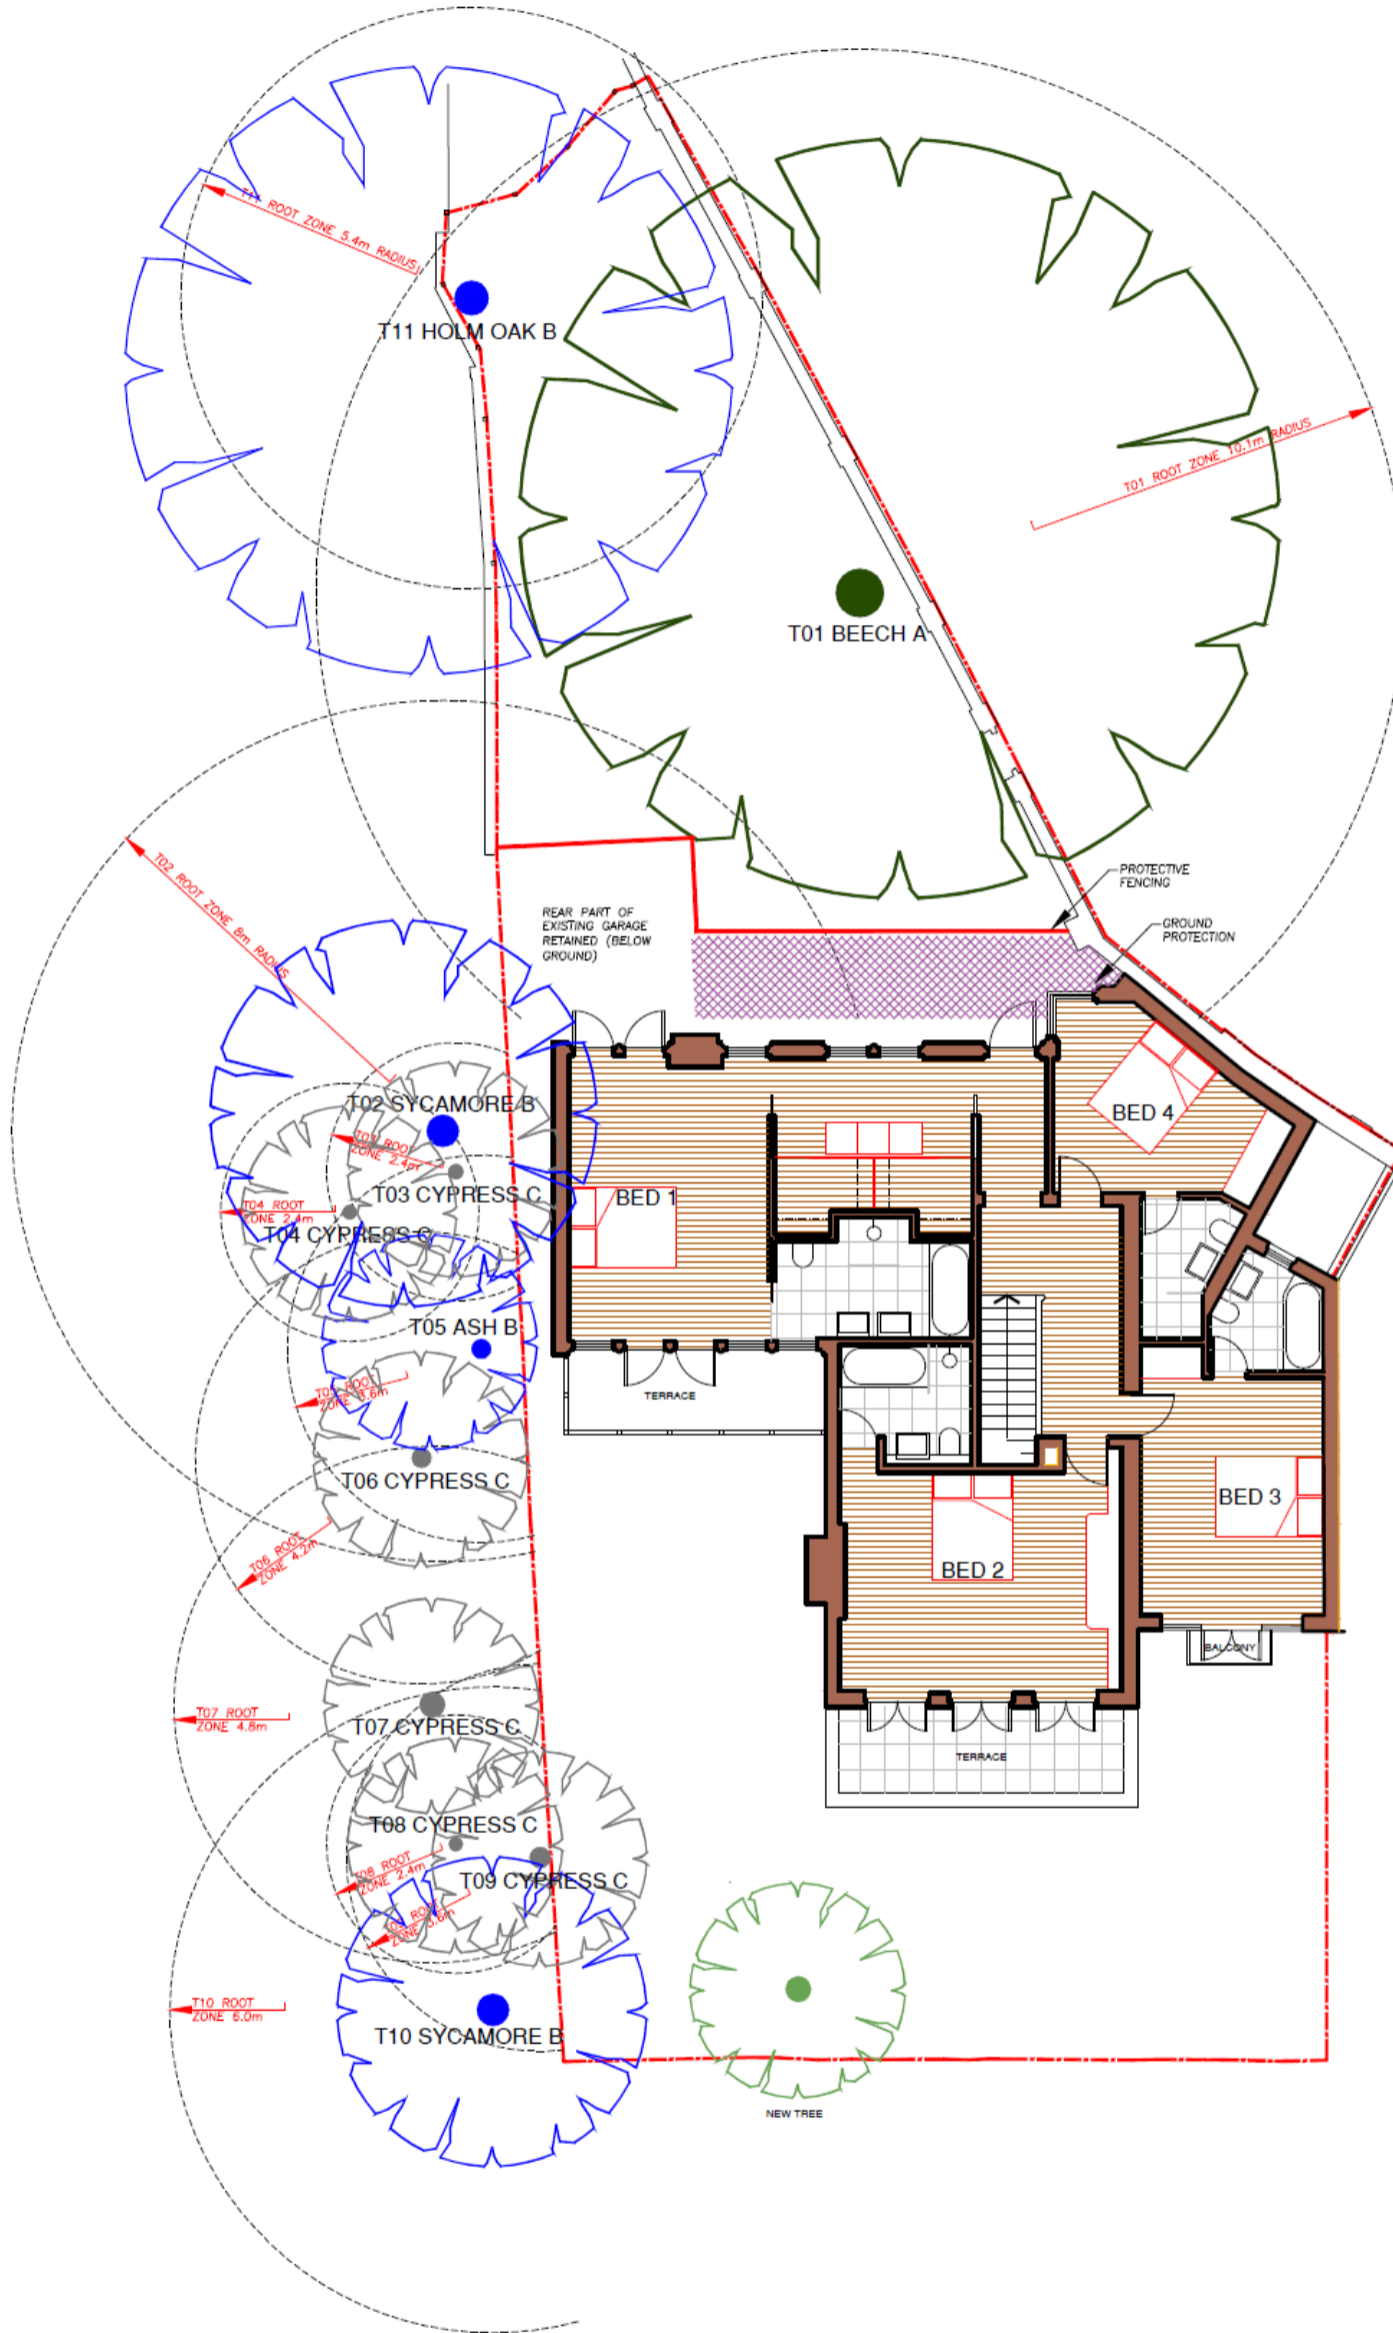
APPENDIX MD7

Tree protection plan (first floor) showing retained trees, tree numbers and root protection areas (dashed circles). The location of protective fencing is shown as red lines, ground protection as blue hatching and above-ground no-dig driveway as purple hatching.
