ADDENDUM TECHNICAL REPORT

Deltamist Limited  
Flats 1 - 9  
8 Compayne Gardens  
NW6 3DH

SUBSIDENCE CLAIM

DATE 23 September 2022

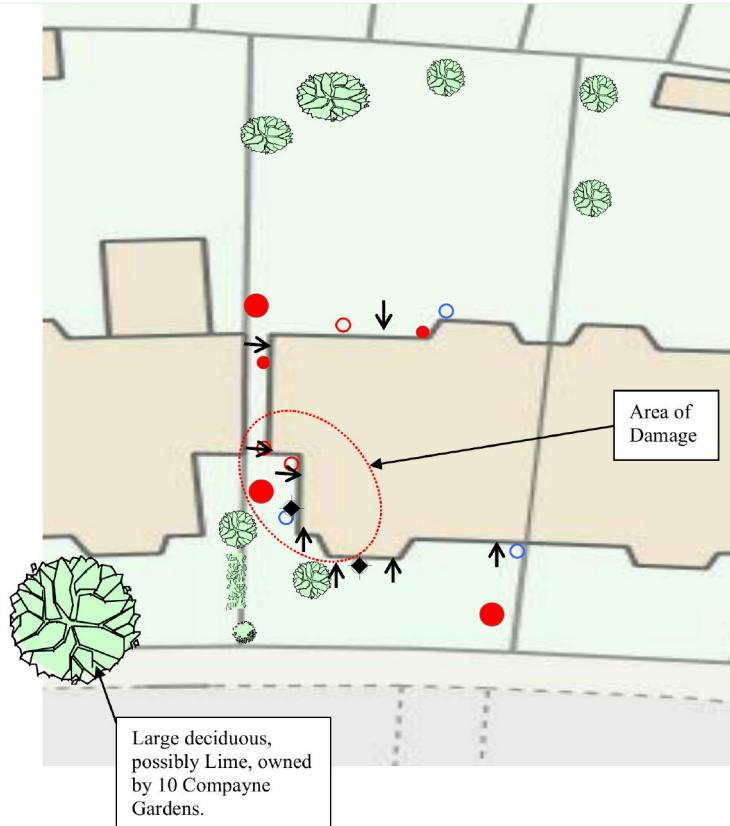
**Site Plan**

A trial hole was excavated to expose the foundations - see site plan for location and the diagram below for details. The foundation is 3 brick corbels over concrete bearing onto dry, stiff, brown, gravelly, silty CLAY. Live roots were observed.

A number of roots have been identified to a depth of 2.17m below ground level from the species LIME, corresponding with the large tree on the pavement in close proximity to the damage.

Defects were identified to one drain close to the front left corner of the main house, but not the front projection which is subject to movement. We have recommended one drain is lined as a precaution, but there is no evidence that water seepage from the defect is influencing ground conditions.
