# Site Investigation Report

Job Information	
Client	Crawford & Co
Client ref	[Redacted]
Visit date	07/03/2022
Report date	07/03/2022

Job Summary	
✓	CCTV survey undertaken. <a href="#">Read more.</a>
!	Drainage repairs required. <a href="#">Read more.</a>
⚠	1 trial hole undertaken. <a href="#">Read more.</a>
!	Trial Hole 2 Aborted. <a href="#">Read more</a>

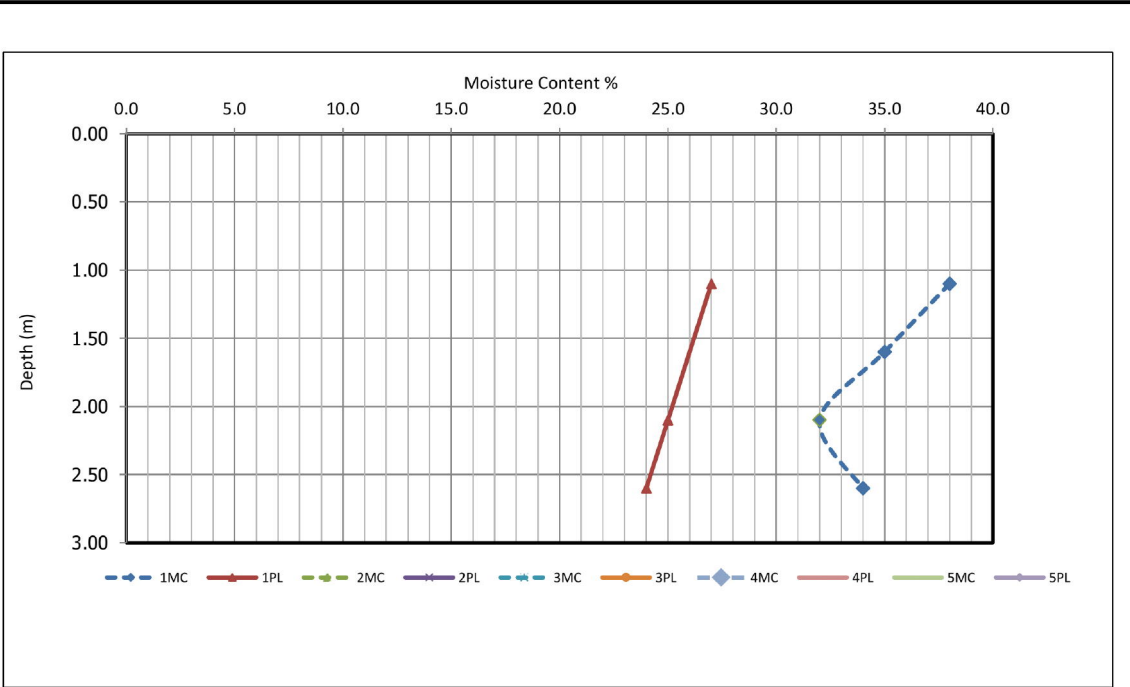
TH Trial Hole	Sample Type	Depth (m)	Moisture Content %	Liquid Limit %	Plastic Limit %	Plasticity index %	Passing ,425mm %	NHBC Chapter 4.2	Remarks
TH1	D	1.10	38	75	27	48	75	HIGH VCP	CV Very High Plasticity
TH1	D	1.60	35						
TH1	D	2.10	32	72	25	47	99	HIGH VCP	CV Very High Plasticity
TH1	D	2.60	34	71	24	47	98	HIGH VCP	CV Very High Plasticity

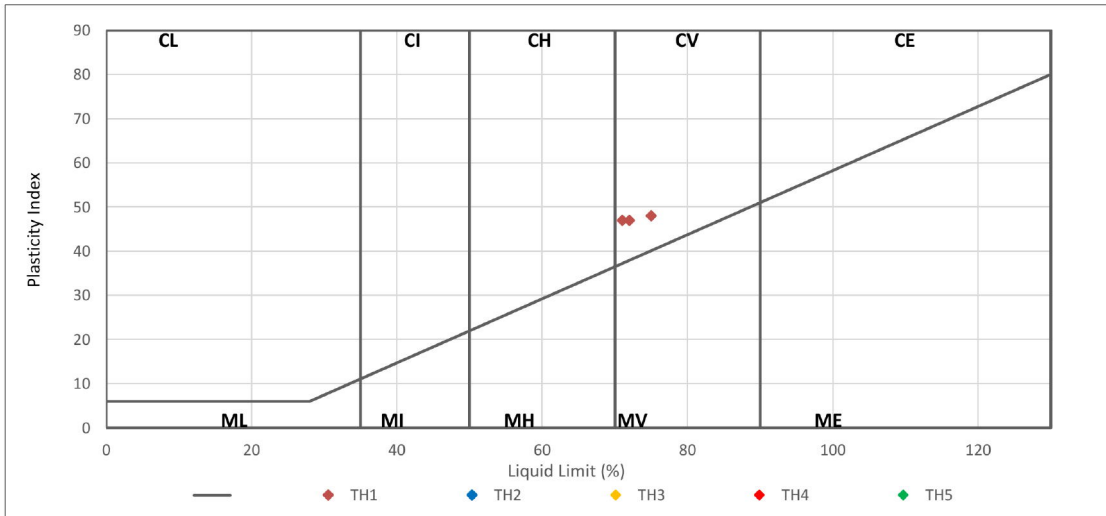
PLASTICITY CHART FOR CASAGRANDE CLASSIFICATION  
BS 5930:1999+A2:2010

Modified Plasticity Index (PI) <10 : Non Classified  
 Modified PI = 10 to <20 : Low volume change potential (LOW VCP)  
 Modified PI = 20 to <40 : Medium volume change potential (Med VCP)  
 Modified PI = 40 or greater : High volume change potential (HIGH VCP)
